Analyzing Failure Characteristics and Potential of Landslides in Hai Van Mountain, Vietnam

Tien PHAM⁽¹⁾, Kyoji SASSA⁽²⁾, Kaoru TAKARA⁽¹⁾, Khang DANG⁽¹⁾ and Loi DOAN⁽³⁾

(1) Disaster Prevention Research Institute, Kyoto University, Japan

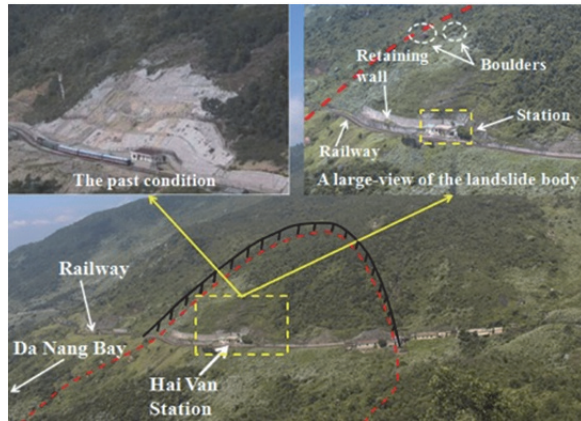
Fig. 5 Landslide description in May, 2014 and its past condition (a photo taken by Institute of Transport Science and Technology in Vietnam)

Field investigations indicated an active deep landslide with main scarp (a black color line) and body parts (a red color dotted line) on the slope

behind the Hai Van station (Fig. 5). It is very clear to see that the landslide body have a tongue-shape and a convex surface. Estimated size and extent of landslide are about 150 m and 250 m of width and length, respectively. Landslide types are translational or rotational modes like a tongue-like shape landslide, which has a potential sliding surface existing in the layer of weathered granitic rocks with a depth more than 15 m.

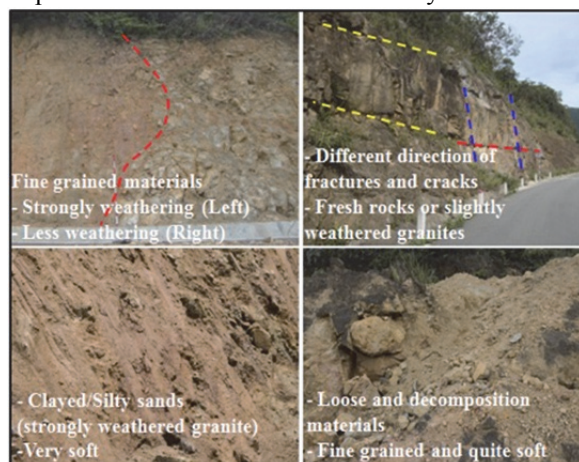
Fig. 6 Materials of weathered granite rocks slide. In addition, in the layer of high permeable

Various materials of granite rocks with different weathering grades were found around the landslide area in the site survey such as a thin layer of colluviums, loose soil-like materials, slightly soft and fine grained materials, clayed or silty soil-like material and sand-like materials. The detailed description of various weathered granite materials is presented in the Fig. 6. Among them, granites are in both fresh or decomposed types completely with strong or less weathering degree in different layers and directions. The weathering of granitic rocks not only results in decreasing of material strength on the slopes but also the materials are very sensitive to

materials like sands, rainwater is easily to infiltrate into sub-surface resulting in increasing of pore-water pressure of which poses the slope to failures.

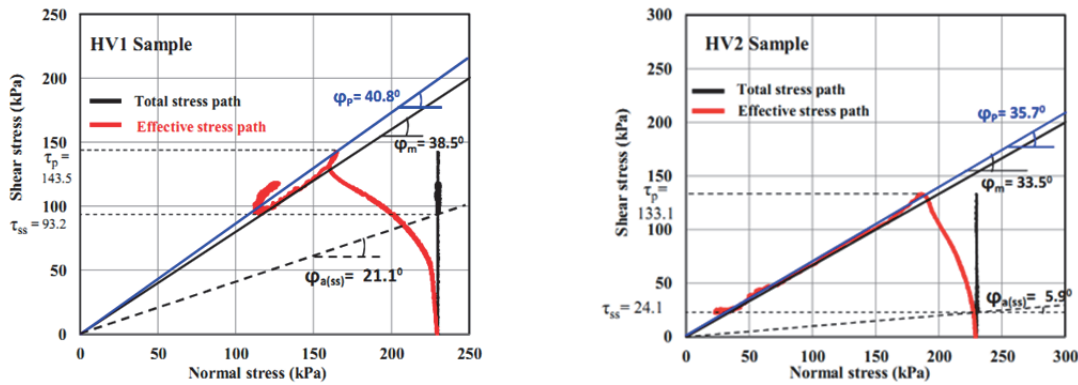
Fig. 7 Effective stress path of un-drained shear stress control test for HV1 sample (left) and HV2 sample (right)

The shear stress control tests are not only to measure physical mechanical soil properties but the simulation is also very useful to investigate failure behavior of landslide during motion and post-failure period (Sassa, 2004). The test results of two samples are presented in the Fig. 7 that shows the effective stress path (a red color line) and the total stress path (a black color line) as well as physical parameters monitored including shear stress at peak τ_p and at steady state τ_{ss} , friction angle during motion ϕ_m , peak friction angle ϕ_p , apparent friction angle $\phi_{a(ss)}$. For HV2 sample, stress path that reached the failure line (red color line) and then moved down rapidly along the failure line to the steady state stress point at a very low value of residual strength (24.1 kPa). In contrast, after reaching the failure line, shear resistance of HV1 sample gradually decreased to a constant value of a higher residual strength (93.2 kPa) before the stress path had a tendency to go inversely along with a negative in pore-water

pressure value. The reason is because there was excess pore-water pressure generation during shear displacement after the failure of HV2 sample whereas there was not much increasing of pore pressure for HV1 sample. The peak friction angle (ϕ_p) of HV1 sample and HV2 sample are around 41.0° and 36.0°

with 143.5 kPa and 133.1 kPa of maximum shear resistance, respectively. The friction angle during motion (ϕ_m) of two landslide samples at large displacement are about 38.0° for HV1 soil sample and 33.5° for HV2 sand sample.

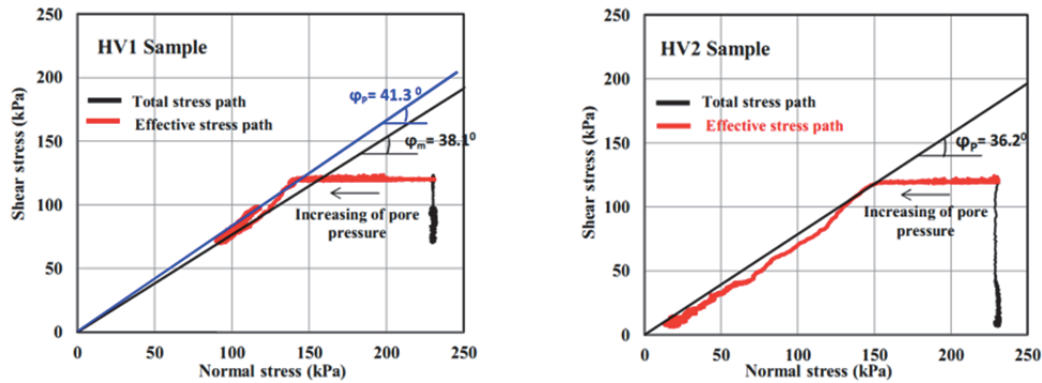
Fig. 8 Effective stress path of pore-water pressure control tests on HV1 sample (left) and HV2 sample (right)

Rainfall-induced landslides were produced by increasing gradually pore-water pressure simulating the rise of ground-water level during rainfalls. In these tests, both samples were consolidated to 230kPa in normal stress and 120 kPa in shear stress. Then pore-water pressure was increased up to 200 kPa at a rate of 1.5 kPa/sec for HV2 sample and at a lower rate of 0.2 kPa/sec for HV1 sample due to its low permeability. The test results of two landslide samples are shown in the Fig. 8, with red color line showing effective stress path and black color line showing total stress path.

The results show that HV1 sample failed around 95 kPa of pore-water pressure increment while failure occurrence of HV2 sample was earlier to occur with about 80 kPa of additional pore-water pressure value. The critical pore pressure ratios of HV1 sample and HV2 sample (r_{u1} and r_{u2}) are corresponding to 0.41 and 0.34. For the HV1 sample, the friction angle at peak (ϕ_p) stayed at about 41.3° and for the HV2 sample, this angle value was only 36.4° .

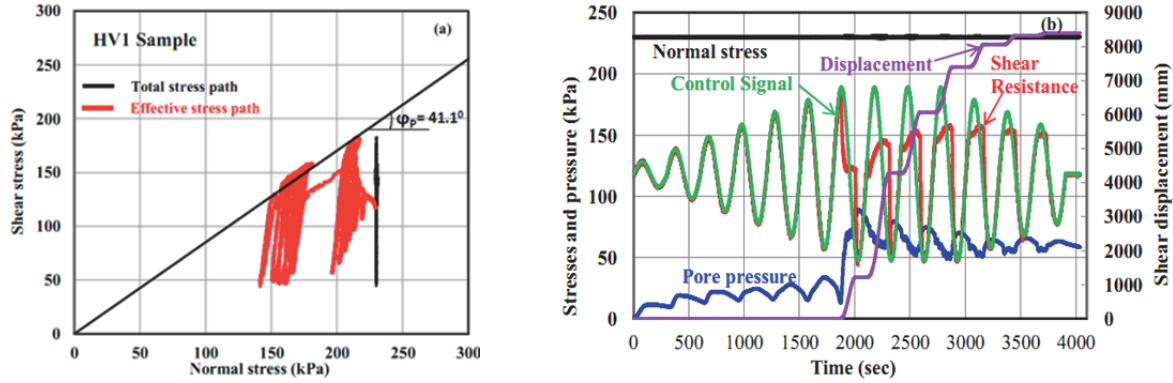
Fig. 9 Effective stress path (left) and time series of cyclic loading test for HV1 sample

surface was created at 230 kPa of normal stress and at 120 kPa of shear stress in the drained condition. Next, the initial cycle of shear stress increment ± 10 kPa in sine curve and the second cycle of shear stress increment is also ± 10 kPa until 7th cycle and 5th cycle of shear stress increment for HV1 sample and HV2 sample respectively under un-drained condition. The results of cyclic tests of HV1 sample and HV2 sample are presented in the Fig. 9&10, respectively. Figures 9-(a) and 10-(a) present time series data of cyclic tests, where the black line represents normal stress, the red line shows the shear resistance mobilized on the sliding surface and the green line shows the control signal for shear stress which was given by the servo-stress control motor. During tests, the pore-water pressure (a blue color line) was monitored along with the shear displacement (a purple color line). Figures 9-(b) and 10-(b) show the stress path, with a red color line showing effective stress path and a blue color line showing total stress path. Similarly to the results of un-drained shear stress control tests, friction angles at peak of landslides are approximately 41.1° for HV1 sample and 36.5° for the HV2 sample.

failure line at the last cycles of cyclic loading, shear behaviors of two samples are very different in post-failure stage. Shear displacement ceased at large displacement of 10 m for HV2 sample landslides while movement of HV1 sample landslides stopped after cyclic loading and start to move very slowly at the next cycles. The rapidly accelerated motion was produced after failure of HV2 sample. By contrast,

shear displacement and deformation of HV1 sample were accumulated only during cyclic loading. Consequently, at the last cycle of shear stress loading, there was no more shear displacement and pore-water pressure generation. Thus, landslide movement stopped at around 8.4 m of shear displacement before the termination of simulation tests.
