Engineering Geological Asset Management for Large Dams

Abstract

4. Case study

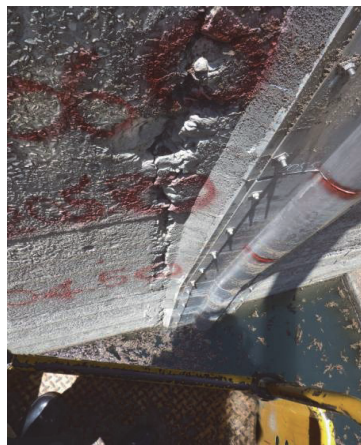
Photo.1 is an open crack along a transverse joint of a gravity dam. This crack is thought to have opened by a strong earthquake. This transverse joint exists just on steep and partly over-hanged foundation. Therefore, loosen rock mass, which has been formed by river erosion in long period, may affect the occurrence of open crack. But it is generally difficult to determine the cause. Therefore, in this case, drilling surveys and borehole observations were performed to confirm the stability of foundation.

Photo.1 Open crack along a transvers joint

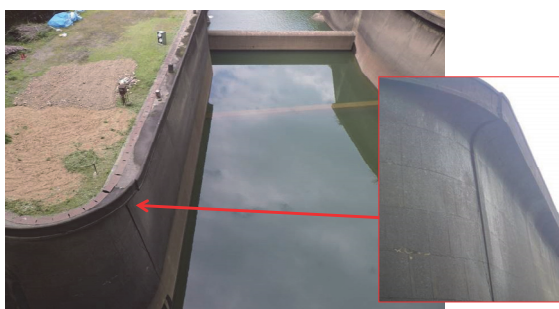
Photo.2 shows small displacement of a joint of training wall of stilling basin. In this case, it was uncertain when and why the displacement has occurred. Furthermore, there was no information of the foundation. Then, some drilling investigation and the monitoring of deformation by inclinometer and groundwater table are performed.

Photo.2 Displacement of a joint of training wall of stilling basin

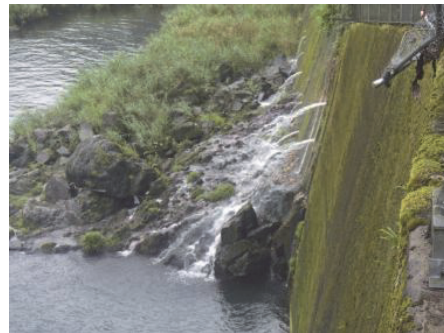
Photo.3 is leakage water from a retaining wall which is located in the downstream of a dam. The water passed under the dam foundation or right hand rim grout line. The geology is the Tertiary volcanic rocks, and there are many cooling joints in the rock

mass. It is generally difficult to find the leakage route. Therefore, in this case, contour maps of ground water table and its change in time series were checked along the dam site and downstream to clarify abnormal ground water table zone.

Photo.3 Leakage water from dam

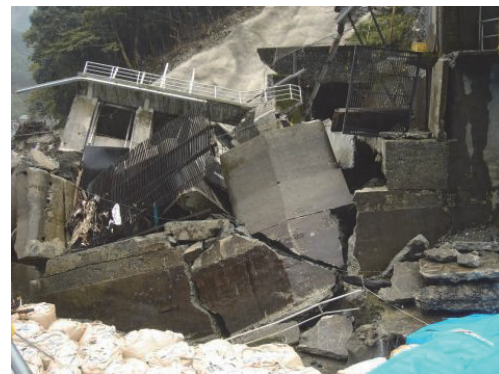
Photo.4 is the collapse of a weir (not large dam). The weir was constructed about 80 years ago and the foundation was partially river deposit, and the deposit was eroded by flood stream or groundwater pressure.

Photo.4 Collapse of a weir by erosion of foundation

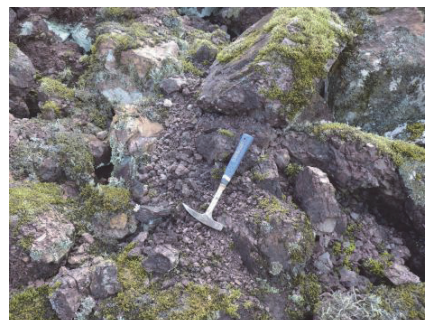
Photo.5 is the deterioration of rip lap of a rock fill dam. In this case, the cause is thought to be low quality of rock material against freezing and thawing because some rocks are porous and contain clay minerals. But many rocks are sound, dam is totally evaluated as sound.

Photo.5 Deterioration of rip lap of rock fill dam by freezing and thawing

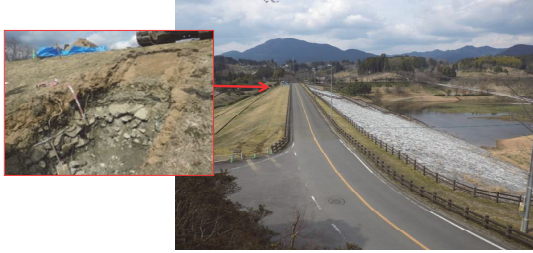
Photo.6 is a rock fill dam after repaired rip lap rock material. The rock contains laumontite and deteriorated by the repetition of dry and wet. This dam was covered with soil to prevent the repetition of dry and wet for downstream side, and replaced with rocks of good quality for upper stream side.

Photo.6 A rock fill dam after repaired laumontite bearing rip lap rock. (Left photo is trench investigation for checking deterioration.)

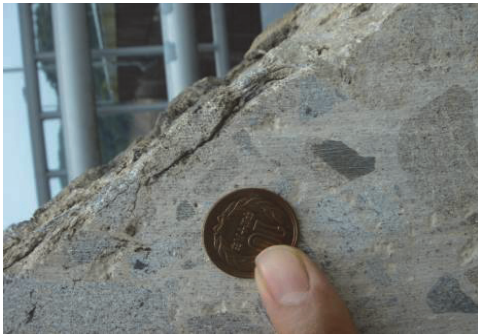
Laumontite is also problematic for dam concrete. Photo.7 and photo.8 is the case. The aggregate is mainly sandstone and contains laumontite in matrix. In this case, deteriorated surface of dam concrete was scraped and covered by 30cm thick of new concrete of good quality.

Photo.7 Crack and pop up of dam concrete. (The aggregate contains laumontite.)

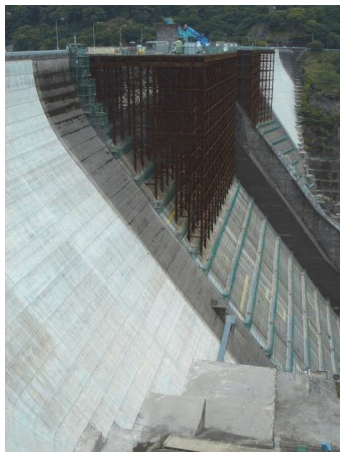
Photo.8 Repairing of dam concrete. (Same dam as photo.7)

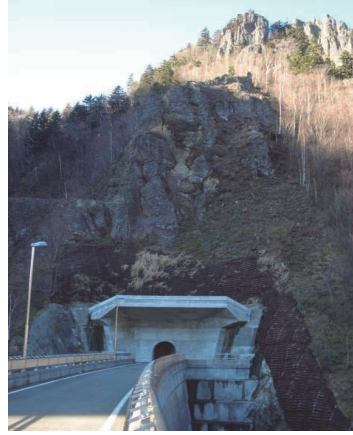
Photo.9 is a rock shed on a dam crest. Huge rock masses distribute on slopes near the dam. Not only dam managers but also visitors in sightseeing are dangerous, then the dam office has constructed some countermeasures such as shed, rock net, and rock anchor around the dam.

Photo.9 Rock shed on a dam crest

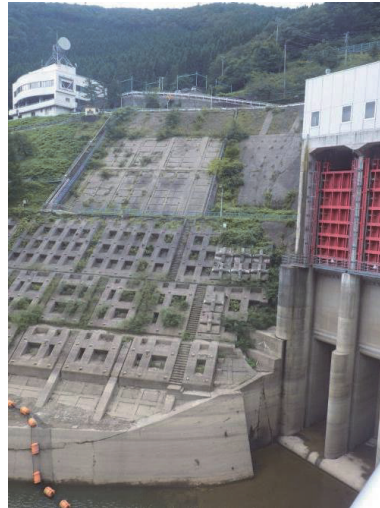
Photo.10 is a landslide block near the outlet of arch dam. The management office of the dam in the photo was constructed on the landslide, because this district is very mountainous and there was no flat or gentle slope near the dam except for the landslide. In this case, monitoring of the landslide movement is performed long time, the movement is very small.

Photo.10 Landslide near a dam

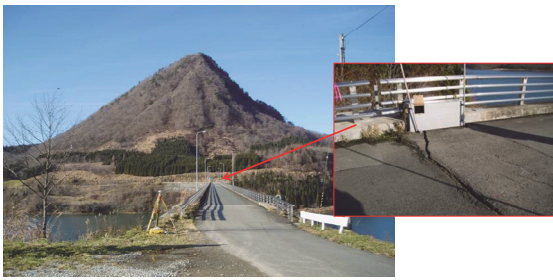
Photo.11 is a landslide near a reservoir. The landslide topography is matured, therefore the landslide is thought to have moved for long time before the dam construction. The abutment foundation of the road bridge is on the landslide, and deformed several cm/year by landslide movement.

Photo.11 Landslide near reservoir and a bridge on it.

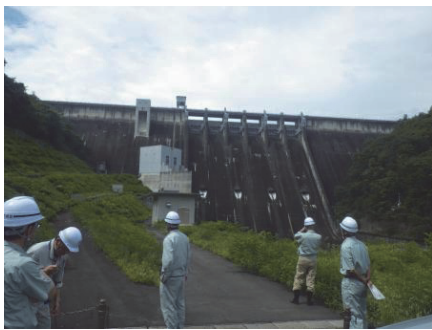
Photo.12 is a very old dam. The construction has started from 1941, stopped by World War II, and completed in 1954. Therefore, geological data, maps and documents are few, even foundation sketch data does not exist. The lack of geological data has become a big problem for administration because weak serpentine widely distributes in this area and it was impossible to estimate the stability of the dam. Then drilling survey was conducted. Finally, the survey revealed that the foundation was not serpentine but tight and strong amphibolite rock.

Photo.12 Old dam constructed before and after World War II.
