Features of slope disasters on roads caused by the 2011 off the Pacific Coast of Tohoku Earthquake

Ken-ichi ASAI⁽¹⁾, Koji MIYAMOTO⁽²⁾ and Yasuhito SASAKI⁽¹⁾

(1) Public Works Research Institute, Japan

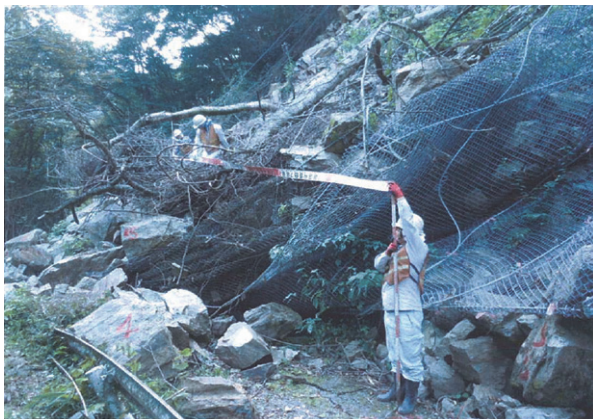
Photos 1 and 2 show a case of rock slope failure on a ridge slope, about 600m³ in volume, caused by the aftershock on 11th April in Fukushima Prefecture. Basement geology is the Mesozoic schist. Open joints of reverse dip exist as shown in Photo 2, which

Photo 1 A case of rock slope failure in the Mesozoic schist area

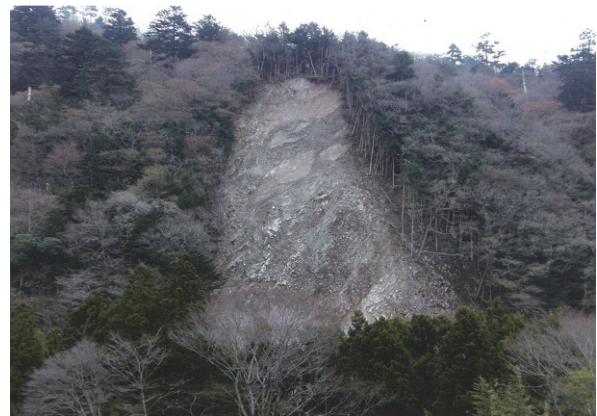
Photos 3 and 4 show another case of rock slope failure on a ridge slope, about 3,000m³ in volume, caused by the same aftershock. Basement geology is the Mesozoic granodiorite. Joints of dip slope exist as shown in Photo 4, which effected the occurrence of the failure.

Photo 3 A case of rock slope failure in the Mesozoic granodiorite area

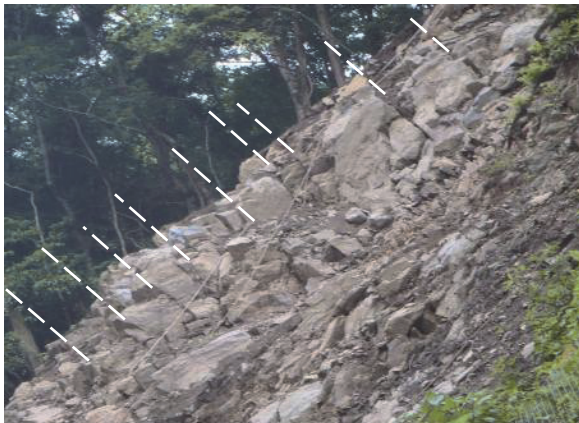
suggests toppling movement of the slope before the failure.

Photo 2 Open joints in the rock slope at the failure shown in Photo 1 (white broken lines)

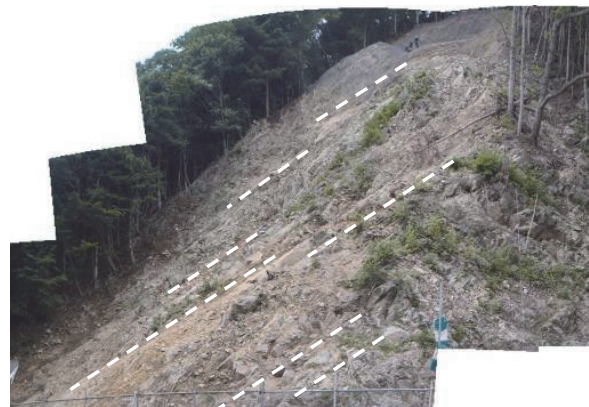
Photo 4 Joints of dip slope in the rock slope at the failure shown in Photo 3 (white broken lines)

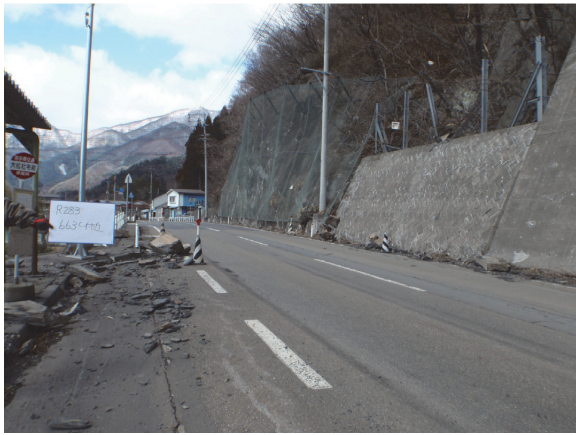
Photo 5 and 6 show a case of rockfall caused by the main shock. Basement geology is the Paleozoic slate. Several rocks, a maximum diameter of 1m, fell from a loosen rock slope, broke the rock fence and reached the road.

Photo 5 A case of rockfall in the Paleozoic slate area

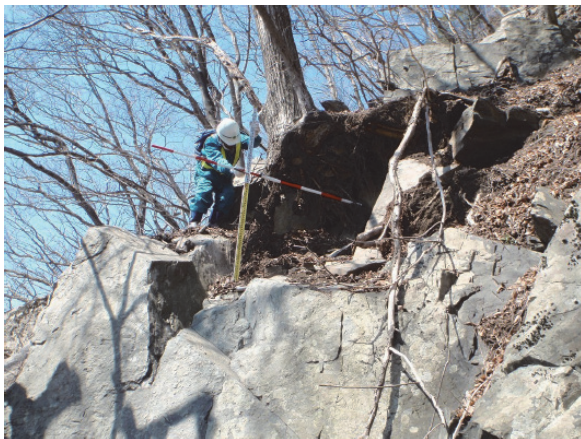
Photo 6 Source of the rockfall shown in Photo 5

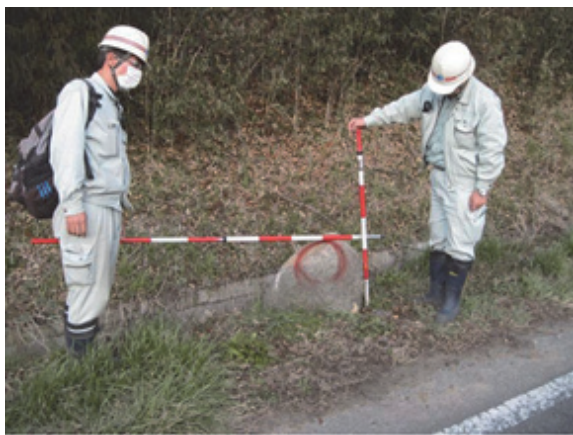
Photo 7 and 8 show another case of rockfall. Basement geology is the Mesozoic granodiorite. One of the corestones, a maximum diameter of 0.6m, remained from weathering fell down to the road.

Photo 7 A case of rockfall of a corestone remained from weathering in the Mesozoic granodiorite area

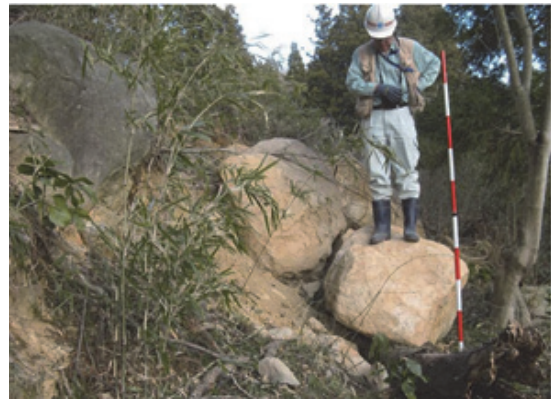
Photo 8 Source of the rockfall shown in Photo 7

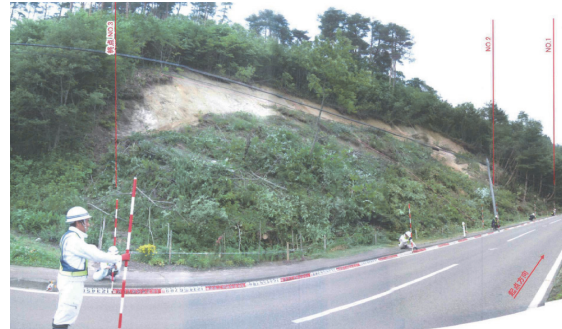
Photo 9 and 10 show a case of soil slope failure on a cut slope, about 1,100m³ in volume and 1.5m in thickness, caused by the main shock. Basement geology is the Mesozoic granite. Surface soil 'masa' formed by weathering of granite fell down to the

Photo 9 A case of soil slope failure on a cut slope in the Mesozoic granite area

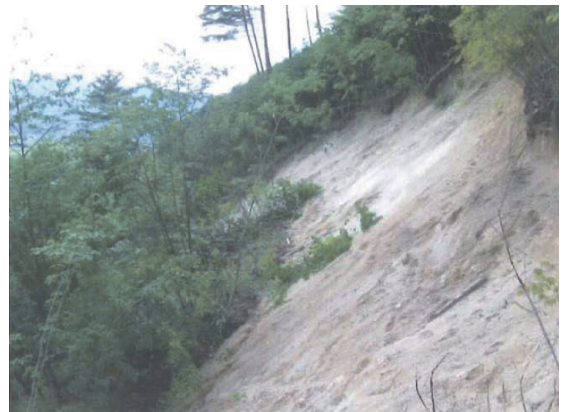
Photo 10 Upper part of the failed slope shown in Photo 9

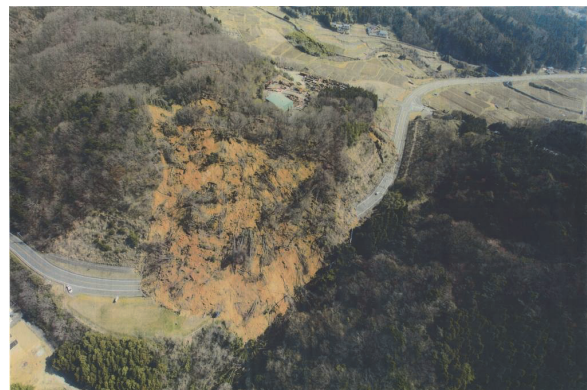
Photo 11, 12 and 13 show a case of deep-seated landslide, about 775,000m³ in volume, caused by the aftershock on 11th April in Fukushima Prefecture. Basement geology is the Miocene sandstone and siltstone. Its slip surface dips 10 degree, which is concordant to the dip of the bedding plane. No old landslide topography was recognized in this site.

Photo 11 A case of deep-seated landslide in the Miocene sedimentary rock area

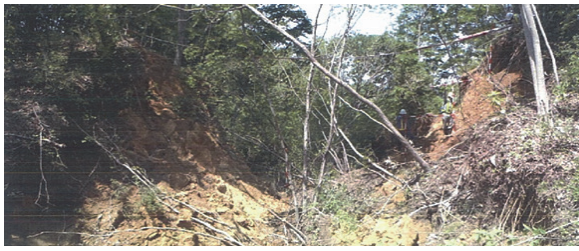
Photo 12 Depression zone at the top of the landslide shown in Photo 11

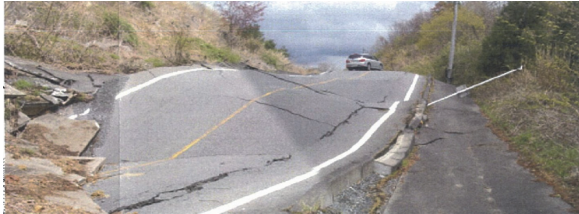
Photo 13 Uplifted road at the toe of the landslide shown in Photo 11

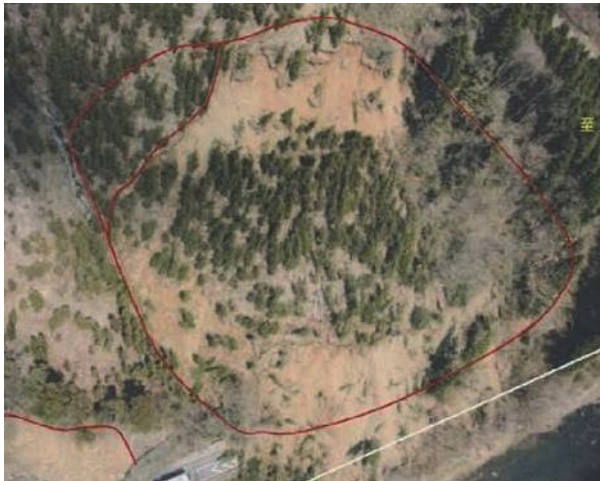
Photo 14 and 15 show another case of deep-seated landslide, about 65,000m³ in volume, caused by the same aftershock. Basement geology is the Mesozoic schist, but landslide mass consists mainly of weathered soil as shown in Photo 15. This landslide occurred in the side part of old landslide topography as shown in Fig.9.

Photo 14 A case of deep-seated landslide in the Mesozoic schist area

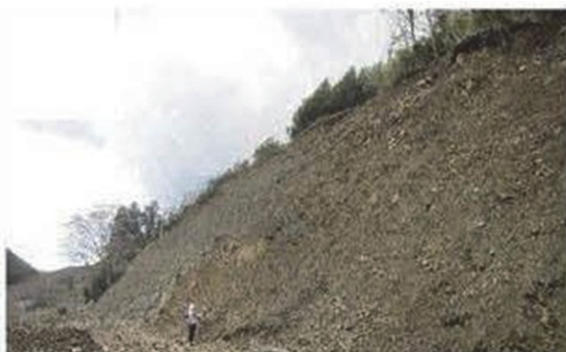
Photo 15 Outcrop in the lower part of the landslide shown in Photo 14

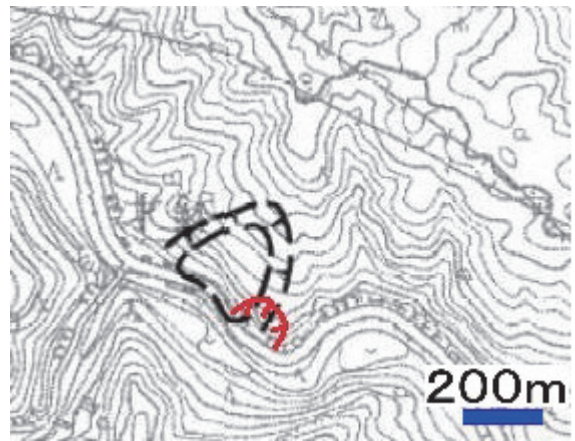
Fig.9 Landslide Map by National Research Institute for Earth Science and Disaster Prevention, Japan

Red line (added by the authors): New landslide shown in Photo 14

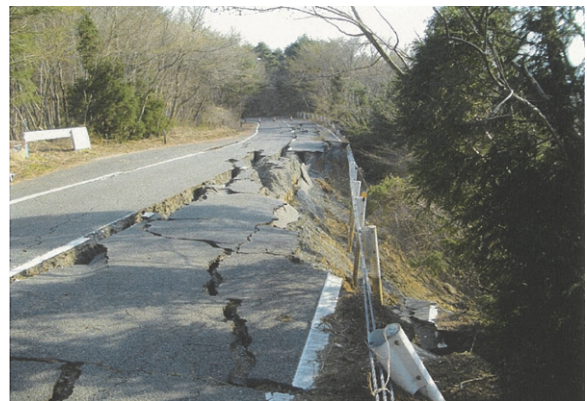
Photo 16 and 17 show a case of embankment failure, about 900m³ in volume, caused by the aftershock on 11th April in Fukushima Prefecture. This embankment was constructed filling a valley, maximum height of 20m. In the case of the embankment filling the valley like this, it is thought that ground water is likely to gather, resulting in the

Photo 16 A case of failure of embankment constructed filling a valley

high water content in the embankment and high risk of collapse.

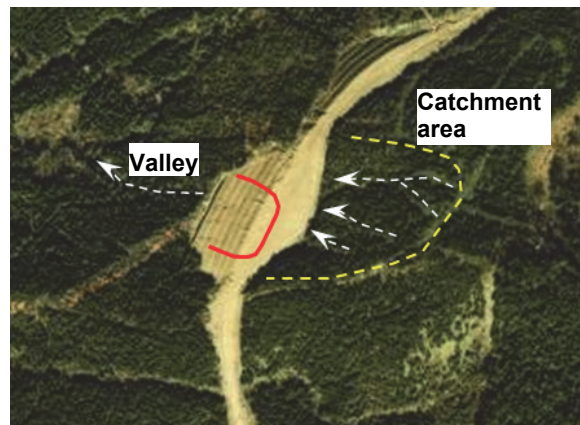
Photo 17 Aerial photograph of the embankment in Photo 16, taken 36 years before the disaster by Geographical Survey Institute (present: Geospatial Information Authority of Japan).

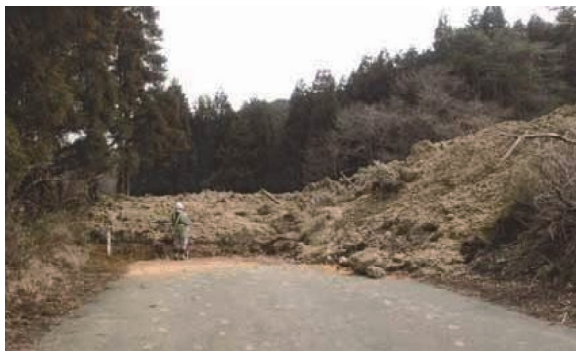
Photo 18, 19 and 20 show another case of embankment failure, about 9,800m³ in volume, caused by the main shock. This embankment was a part of a pastureland near the road, which collapsed and filled the road. This pastureland looks like a gentle slope now. However, as shown in Photo 20, an aerial photograph taken 35 years before the disaster revealed that the pastureland was constructed by filling the valleys, and the failed embankment was just situated in one of the filled valleys.

Photo 18 A case of failure of embankment which filled a road

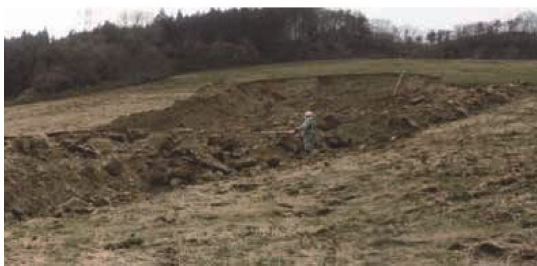
Photo 19 Upper part of embankment failure shown in Photo 18

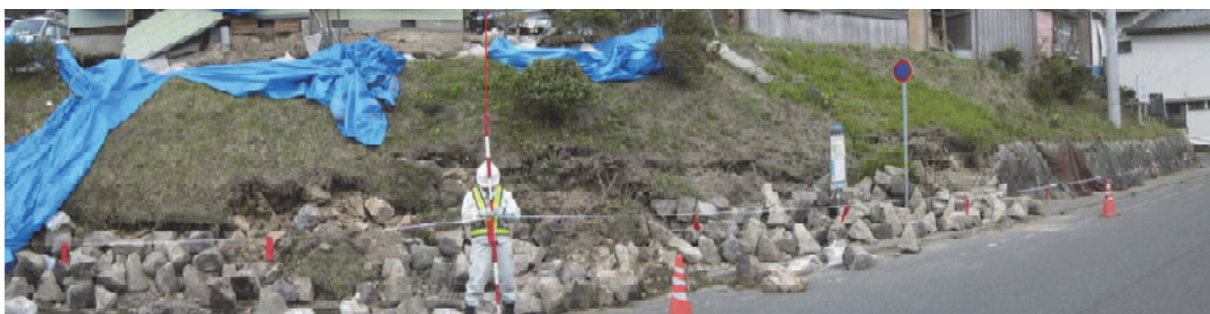
Photo 21 shows a case of the collapse of masonry wall on the embankment slope near the road. Many stones were scattered on the road. Many of masonry walls constructed in old age, and have a steep dip. They are likely to fail or deform by the strong earthquake.

Photo 21 A case of failure of masonry wall near the road

- 5) Many of masonry walls are likely to fail or deform by the earthquake because they constructed in old age and have a steep dip. It needs to find these sites as hazardous sites against disaster.
- 6) The disaster is easy to occur repeatedly at the site where the past disaster history exists and the cause of the disaster remains even now.

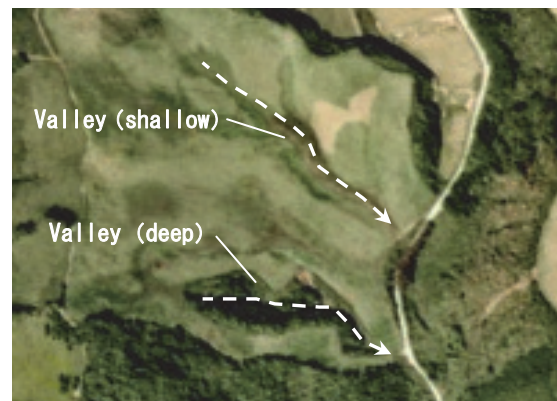
Photo 20 Aerial photograph around the site in Photo 18, taken 35 years before the disaster, by Geographical Survey Institute (present: Geospatial Information Authority of Japan). This photo shows the topography before filling the valley. The embankment filling the deep valley collapsed, and the embankment filling the shallow valley did not collapsed but deformed. (Broken lines were added by the authors)

investigation of present geography. It needs to investigate history of topographic change by development using past aerial photograph, etc.
