Washout of clay-rich gouge in a pre-grouted fault zone and increase in groundwater inflow during tunnel excavation in Neogene siliceous mudstone (Horonobe, Japan)

Eiichi ISHII⁽¹⁾, Yuta HASHIMOTO⁽²⁾ and Daisuke INAGAKI⁽³⁾

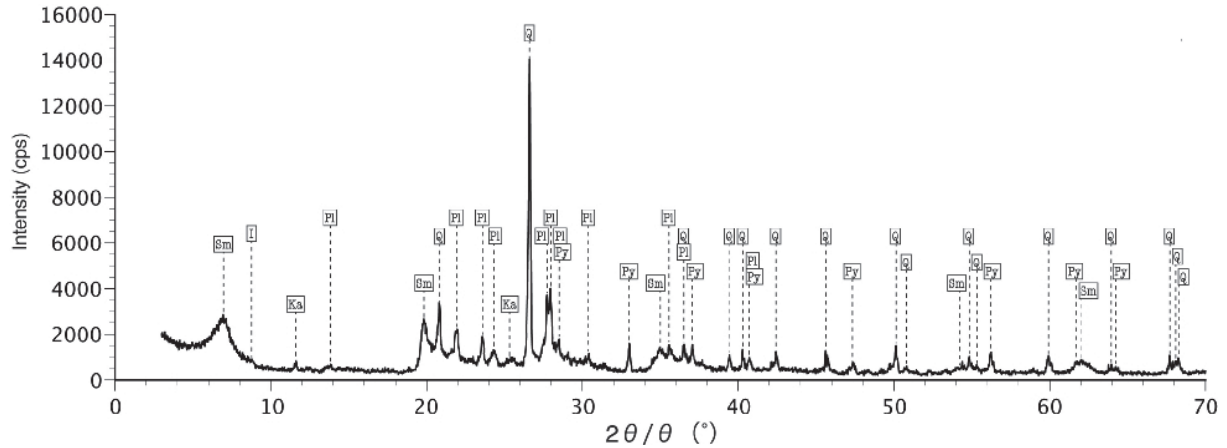
Fig. 3 Result of XRD analysis of gouge (whole-rock) of the S1 Fault.

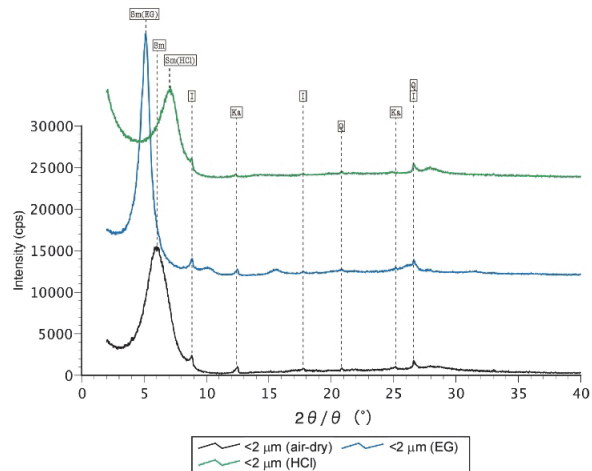
Fig. 4 Results of XRD analysis of gouge (<2 μm fraction) of the S1 Fault.

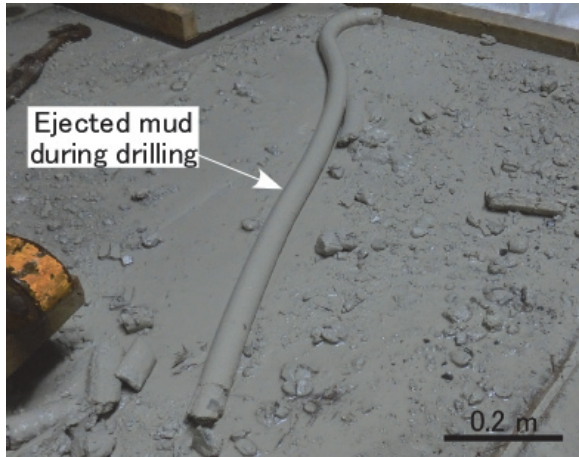
Fig. 6 Muddy material ejected from a borehole during drilling.

ejected from boreholes during drilling (Fig. 6). Excavation of the S1 Fault revealed clay-rich gouge (~10 cm thick) and a surrounding damage zone (a few meters thick). However, the gouge itself was not cemented by grout material (Fig. 7) whereas the gouge-bounding fractures and damage zone fractures were cemented. Intensive spalling occurred at the S1 Fault. During excavation of the fault, the clay materials were increasingly washed out into the tunnel through the rockbolts penetrating the fault and along the boundary between the shotcrete and the gouge on the excavation sidewall (corresponding to the spalling zone and possibly not fully shotcreted) at a flow rate of $<1 \text{ m}^3/\text{hr}$ (Fig. 8a and 8b). After an excavation face exposing the S1 Fault was temporarily shotcreted, a major groundwater inflow suddenly occurred, breaking the shotcrete corresponding to the gouge (Fig. 8c). As a result, the inflow rate temporarily increased to five tens of cubic meters per hour. Observations of the broken shotcrete and at the excavation sidewall revealed that the gouge

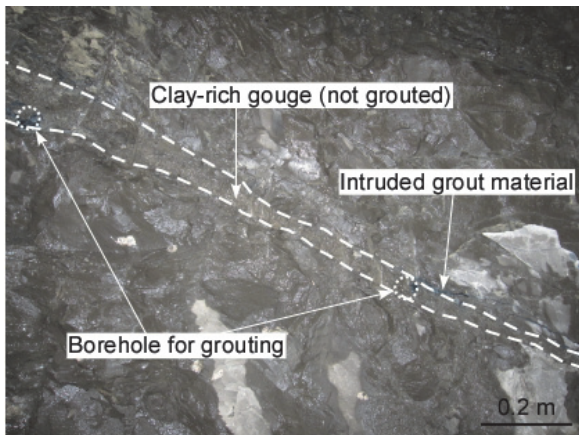
Fig. 7 Occurrence of clay-rich gouge pre-grouted on an excavation face.

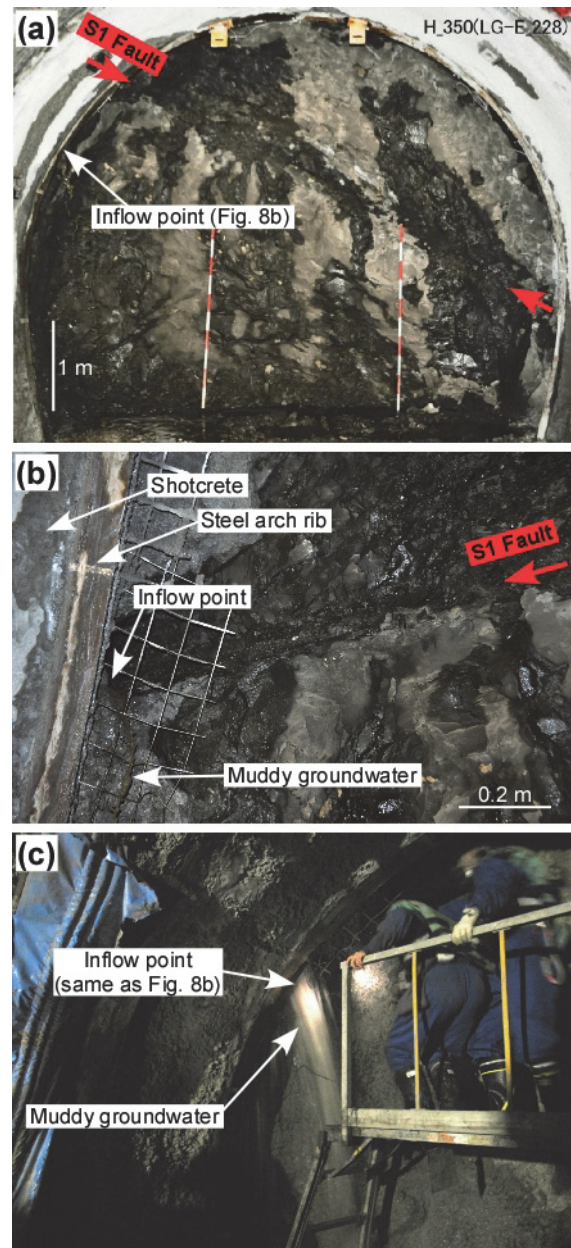
Fig. 8 (a) Excavation face exposing the S1 Fault in the tunnel. (b) Inflow of muddy groundwater from the boundary between the shotcrete and the gouge of the S1 Fault on the excavation sidewall. (c) Major inflow from broken shotcrete corresponding to the gouge of the S1 Fault.

was largely eroded away from the S1 fault (no photos due to the regulation of the scene). This sudden inflow required post-grouting for more than 1 month.

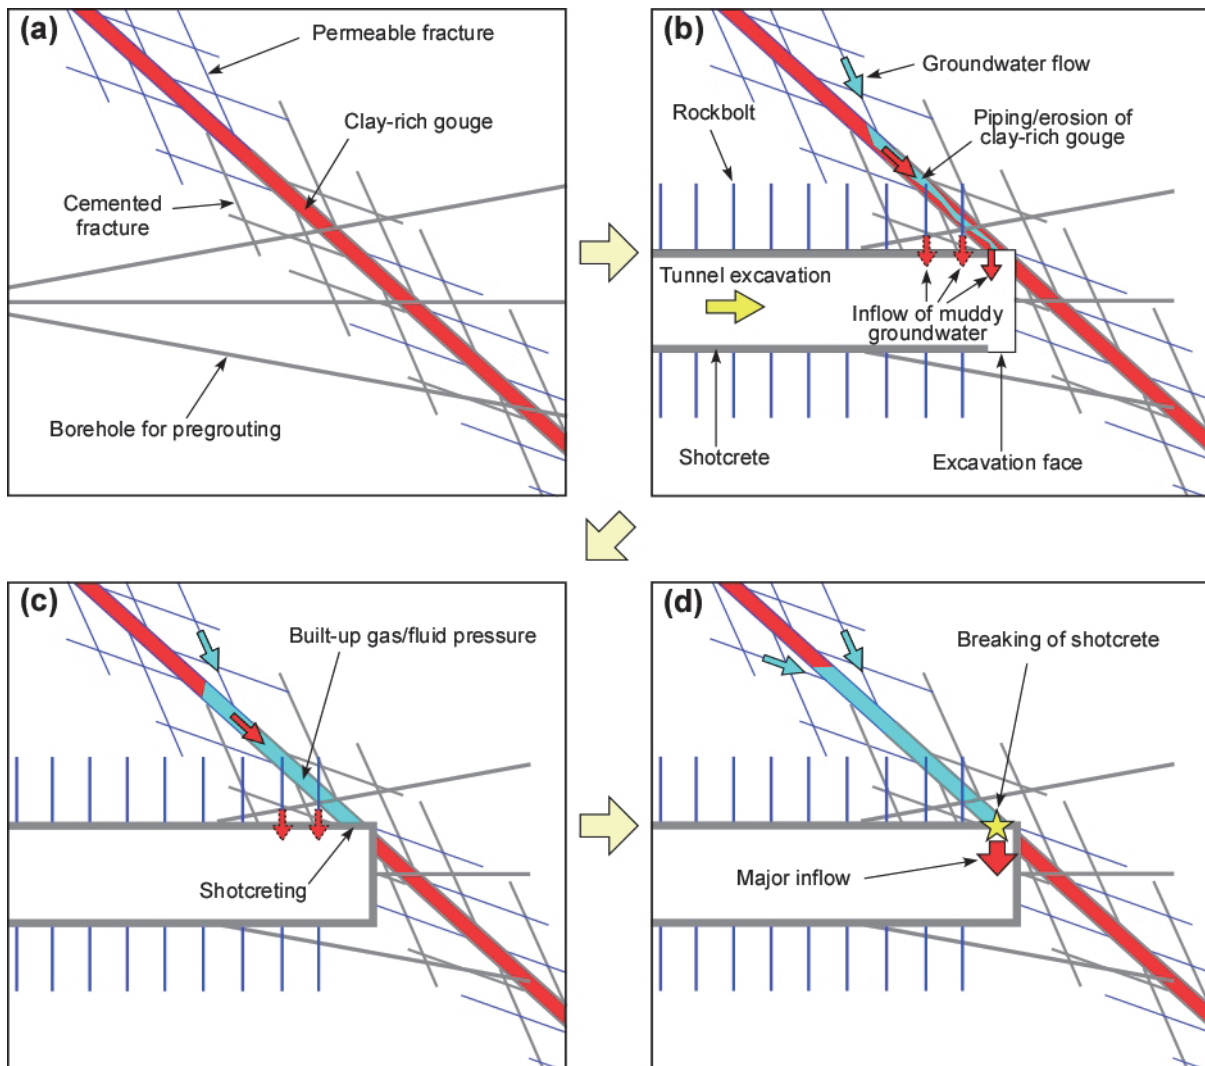
The above observations indicate that piping/erosion in the clay-rich gouge of the S1 Fault occurred by washout of the clay materials into the tunnel through rockbolts penetrating the S1 Fault and along the boundary between the shotcrete and the

gouge on the sidewall during excavation (Fig. 9). Clay is commonly resistant to liquefaction; however, in this case the groundwater flow into the tunnel and the gas/fluid pressure build-up due to shotcreting probably accelerated liquefaction or fluidization and thereby caused washout of the gouge. When a fault zone including such clay-rich gouge is pre-grouted, washout of the gouge during excavation should be fully prepared because the gouge itself is not cemented by pre-grouting due to its low porosity, meaning that flow channels may form by piping/erosion. For example, expanding the grouting area and/or reducing the number of rockbolts might

Fig. 9 Sketches showing the processes assumed to have caused the major inflow during tunnel excavation (horizontal sections). (a) The gouge-bounding fractures and damage zone fractures of the S1 Fault intersecting the boreholes were cemented by pre-grouting. (b) During excavation, the gouge was washed out into the tunnel through the rockbolts penetrating the gouge and along the boundary between the shotcrete and the gouge on the excavation sidewall. The resulting piping/erosion of the gouge induced groundwater flow from the outer aquifer of the pre-grouted zone. (c) After an excavation face exposing the S1 Fault was temporarily shotcreted, gas/fluid pressure in the S1 Fault zone built up. (d) A major inflow occurred, breaking the shotcrete.

be effective in preventing the washout of clay-rich gouge.
