8. LEAKAGE PATH OF KOKA RESERVOIR IN ETHIOPIA RIFT VALLEY AND ITS ESTIMATION USING HYDROGEOLOGICAL TECHNIQUES

エチオピア, Koka 貯水池の漏水と水理地質面からの漏水ルートの解明

Ethiopian Institute of Geological Surveys, Ethiopia, ○ Sileshi Mamo
Department of Geoscience, Shimane University, Japan, Shuichiro Yokota

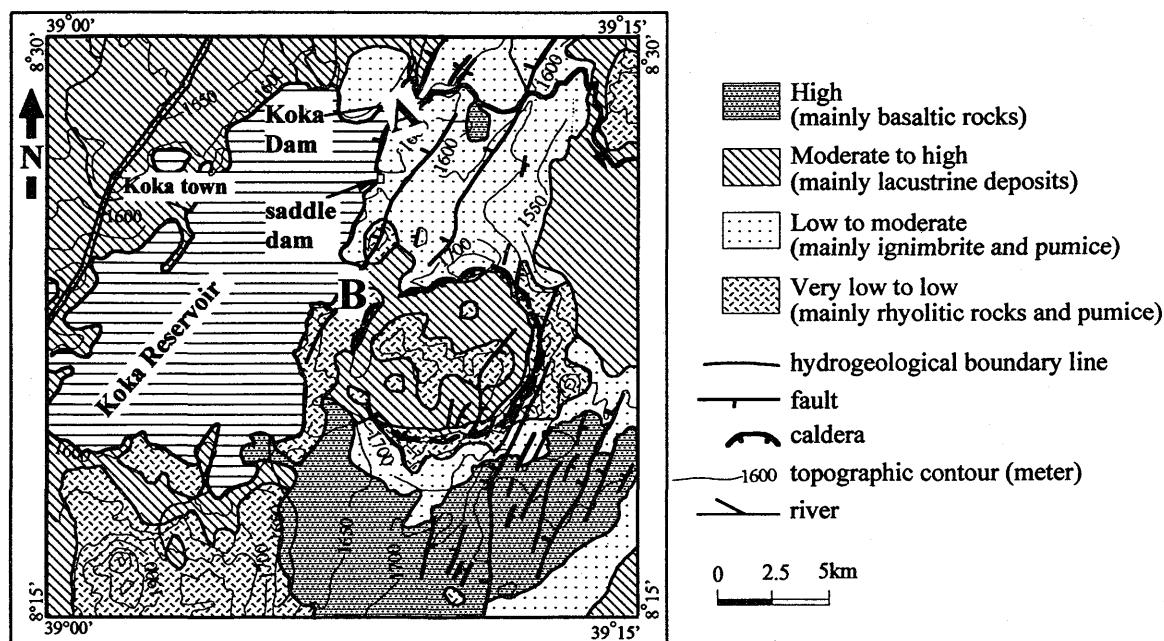
Figure 2. Topographic and permeability outline around the Koka Reservoir. The tones are permeability grades (very low to high).

These studies concluded leakage through the whole reservoir floor. However, according to the present study, reservoir leakage is found to be through the downstream right shore, A - B in Figure 2.

The downstream right margin (A – B in Figure 2) is constituted by recent alluvium, pyroclastic deposits with pumice and tuff beds frequently highly weathered and some beds slightly to highly indurated, slightly to moderately and highly jointed rhyolite and ignimbrite form this reservoir margin. More than three joint sets exist in volcanic rocks and especially at the contact with the reservoir water, they are open and interconnected and the dominant ones have southeast dip direction. Northeast dipping ones are also important. They have shallow to sub-vertical dip ($20-80^{\circ}$). Recent normal faults also cross this reservoir bank, and the reservoir margin downstream of the saddle dam, which may be old river course, is a fault scarp. These jointed volcanic rock masses (moderately high permeable), pyroclastic deposits of low to moderate permeability, and faults as well

as saddle prevail reservoir water leakage to the aquifer in the northeast adjacent area, although minor topographic divide exist between the two sub-basins.

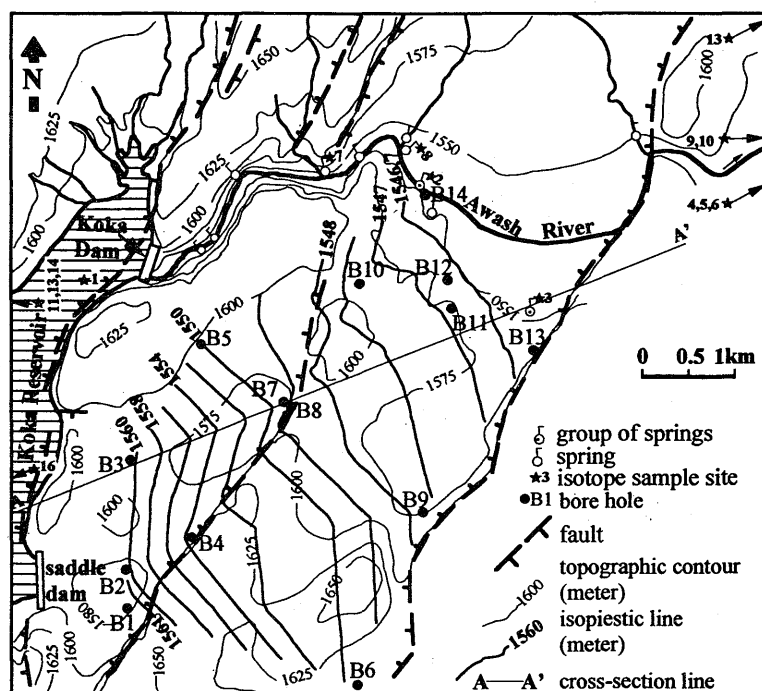
Figure 3. Ground water table map (for 14 September 1969).

Hydraulic head difference between reservoir level and ground water table, ground water flow direction, relatively steep ground water table gradient close to shore flattening out ward and moderate high permeability of formations (Figs. 3 and 4) indicate leakage/underflow in this area. The reservoir water contributes to this ground water discharge/hot springs at the right bank of Awash River, downstream of the Koka Dam.

Ground water table increment map made using ground water table data of the lowest ground water table/during maximum recession (13 August, 1969), and maximum reservoir water level (14 September, 1969) also shows ground water source from the reservoir in the west/saddle dam area and another regional ascending water source in the northeast/around B13 (see Fig. 3). Average reservoir leakage velocity in the order of 10^{-5} cm/s is estimated on the basis of the reservoir and ground water levels relationship.

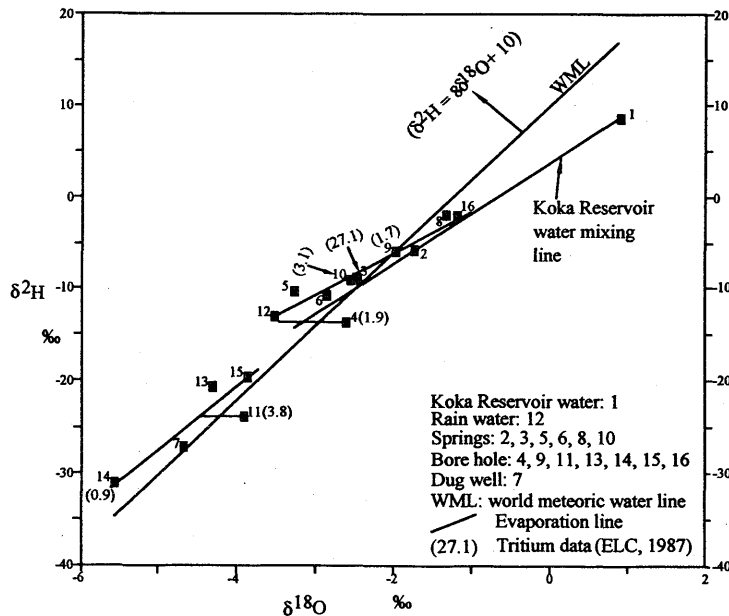
Figure 5. $\delta^2\text{H}$ versus $\delta^{18}\text{O}$ graph.

Available isotope data evidence reservoir water mixing along ground water flow direction in the northeast reservoir vicinity (Fig.5), which indicates leakage through the mentioned reservoir margin. Reservoir water contribution of 45%, 29%, 27%, and 55%, 46% and 31% is estimated on the basis of ^{18}O and ^2H data respectively, for ground waters 2, 3 and 4 taking in to account ground water 11 as end member of pure ground water. Reservoir water contribution decreases away from the reservoir. Location of ground water points is given in Figure 3.

Two ground water sources seem to exist in the area: local enriched meteoric water (upper part) and depleted upland rain water for ground waters at the lower left in Figure 5. This group

seems old water/paleo-ground water (?) at places mixed with local/modern ground water. Hydrothermal oxygen exchange processes with aquifer seem to have given oxygen shift for ground waters 4 and 11.

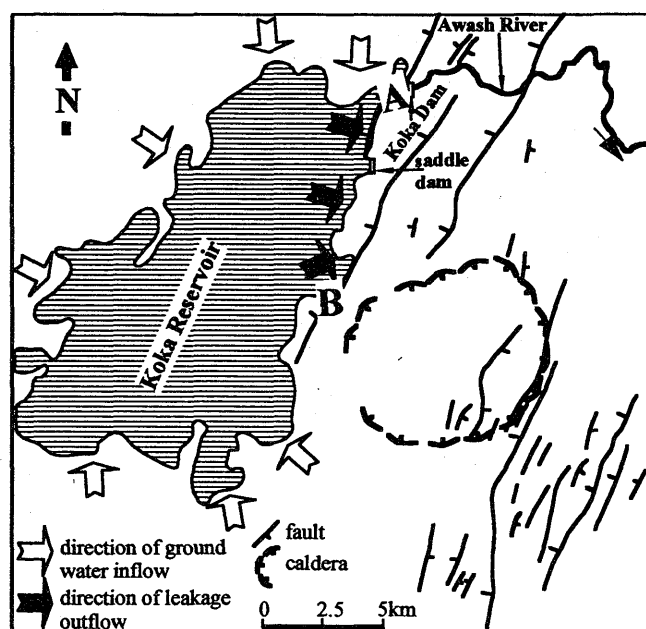
Figure 6. Conceptual reservoir leakage model.

Koka Reservoir leakage path is identified to be in the right margin (A-B in Figure 6). Leakage occurs through pyroclastic deposits, jointed volcanic rock masses, fractured and brecciated zone of faults and beneath the saddle dam although its foundation has been made consolidated/rimmed. Reservoir leakage water joins/spreads into low-lying ground water in the adjacent northeast area. This ground water feeds the Awash River in close downstream area.

Leakage does not occur through the whole reservoir floor area as proposed by previous studies, and no leakage is anticipated through other parts of reservoir margin.
