9. Structural Characteristics around the El Toro Mine and its Influence on the Un- stability for Chambers, Colombia

コロンビア, El Toro 石灰岩鉱山周辺の地質構造と坑道内の不安定現象

Graduate Student, Shimane University, Japan, ○ Fabio Antonio GIL ESCOBAR
Department of Geosciences, Shimane University, Shuichiro YOKOTA.

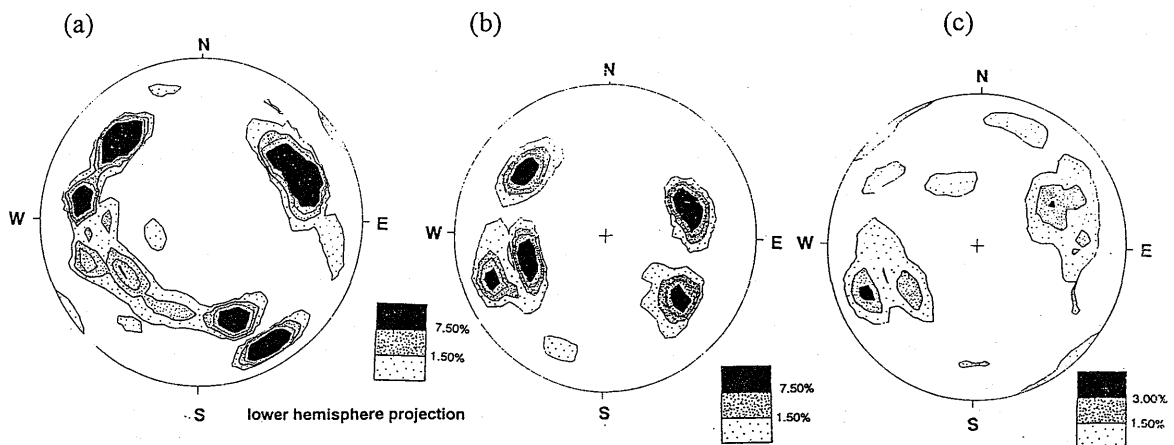
As shown in Figure 5(a), the dominant direction of joint planes within schistose rocks is NNW-SSE with steeply dips, and they almost coincide with S_1 strike. As shown in Figure 5(b), joint planes within the marble body are dominant in NNE-SSW, NNW-SSE with variable dips eastward or westward and almost coincides with those of fault planes.

Faults observed in chambers are divided into 3 groups by direction; *i.e.* NNE-SSW, NNW-SSE, and N-S with variable dips eastward and westward respectively (Figure 5(c)). Displacements and relative movements are also recognized along some of them in chambers and exposures.

Figure 5. Dominant directions of joints and faults planes obtained in and around Abejorral Marble Body. (a) joints in schistose rocks; $n=97$. (b) joints in marble body; $n=396$. (c) faults in marble body; $n=238$. All diagrams are on lower hemisphere projections.

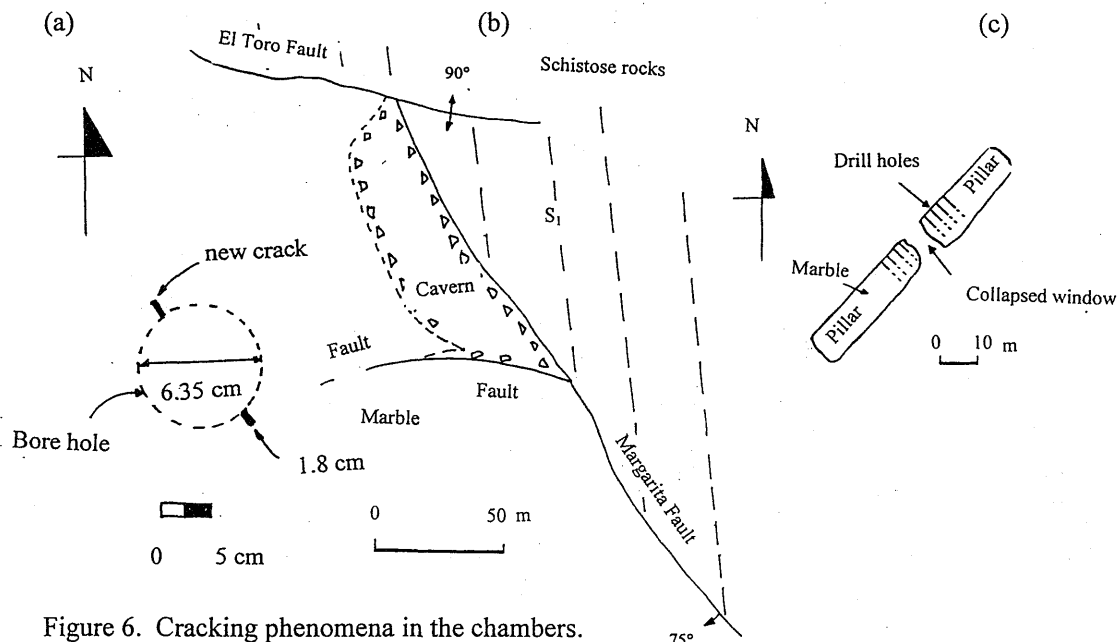
Some tension cracks generated at rim of old holes and extended radially and longitudinally trough out of it at least two years after drill. The strike of generated cracks is almost N40°W and vertical (Fig. 6 (a)).

Many naturally dissolute caverns elongating in NW-SE trend exist within the marble body. One of the biggest is shown in Figure 6(b). It has 90m long and 35m width. Most of caverns are recognized along NW-SE trending fault planes. Probably, underground water dissolute narrow portion along these fault planes, which had been formed as extensional fractures.

Moreover, a big window appeared within a pillar as excavation proceeds as shown in figure 6(c). This window may be a collapsed portion of fractured zone of NW-SE trend. Its volume attains to $5 \times 5 \times 6 \text{ m}^3$. Similar phenomena were recognized at least on the other four pillar walls. Block falling is also occurred from walls and roofs.

Figure 6. Cracking phenomena in the chambers.

(a) crack development. (b) evolution of the natural dissolution cavern. (c) big window development.

- (2) Among some unstable phenomena, cracks propagated from rim of old boreholes most of which have NW-SE trends and is concordant with dominant faults and joints. Therefore, they may be tension cracks generated under heterogeneous rock mass condition and effect of pre-existing faults in addition to NW-SE trending tectonic compression in this region.

- (3) Considering that big windows appeared in pillars has NW-SE trend and is located in a restricted zone adjacent to main fault, they may be closely related to fracture zones along the fault.

- (4) Taking into account that natural caverns are developed along NW-SE trending fault and are elongated NW-SE and links to ground surface, they are understood to have been formed by ground water dissolution along faults and have spread out by fracturing due to same mechanism of windows and tension cracks mentioned before.

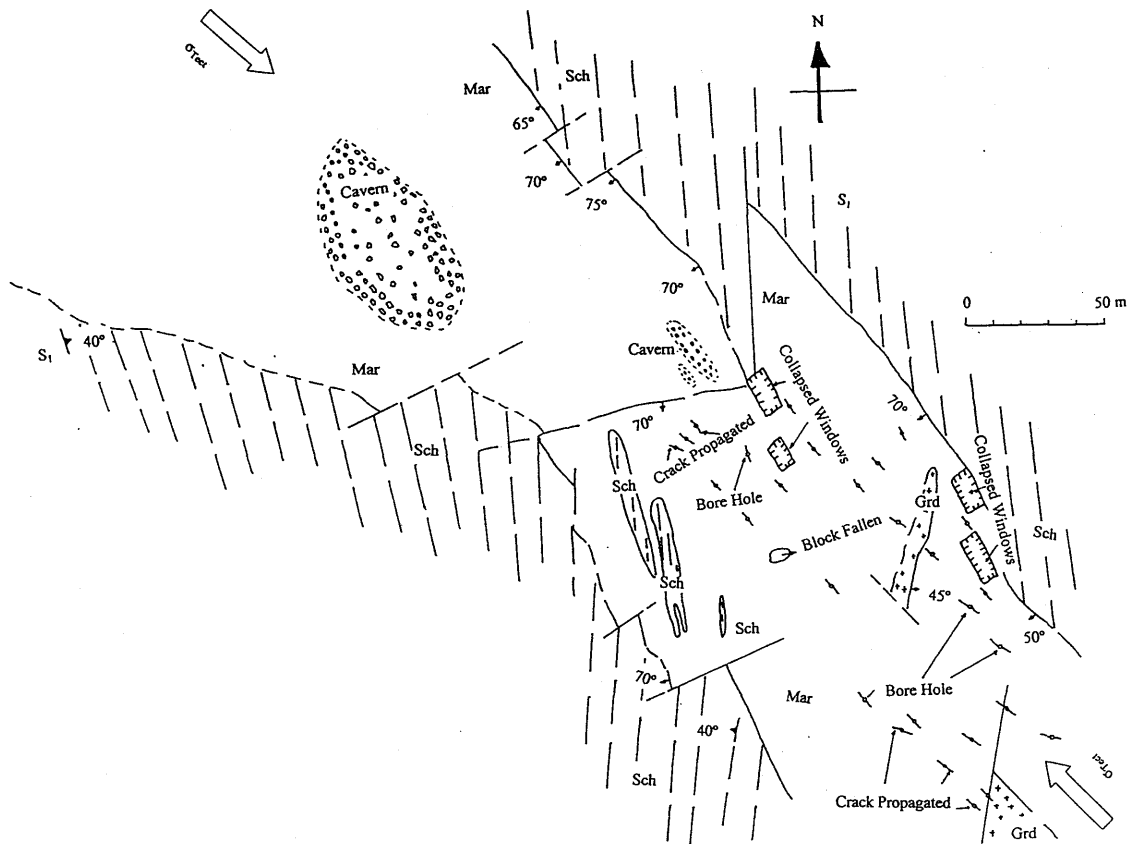
Figure 7. Relationship among heterogeneous condition, deformation and cracking and tectonic residual stress field.

stress follows NE-SW trend. The former almost coincides with the direction of cracks and the latter is perpendicular to them. Therefore, these phenomena may be interpreted to have been occurred within the anisotropy rock mass condition under residual tectonic stress field and its perturbation is due to artificial excavation (Fig. 7).
