A Hydrogeological Study for the Hiroshima August 2014 Disaster

Tomoaki KAYAKI, Seisuke MIYAZAKI, Kazuyuki MUKAI, Mitsunobu TERAMOTO and Sung Gi HU

(Study Group for the Groundwater Environment of the Fan)

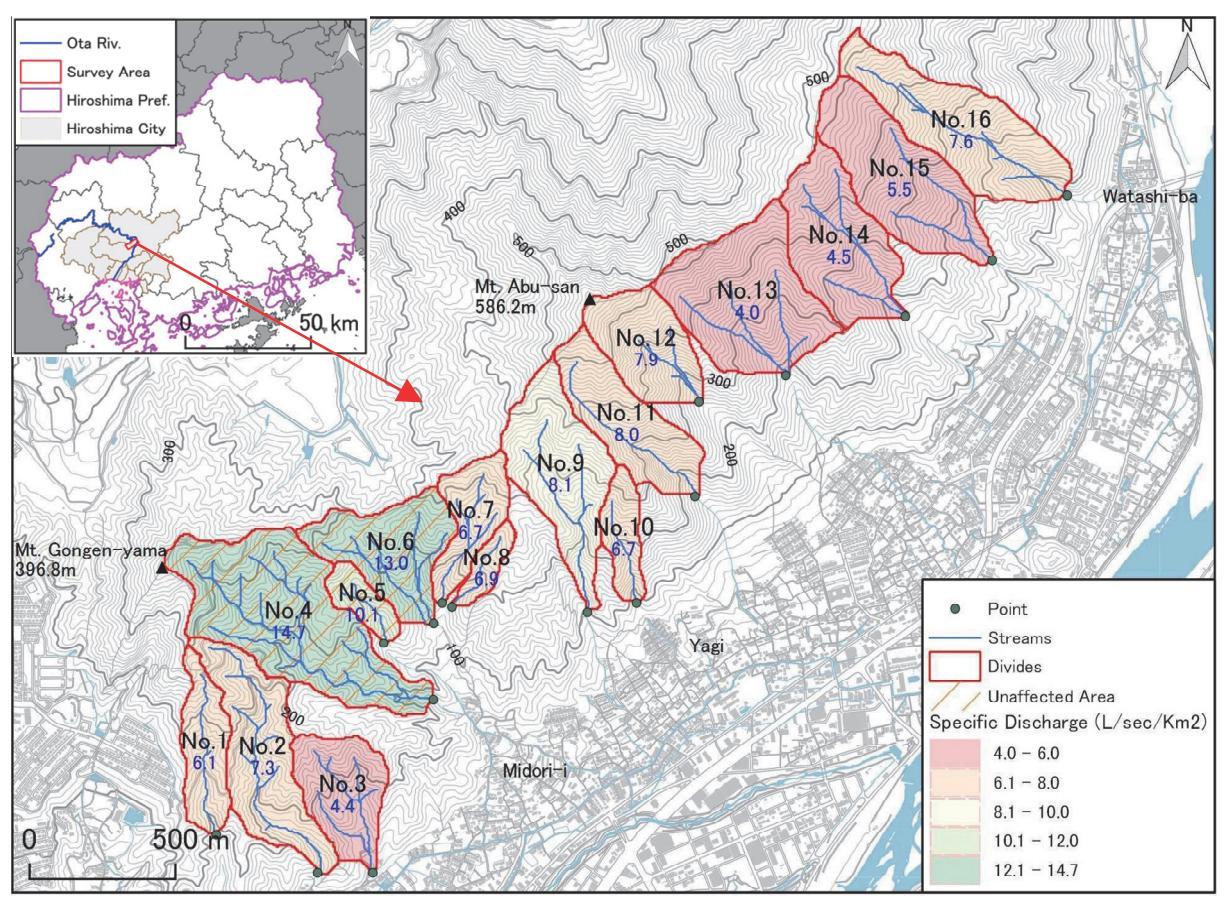
Fig.1 Study area, sixteen divides and specific discharge values

Measurements for all divides were done in January 11, 2015 and the results of both discharge and drought specific discharge are shown in Table 2 and Fig.1. As shown in Table 2, the mean discharge and its volume at granitoid dominant Yagi area (No.7 to No.10, debris flow affected area) are showing to 7.1 $\ell/sec/km^2$ and 0.61mm/d. On the other hand, discharge and its volume of debris flow un- affected area, especially divide No.4 yield values of 14.7 $\ell/\text{sec/km}^2$ and 1.27mm/d. This is a remarkable difference in discharge and volume between these two areas. Especially No.4 to No.6 $(12.6\ell/\text{sec/km}^2 \text{ and } 1.09\text{mm/d})$. in mean value) divides are showing twice values in compared to the mean values of all but three of the 13 divides (0.51mm/d.), where the debris flow had un-affected. This implies that occurrence of debris

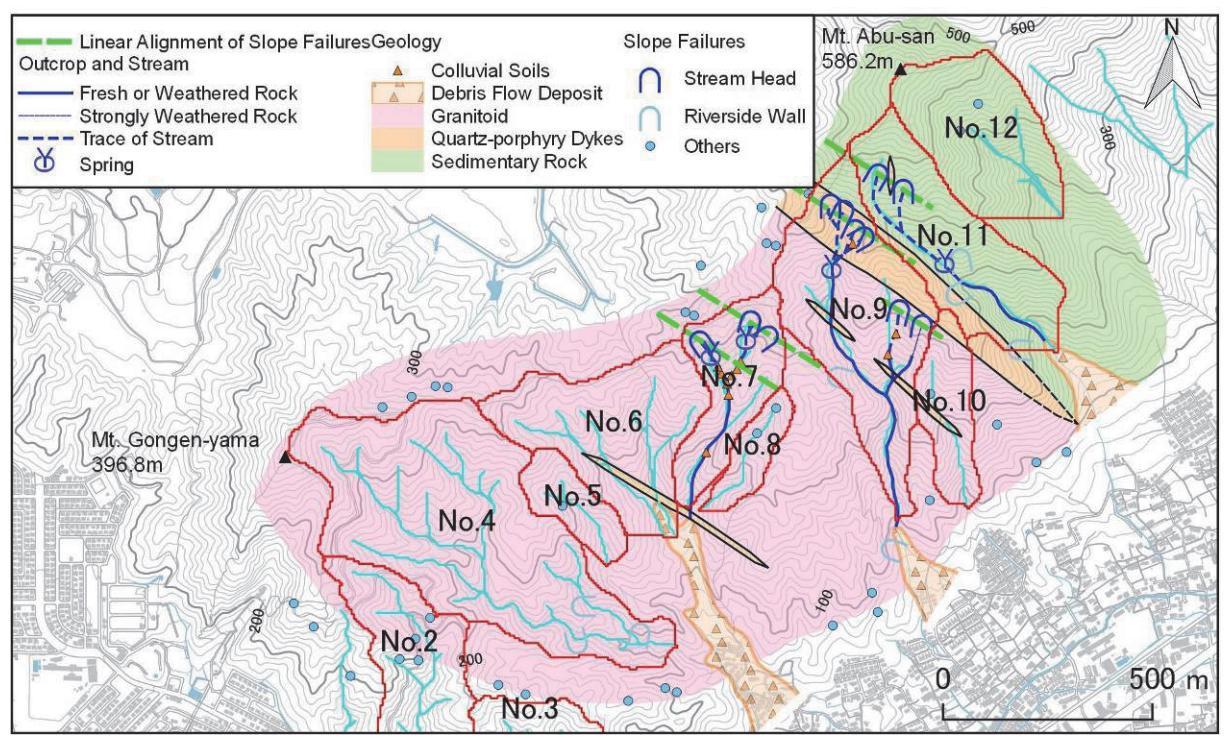
Fig.2 Geology of divides No.2 to No.12

and two in sedimentary rock area), where the collapse occurred at the southwest side of the mountain slope. However, the amounts of debris in the latter case are comparatively small (1m to 3m thick) and show only about 200 to 800m³ colluvial soils (Fig.2).

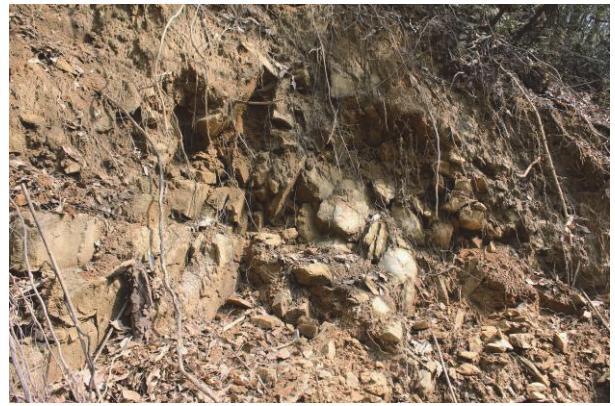
Granitoid is distributed around the divides No.1 \sim No10, while the sedimentary rocks (changed to hornfels by contact metamorphism of granite) are mainly occupied in the middle to upstream in the divides No.11 \sim No.16 area as roof pendant in this district. The thick colluvial soils cover the valley walls from top to bottom in every divide, except in the No.9 divide, which is covered by remarkably thicker colluvial soils. Granitoid (mainly consist of hornblende bearing biotite granodiorite) is solid and hard, and comparatively fresh. The weathering effects increase with height, but in a minor way. The weathering effects are broader and extend more deeply in the granitoid of Midori-i area (No.4 divide, Photo.1) than in Yagi-sawa area (No.9 divide, Photo.2).

Photo.1 Strongly-weathered granitoid in divide No.4 Photo.2 Characteristics of joint system and cracks in

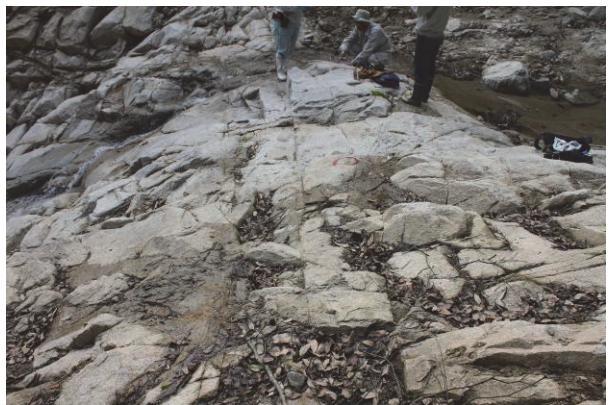
boundary between granitoid and sedimentary rocks (divides No.10 and No.11). No fault or sheared zones are observed in the granitoid area (divides No.1-No.10). The characteristics of the joint system and cracks (Photos 1 and 2) are different between the valley less-affected (divide No.4) and that severely affected (divide No.9) by debris flow calamity. In divide No.4, which was less-affected, showed a sporadic occurrence of joints and cracks in the field, but the joint system is large compared to other divides and degrees of adhesion is not good. Therefore we concluded that divide No.4 shows both high permeability and high discharge. On the other hand in divide No.9, though the three dimensional and small scale joints systems are comparatively well-developed, they are stuck firmly to each other. So the impermeable bed is forming in this divide.

In divide No.9, four occurrences of collapse in the vicinity of the river head (375m to 480m msl.) of Yagi-sawa. The slope failure (1.5m to 3m in thickness of surface soil) occurred along the deteriorated and softened cracks in bed rock caused by weathering, where colluvial soils and severely weathered part of host rocks collapsed in to shallow hollows on the slope. Those four sites extend NW-SE and are possibly controlled by geotectonic movement. Along the left tributary of Yagi-sawa, two places of slope failures were occurred at 270m to 260m (msl.). Both cases occurred at the outcrops of deteriorated granitoid and at a surface moistened by spring water.

Photo.2 Characteristics of joint system and cracks in divide No.9

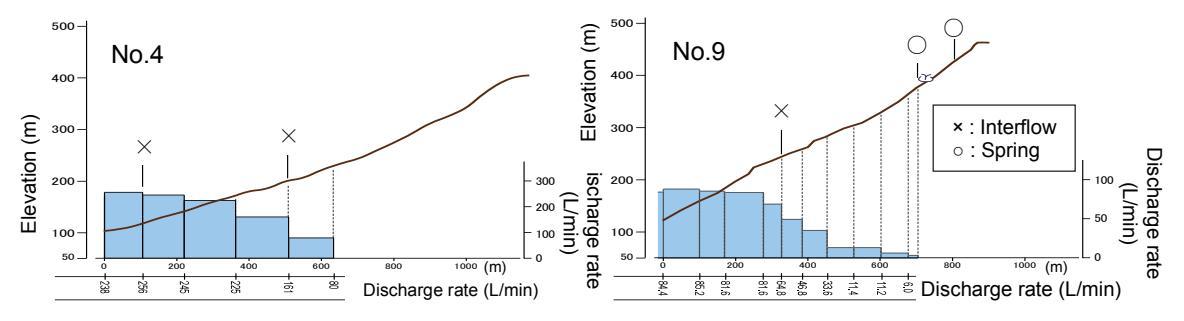
flow is related to the drought specific discharges. In compared to drought discharge in divide No.4 and No.9, discharge of the former is constantly increase by the downstream, while the latter do not increase (Fig.3).

Fig.3 Topographic characteristics of the watershed in debris flow affected and un-affected areas

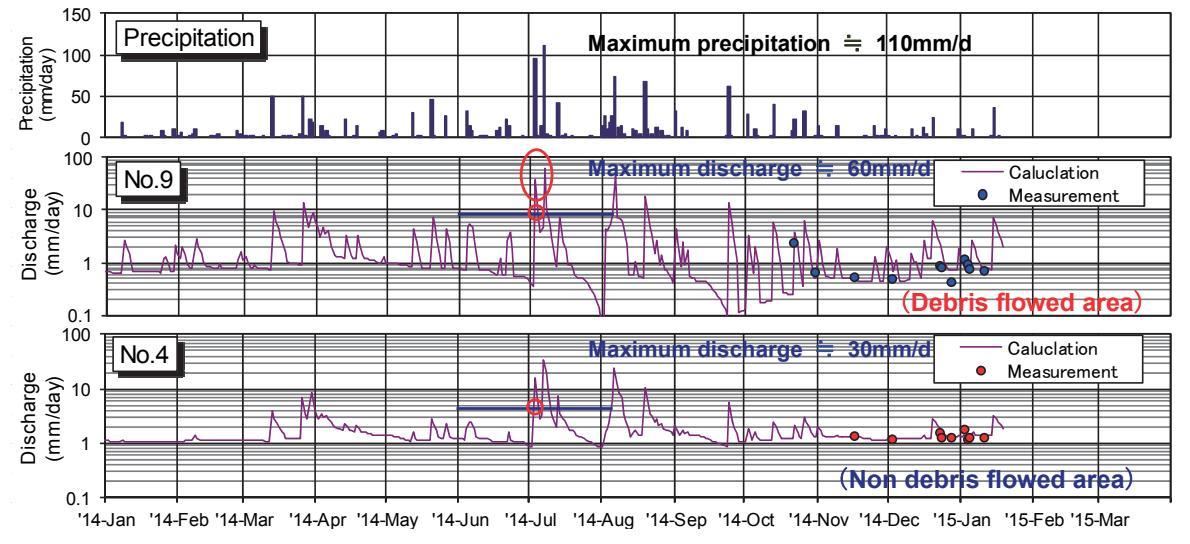
However, as shown in Fig.4, discharge in No.9 divide shows a distinct high in comparison to that in No.4 divide. Hence, it can be intuitively estimated that non-precipitation continued at No.9 is continued, the discharges would have been decreased.

Trial calculation based on peak discharge (240mm/d., August 20th 2014 by the Meteorological Agency of Japan) in a day are carried out for both debris flow affected divides and un-affected divides. There is clear difference in the runoff between No.9 and No.4 divides as the discharge at the time of debris flow is estimated as 155mm/d. in the former and 77mm/d. in the latter.

Fig.4 Discharge hydrographs for both debris flow affected divide (No.9) and un-affected divide (No.4)

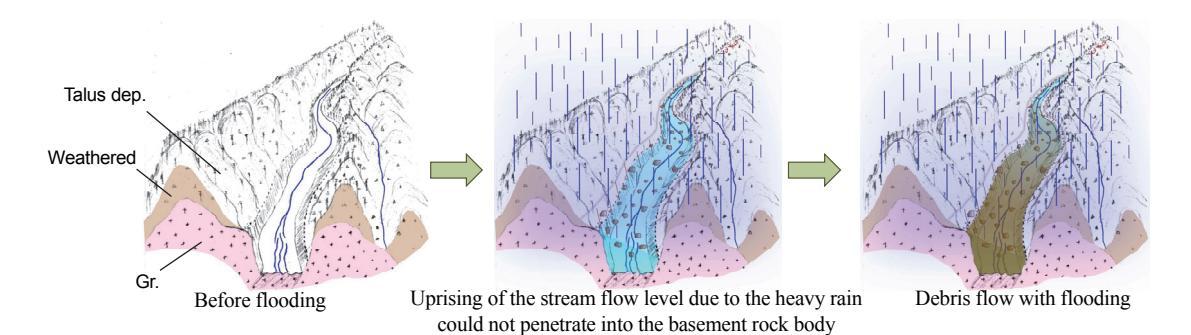
Fig.5 The illustration showing the flooding processes in Yagi-sawa area (Divide No.9)
