## Stability analysis of Shijiaping landslide and its effect on the safety of a 750KV substation in Tianshui, China

Lihui LI, Xiaolong DENG, Yufang TAN, Ruilin HU

As a part of Lanzhou East-Tianshui-Qian county electric power transmission project, one 750KV substation engineering was planned to build in Gangu County, Tianshui, China. However, field investigation revealed that an ancient Shijiaping landslide is situated on the left bank of the substation site. In order to assess the suitability of the substation site and ensure its safe operation, the evaluation of landslide stability and its effects on the site was performed. By using limit equilibrium method and numerical calculation, the results were drawn, which indicated that in natural state, the Shijiaping landslide is stable at present, yet creeping may occur in rainstorm season due to the softening of underlying mudstone. In the most adverse condition as the combination of rainstorm and earthquake, the landslide would be unstable. However, the landslide does not pose threat to the safety of the transformer substation site, for there is on chance for the occurrence of long run-out landslide. The results in the paper played

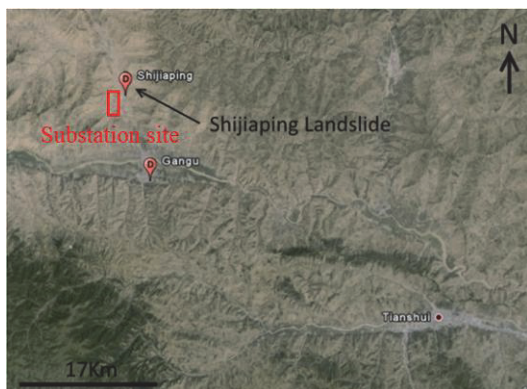
Fig.1 Location of Shijiaping Landslide

The planned substation was to be built at 300 meters away from north of Shijiaping, Xinxing town, Gangu county. It is 11.5km away from Gangu county (Fig.1). The traffic is convenient, the Gangu-Tongwei highway passes through on the 30 meters to the west of substation.

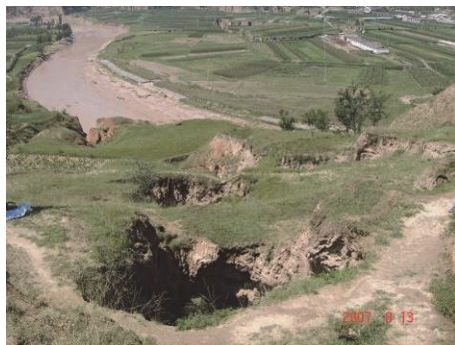
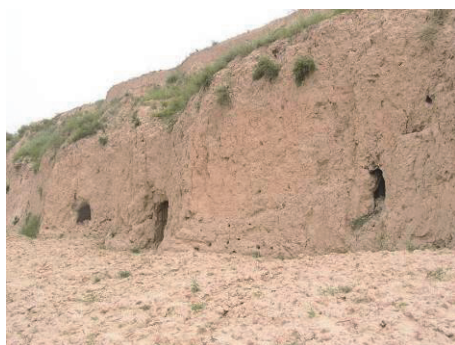
Fig.3 Sinkholes in the leading edge and backscarp of Shijiaping Landslide

Field investigations revealed that sinkholes and gullies are highly developed in landslide body. There are sinkholes parallel to the trailing edge and sidewall of the landslide, as Figure 3 illustrates. The sinkholes almost string-shaped distributed along the gullies, trailing edge and sidewalls of the landslide. Moreover, several rockfalls have been observed on the frontal parts

near southern sidewall of the landslide.

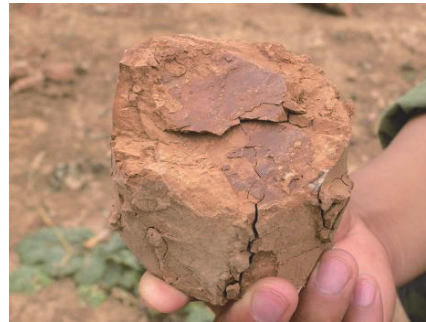
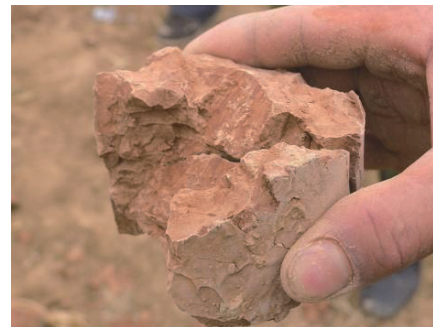
Fig.4 Mirror surface and striation in drill cores

The strata of landslide body contain Neogene rocks and Quaternary accumulations. The outcropped Neogene strata are mainly in gullies of the landslide body and partial areas along banks of Sandu River sporadically. The rocks are mainly mudstone with thickness more than 50cm. In the upper mudstone layer, vertical joints are highly developed. The rock would soften when it absorbed water, and cracked after losing water, i.e., it has the feature of water-expanding and dry dehydration. The Quaternary strata rocks are mainly the Malan loess, redeposited loess, silty clay, gravel soil, calcareous cemented conglomerate and flood plain deposits. Additionally, black clay with humus outcrops could be observed at local area. The Malan loess is thicker with a maximum thickness of 40m, vertical joints and sinkholes are highly developed in this layer. Mudstone interbedded with silty clay is also found in landslide accumulation. Six interlayers can be found from the borehole and trial pit exploration. Striation and mirror surface, as Figure 4 shows, could be easily observed, which implies that the landslide has suffered several slides.
