Post-evaluation of effect of large-scale landslide control based on monitoring measurement

Zhongping ZHANG⁽¹⁾, Honggang WU⁽¹⁾

(1) Northwest Research Institute Co., Ltd. of CREC, Lanzhou 730000,
ztxbywhg@yahoo.com.cn

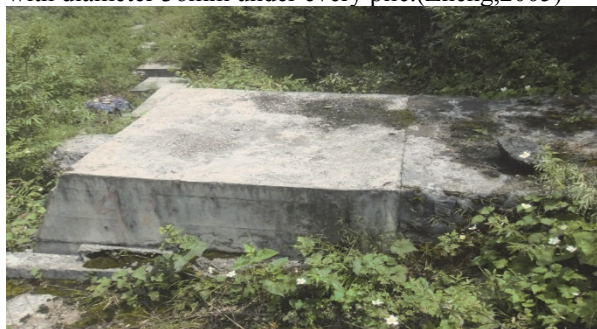
Fig.3 Anti-slide piles of western part

Western part: The west part of No.1 landslide is the most active, the most severely damaged section. It is the main target to restore. So 42 prestressed anchor rope friction piles, which are made of C25 reinforced concrete, are set up in this range (Figure 3). In view of most anchor rope friction piles setting deeply, there are 2 rows for a total of 20 grouting anchors with diameter 36mm under every pile. (Zheng,2005)

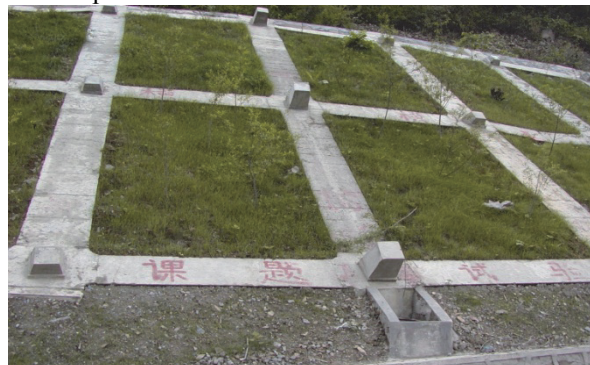
Fig.5 Prestressed anchor cable frames

Inside: Three pieces of anchor cable frame are installed on the inside of the road. They are controlled by highway mileage and the distance from the center of the road which is 8m from the center for all frames (Figure 5). Among them, 23 rib-columns are set up from K2729+990 to K2730+78; 10 rib-columns are installed from K2730+182 to K2730+222; and there are 31 rib-columns from K2730+222 to K2730+342. The material of rib-column and beam is C25 reinforced concrete.

Outside: We use 47 rib which are controlled by the control point coordinates on the outside of the road. Every rib-column has 3 bundles of anchors whose specification is 15Φ15.2.

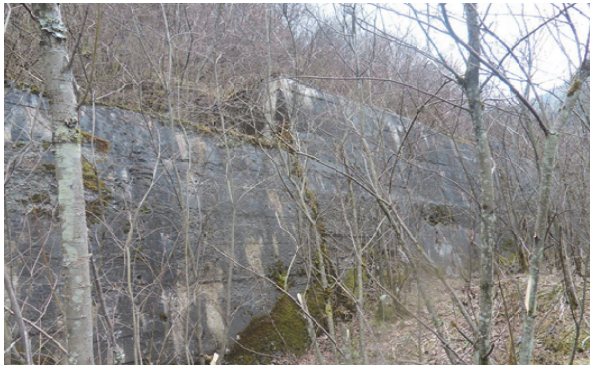
Fig.6 Retaining walls

Retaining wall of the riparian toe plays the significant role of retaining toe and erosion prevention. It's the necessary measure to prevent the failure of anti-slide pile and frame caused by the continuing erosion of the toe down to the slope. The design height of the wall is 8 meters, following Figure 6.

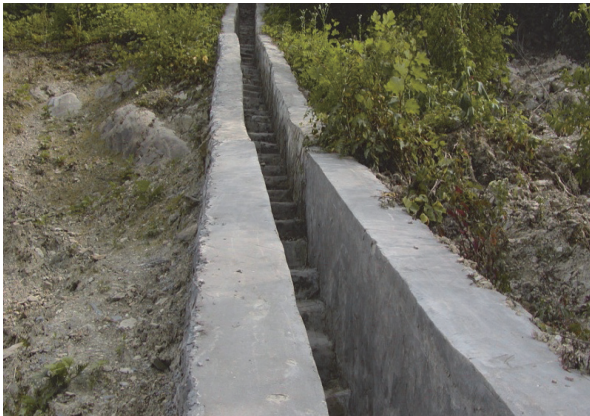
Fig.7 The rapid stream slot for drainage

Drain dykes are divided into intercepting drain

outside the landslide and drain inside the landslide. There are two drain dykes outside the landslide and two groups of drains inside the landslide. The total length of drains is 950 meters. The former should be constructed as soon as possible, and the later may be relatively lagging, following Figure 7.

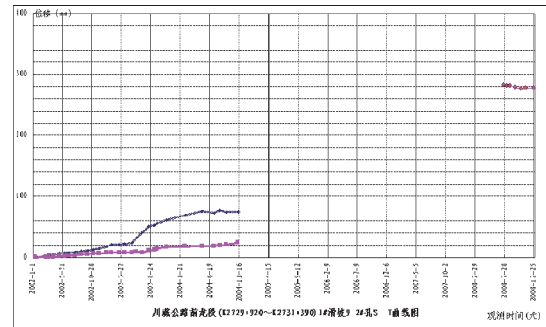
Table 3 The S-T curve graph of 9-3# hole of 1# landslide in Long Qian part of the Sichuan-Tibet Highway

lease. After completion of the treatment (from the end of 2002 to the end of 2004): landslides tend to be stable. In October 2002, retaining and strengthening works was coming to late stage, the constructions of anti-sliding pile and anchor were gradually playing a supporting role, but intermittent or seasonal deformation persists, destructive deformation may still occur. As a result of the treatment, the deformation phenomenon of the landslide has been inhibited. Whether the deep displacement monitoring of landslide or the results of stressing deformation monitoring of anti-slide piles all reveal which compared with before the treatment, deformation in shallow and middle layer of the landslide has been largely discontinued, which in deep layer only appears seasonal or intermittent creeping, having no impact on the overall stability of landslides. The observations of 2008 revealed: during observations, new slide zone was not found in all of the three drilling holes, and there were not any phenomena of sudden deformations which once appeared in the old slide zone. Therefore, deformation of the landslide is still greatly influenced by rainfall and activities of groundwater, the probability of coming up sudden destruction is very small. As shown in table 2-4.
