Rain-induced rock avalanches with a sliding surface along an out-of-sequence thrust

Noriyuki ARAI⁽¹⁾, Masahiro CHIGIRA⁽²⁾

Abstract

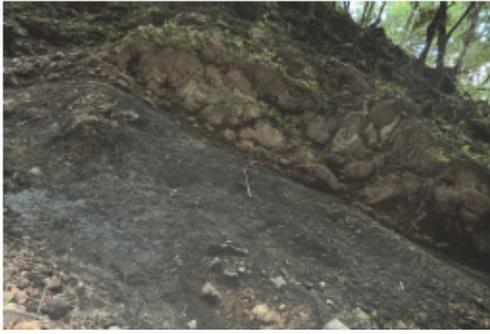
Fig.6 Kawarabi thrust (Arrow 1 in Fig.4). Looking to the northwest. The scale bar is 70cm long

The crush zone of the fault shown in Fig.6 has a black gouge layer wider than 5cm along the top and bottom of the 1.5-m wide crush zone, and the inner zones of the crush zone is composed of clayey fault breccia. Along the base of the hanging wall of the fault, seepage water flowed out constantly, precipitating brown iron hydroxide. This suggests

that the fault would prohibit groundwater flow and would cause pore water pressure build up during rainstorms. At the outcrop of Fig.7, the fault has a 70-cm wide crush zone consisting of clayey breccia and a few layers of 3-5cm thick black gouge along the main shear planes. The relationship between the main shear plane and Riedel shear plane (Kano et al.,1991; Onishi and Kimura, 1995) suggested that the footwall displaced toward N26°E with 10° plunge. Similar sense has been obtained from other outcrops of this fault.

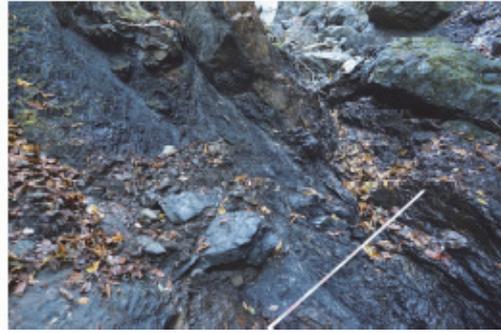
Fig.7 Kawarabi thrust (Arrow 2 in Fig.4). Looking to the southwest. The scale bar is 100cm long.
