## Geomorphological and geological features of the collapsing landslides induced by the 2009 Padang earthquake

Maho Nakano<sup>(1)</sup>, Masahiro Chigira<sup>(2)</sup>, ChounSian Lim<sup>(3)</sup>, Sumaryono gajam<sup>(4)</sup>

(1) CTI Engineering Co., Ltd

(2) Disaster Prevention Research Institute, Kyoto University, Japan

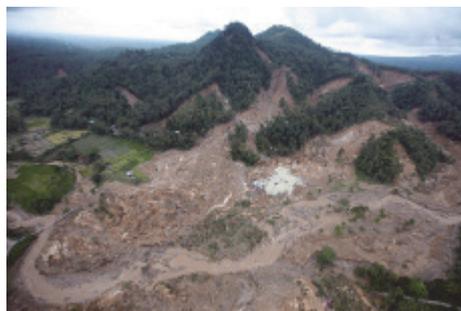
Fig. 1 Landslides triggered by the 2009 Padang earthquake (AP Photo/Dita Alangkara date: Oct 3, 2009).

The Mw7.6 Padang earthquake on 30 September, 2009 triggered many landslides, which were very rapid and highly destructive. Those landslides attacked valley bottom villages and killed at least 130 people (Fig.1). The landslides occurred during heavy rain, of which amounts were not recorded. We made satellite image interpretation and field survey to clarify landslide distribution, characteristics, and the relationship between landslides and the geological or geomorphological features.

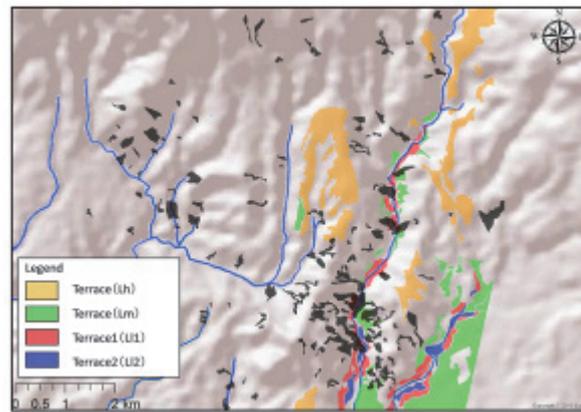
Fig. 3 Distribution of landslides (black) and river terrace.

We found four terrace groups (high terrace, middle terrace, low terrace 1, and low terrace 2 in Fig. 3) and that landslides occurred on the valley slopes which were made by river incision of the high terraces. The slopes incised on the high terraces were recognized to be cut by the scarps of middle terrace and low terrace 1 on the PRISM images. Along the Maggung River, we observed that landslide slopes had been cut by the scarps of low terrace 1. Landslide slopes on nearby tributary catchments can be assumed to have been cut by

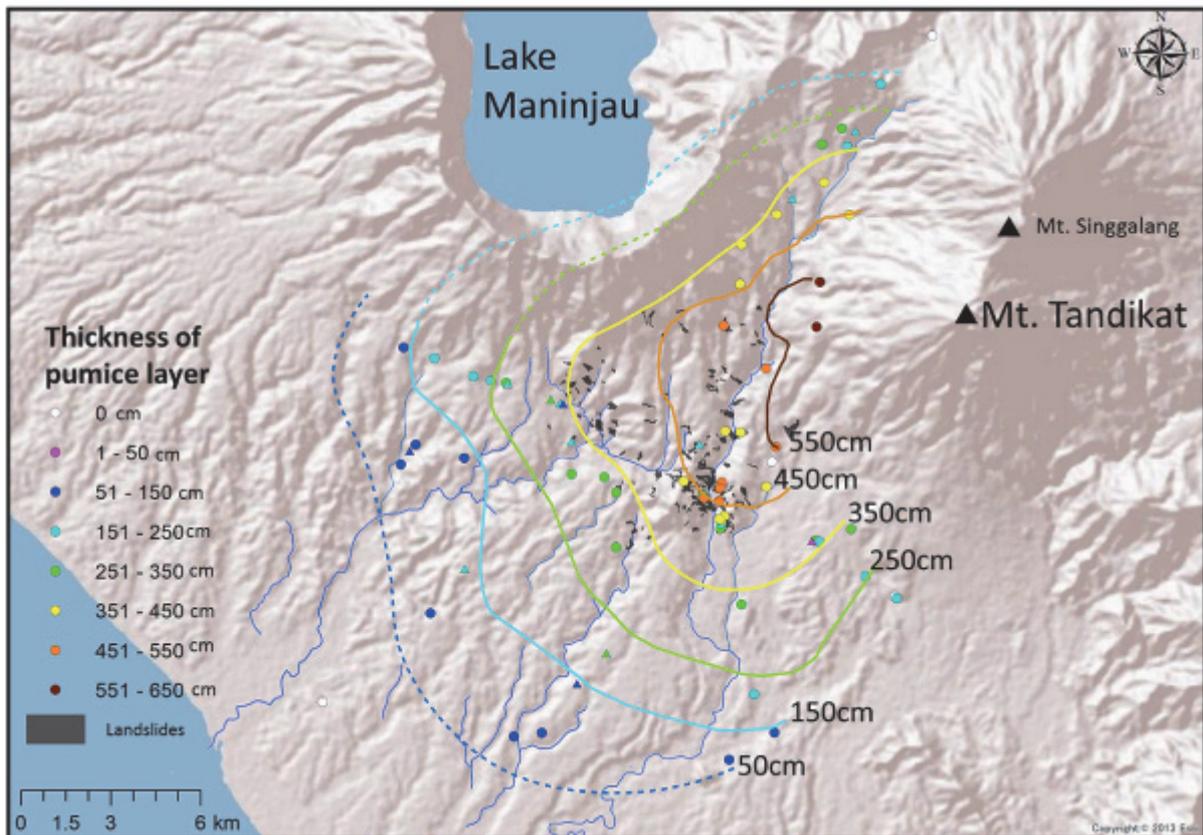
Fig. 4 Isopach map of the Qhpt and the distribution of landslides.

The affected area is widely covered with pumice fall deposits just below the ground surface. This pumice fall deposits has been called as Qhpt and believed to be from Maninjau Caldera (Tjia and Muhammad, 2008), but the isopach map strongly suggests that Qhpt was from Tandikat Volcano (Fig. 4). The age of Qhpt is not specified but is younger than 0.08 Ma, which is the age of pyroclastic flow deposits older than Qhpt (Nishimura, 1980). The distribution of the pumice layer and the landslides indicates that the landslides concentrate in the areas where the pumice layer was 3.5-5.5 m thick. All of the 14 landslides we studied had a pumice layer with slope-parallel layering. Below the pumice layers are heavily weathered gravels or volcanic soils, the latter of which are distributed away from the terraces.

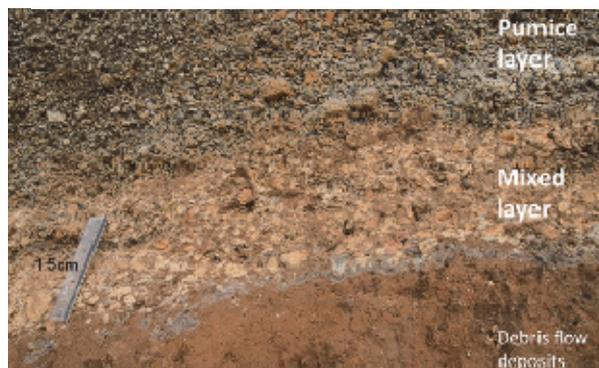
Fig. 5 Mixed layer and overlying pumice layer and underlying debris flow deposits.

Sliding surfaces were made within the base of the pumice layer, where pumice grains were mixed with soil, which is heavily weathered debris flow deposits (Fig. 5). Grains of pumice and soil in the mixed layer were very weak and easily smeared by finger and rich in hydrated 1.0 nm halloysite, while the pumice grains in the main part of pumice layer were hard and scarcely had halloysite. Pumice grains in the mixed layer had no remaining volcanic glass but consisted of halloysite, which had precipitated on the previous bubble walls to form a very fragile framework. According to the cone penetration tests performed on 2 landslide sites, mixed layer had the lowest penetration resistance. Permeability of the mixed layer and the debris flow deposits were about two orders smaller than the permeability of the pumice layer. Simple shear tests for the mixed layer under constant

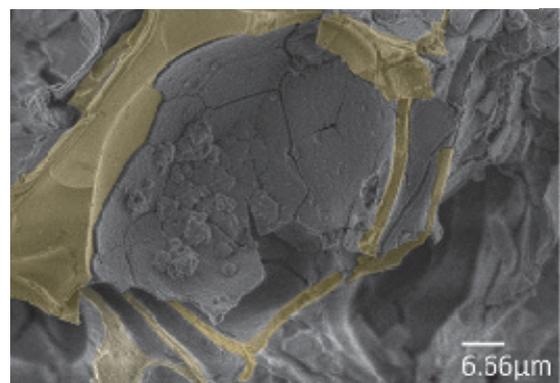
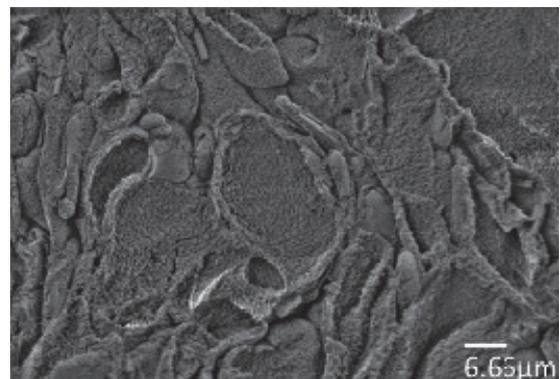
Fig. 6 SEM images of pumice grains. Upper: Pumice grains in the main part of the pumice layer. Volcanic glass (yellow) is covered by amorphous precipitate. Lower: Pumice grain in the mixed layer. No volcanic glass but small spherical halloysite.

The sliding surfaces of the landslides we investigated were all within the mixed layer which is rich in halloysite, at the base of Qhpt layer. Halloysite is contained in the mixed layer and also soil of weathered debris flow deposits just below it, suggesting that it is made after the deposition of Qhpt. Soil much below the mixed layer was lack in halloysite but had gibbsite, which is the residue of intensive leaching. These occurrences suggests that once gibbsite is made by leaching, pumice grains deposited, and then water percolated from the ground surface, got  $\text{SiO}_2$  from the pumice, then reached to the base of the Qhpt and reacted with the soil and pumice to form halloysite. The silica-rich water reacts with gibbsite-rich soil, forming halloysite,  $\text{Al}_2\text{Si}_2\text{O}_5(\text{OH})_4 \cdot 2\text{H}_2\text{O}$  (Kleber, Schwendenmann et al., 2007). Similar reaction has been proposed for the halloysite formation in a paleosol where sliding surfaces were made during the 1978 Izu-Oshima-Kinkai earthquake (Chigira, 1982). Pumice grains in the mixed layer is dissolved to the water and halloysite is presumed to have formed on their surfaces.

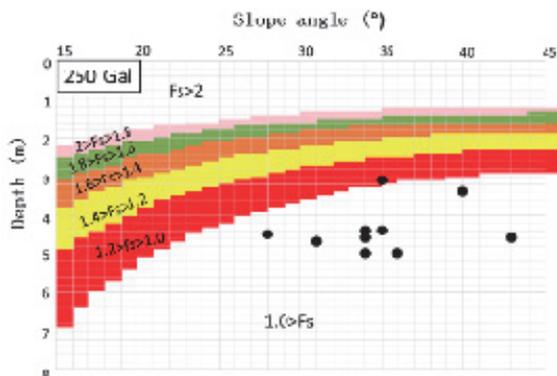
Fig. 7 Safety factors obtained from infinite slope stability analysis with parameters of slope angles and the depth of a sliding surface.

Infinite slope stability analysis has been done with parameters of slope angles and thickness of beds that slid. The strength parameters used for the sliding surface were 18.2 kPa of cohesion and  $15^\circ$  of internal friction angle. One example with a horizontal seismic acceleration of 250 gals is shown in Fig. 7, in which 9 of 10 landslides: all landslides we measured slope angle in field survey, plotted had safety factors less than 1. This acceleration is consistent with that estimated in the affected area by the US Geological Survey.

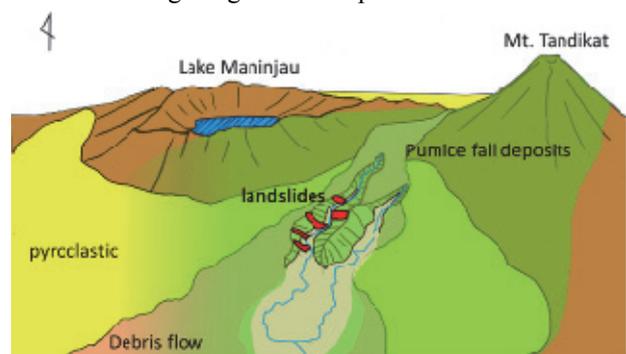
Fig. 8 Bird eye's view of the schematic of the topographic development.

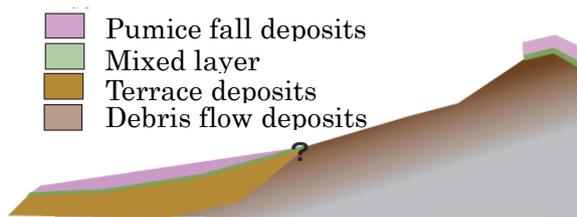
Fig. 9 Conceptual image of the geological profile of the slope.
