Various Models of Slope Stability due to Earthquake Activity in Gunung Tigo, Padang Pariaman, West Sumatera, Indonesia

Abstract

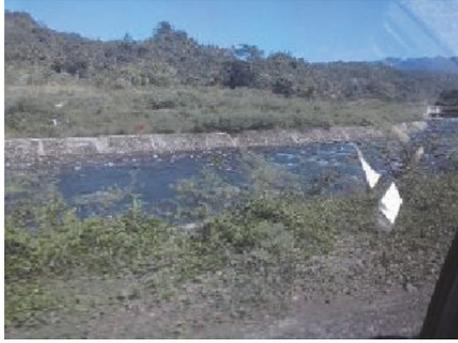
Photo. 1 Rough hills geomorphological unit.

Based on field observation, geomorphological unit in research area is classified as rough hills. This research area is dominated by hills with slopes value 15-70%. It is dominated by V shape valley. It represents that research area is a young valley and lied on hard rock formation. It also indicates that research area has high value of angle of friction,

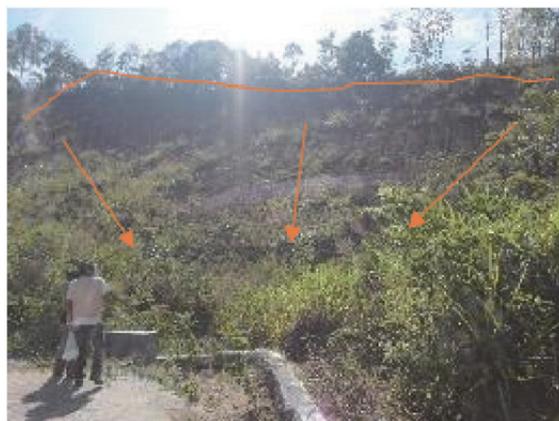
Photo. 2 Slope LB 1 slope that occurred landslide when earthquake happened at 30th September 2009.
