Crushed Rock Mass in Landslide Body of the Cretaceous Sedimentary Rocks

Toshio MIZUTANI, Takeshi NAKAMURA and Keii BAN⁽¹⁾

(1) Shikoku Branch, NIPPON KOEI CO., LTD.

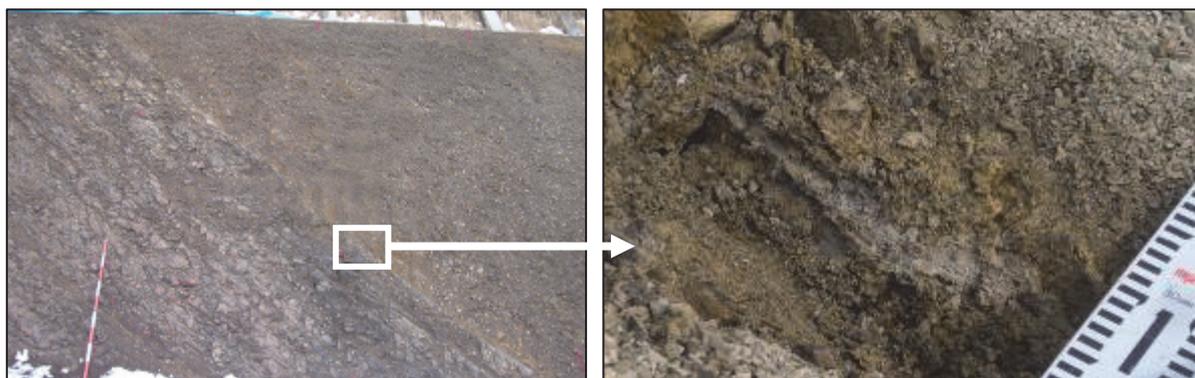
Photo. 4 Boundary of the shale layer

Some clay layers are intermittently distributed along the layer.

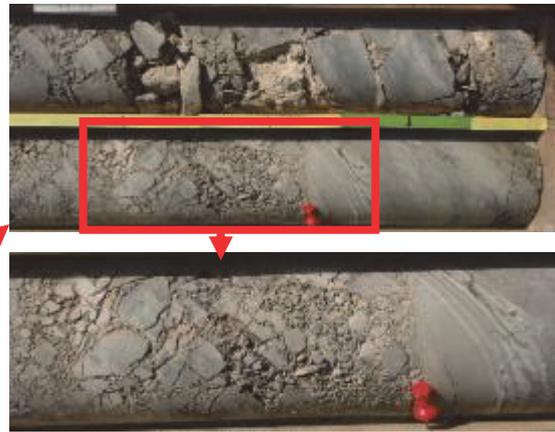
Photo. 6 Borehole core No.5 (GL-15m)

- the slip surface is distributed around the lower part of tuffaceous shale
- rocks around the slip surface are crushed to the grade of Cr2 or Cr3

- rarely deformed and rotated with few oxidized cracks
- almost all the rocks of this layer remain the grade of Cr1a or never crushed

- Boring No.5 : the depth of around 15 meters
- Boring No.2 : the depth of around 20 meters
- The slip surface is distributed around the lower part of tuffaceous shale.
- Rocks around the slip surface are crushed to the grade of Cr2 or Cr3.
- The contrast between upper and lower side of grade of crushed rocks is viewed quite clearly.

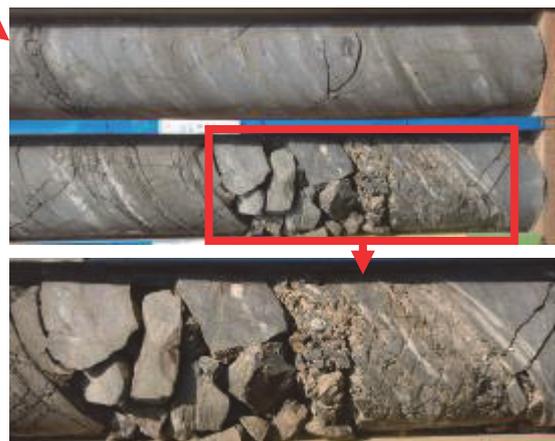
Photo. 7 Borehole core No.5 (GL-25m)

- several centimeters thick crushed zone with some planer structures

- Boring No.5 : the depth of around 25 meters
- Boring No.2 : the depth of around 33 meters
- The slip surface is distributed around the upper part of sandstone.
- It occurs as several centimeters thick crushed zone with some planer structures.
- Rocks of just upper and lower layer of the slip surface remain the grade of Cr1a or never crushed.
