Structure and Stability of Zhangmu Deposit in Tibet

Abstract

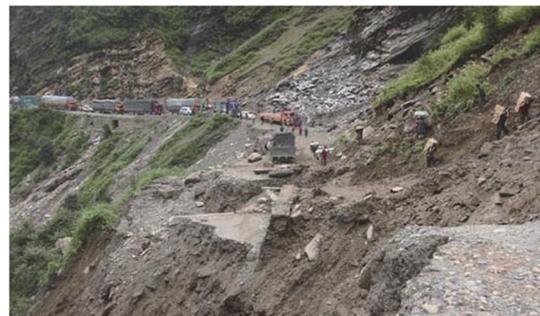
Fig.3 Talus slide in Zhangmu

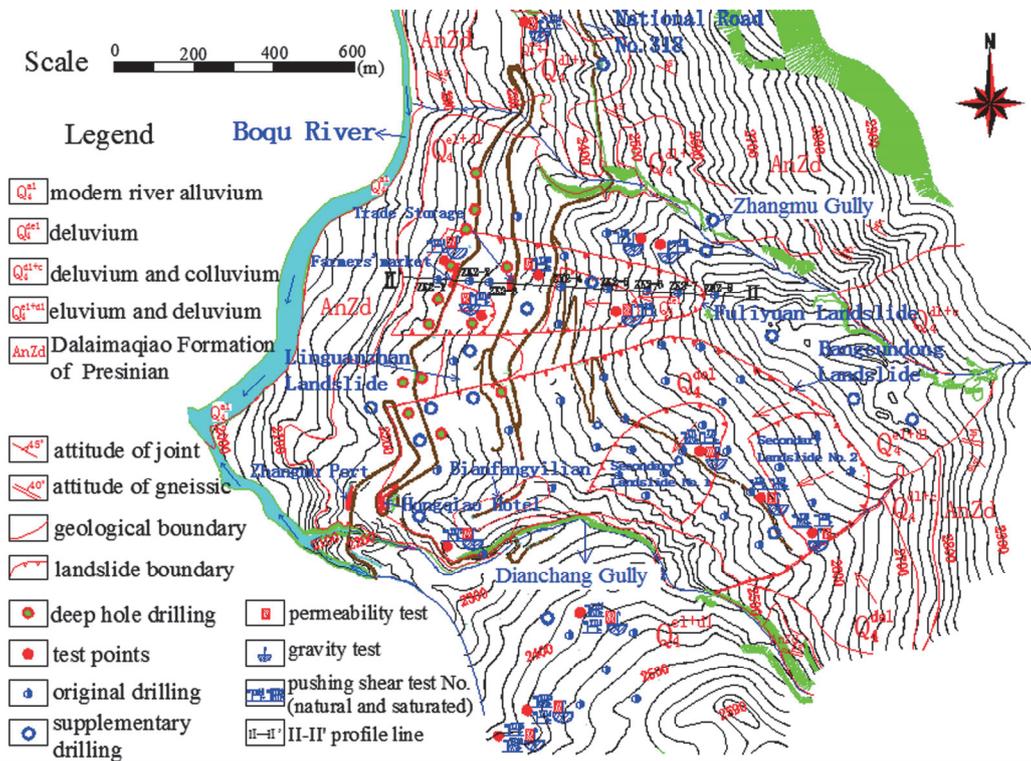
Fig.4 Engineering geological plane of Zhangmu

amphibolite gneiss (Chen NS, Hu GS, Deng W, et al., 2013). There are two main ravines distributed at the north and south of the deposits respectively named Zhangmu Gully and Dianchang Gully, and the latter one is also the main tributary of Boqu River in this area (Fig.4).

was carried out on the basis of preliminary investigation. It includes 31 new boreholes (5 are deep drilling boreholes), 14 trial trenches, and 20 test points of in-site push shear tests, permeability tests, sieve tests and gravity tests distributed in different deformation areas (Fig.4). Through the field investigation, it was observed that the constituents of the deposit are not so simple. The typical section shows that the deposit is not entirely eluvial slope materials (Fig.5). Generally, the upper part of the deposit is mainly gravel soil, mostly tawny, with large content of block stones of different diameter sizes from 5 cm to 5 m. The rocks are angular in morphology and mainly composed of mica schist and quartz schist, and the fine part is mainly silty clay. Beneath this layer of soil, a layer of grey silty clay with a certain amount of gravel is generally developed. This layer has a transitional relation with the underlying bedrock, and the interface between them is blurred (Fig.6). It became obvious that Zhangmu Deposit is not just a single eluvial slope material, but composed of the upper grey-tawny colluvial deposit and lower grey weathered residual deposit. On the east side of Line Bianfangyilian to the old fire brigade, the overall thickness of the deposit is much bigger. The upper colluvial deposit has a maximum thickness of 42-55 m and the particle size ranged from 45 to 100 cm, and the block stone content is between 60 and 80%. Large stone content is reduced in the lower weathered residual deposit which has a maximum thickness of 28-34m and is mainly composed of gravels of 2-10 cm sizes. On the

Previous surveys indicate that, two big ancient landslides respectively named as Fuliuyan Landslide and Bangcundong Landslide which also developed some secondary landslides, and a big deformation body named Linguanzhan Landslide exist on the Zhangmu Deposit (Fig.4).

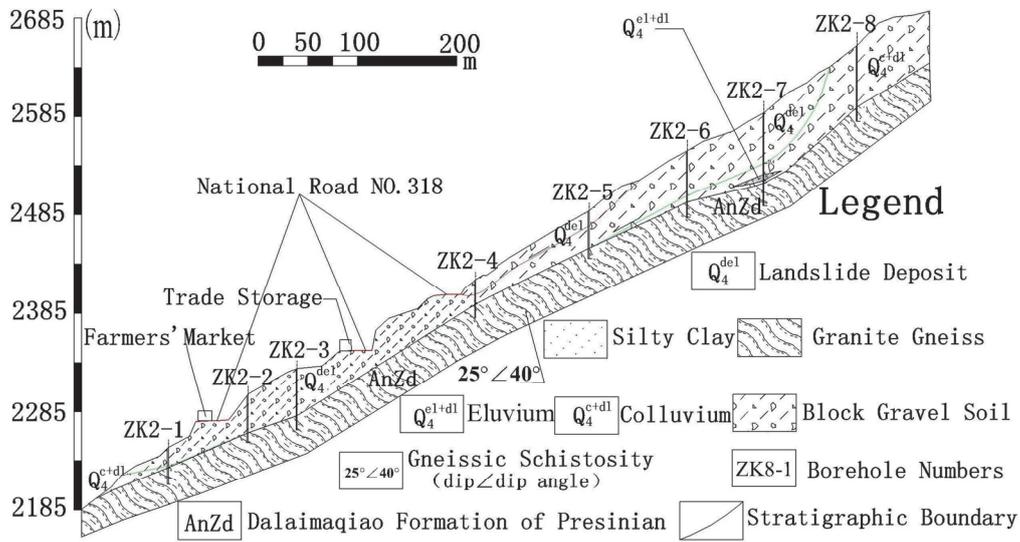
Fig.5 A typical engineering geological section (Line II-II')

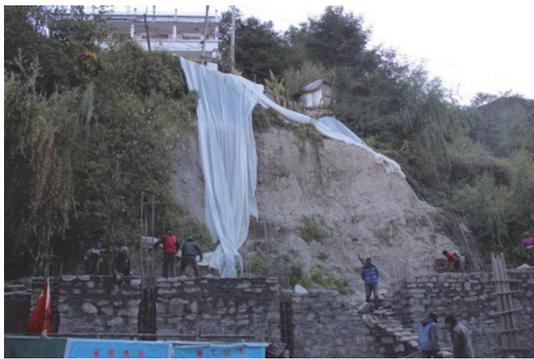
Fig.6 Weathered profile opposite Hongqiao Hotel

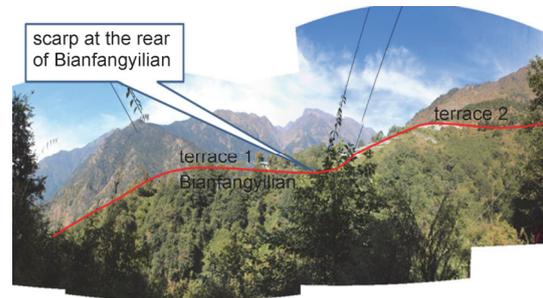
Fig.7 Two terraces on Zhangmu Deposit

The research shows that, two obvious terraced terrains exist on the Zhangmu Deposit (Fig.7), and the boundary is located approximately along the line of Bianfangyilian-Bangcun neighborhood committee building. Although the ground surfaces up and down the scarp are all composed of colluvial deposit, there are still some differences in material compositions. Deposits at upper part of scarp generally has coarse particles, big content of angular stones, small content of fine-grained materials and dense trees on it; but at the lower part, the slope deposit weathered severely and has relatively small particles, less block stone, more fine-grained materials, fewer trees and more grass on it (Fig.8). It suggests that the colluvial deposits up and down the scarp are formed in different collapsed periods. Historically there are two main concentrative collapsing periods, and the lower colluvial deposit is obviously formed earlier than the

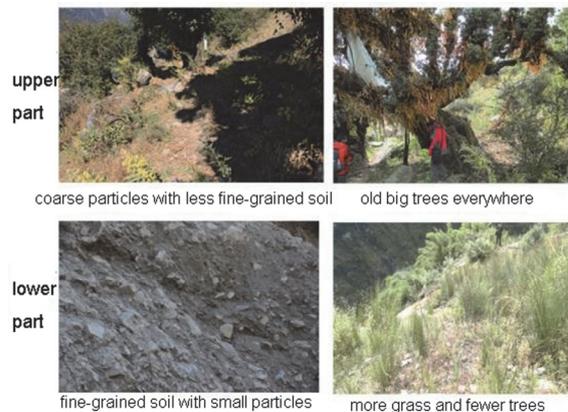
Fig.8 Colluvium features up and down the scarp

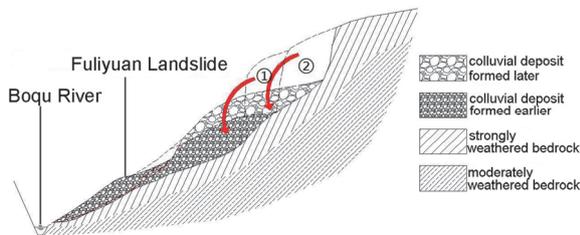
Fig.9 Formation process diagram of Zhangmu colluvium

upper one, and the formation processes are shown in Fig.9.

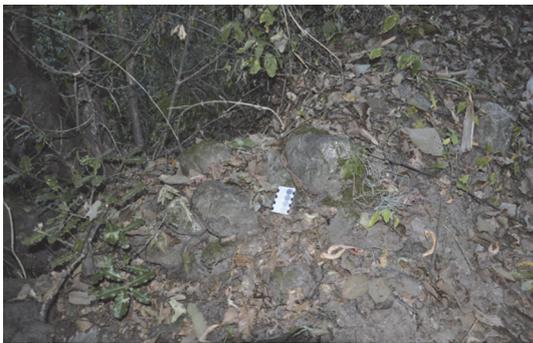
Fig.10 Glaciofluvial deposits in the north gully of Hejia Hotel

It's worthy to note that, a mélange of deposits of fluvial facies and outwash facies referred to as glaciofluvial deposit, because the two kinds of deposits are indistinguishable, was found on the platform along Bianfangyilian in the lower part of the slope (Fig.10). The deposit is mainly distributed on the terrain platform which is in the east of Hejia Hotel north gully, west of Dianchang Gully and south of Bianfangyilian (Fig.11), with an area of about 0.14 km², a volume of 18,400 m³ and consists of gravelly soil, silty clay with gravel stone and silty clay in composition, and is well cemented. Most of the gravel is rounded, and the average roundness is sub-angular and some up to sub-rounded, with a significant action of water flow which has obvious differences in the appearance with other gravel in colluvium. The glaciofluvial deposit has a wide range of grain size, and is mainly in 2-60 cm (about 40%-50%), very large particles above 60 cm about 15%, and fine particles less than 2 mm about 35%.

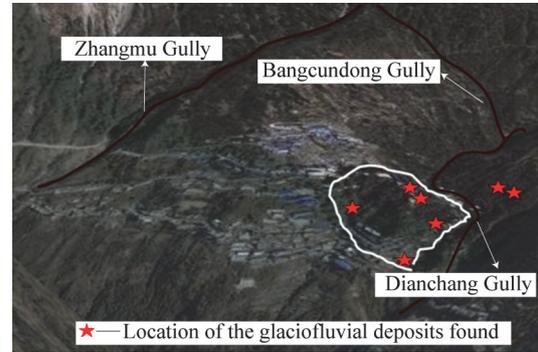
Fig.11 Distribution diagram of glaciofluvial deposits

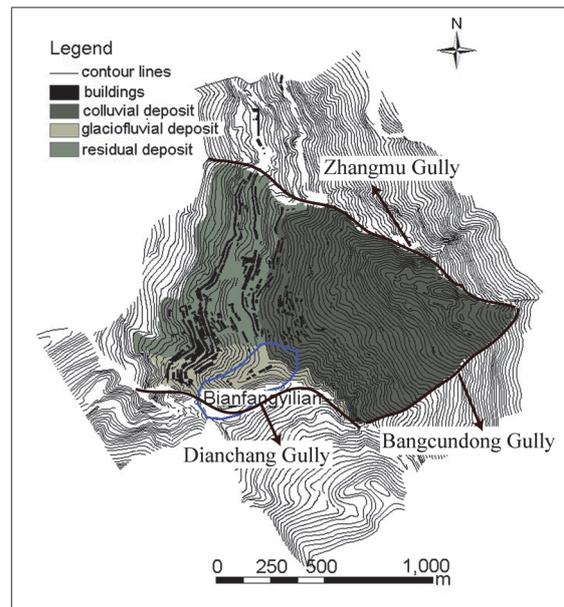
Fig.12 Causation types distribution of Zhangmu Deposit

In summary, Zhangmu Deposit is composed of colluvial deposit, residual deposit, glaciofluvial deposit and landslide deposit (Fig.12). However, since residual deposit is mainly buried under the ground, it's not marked in the figure.

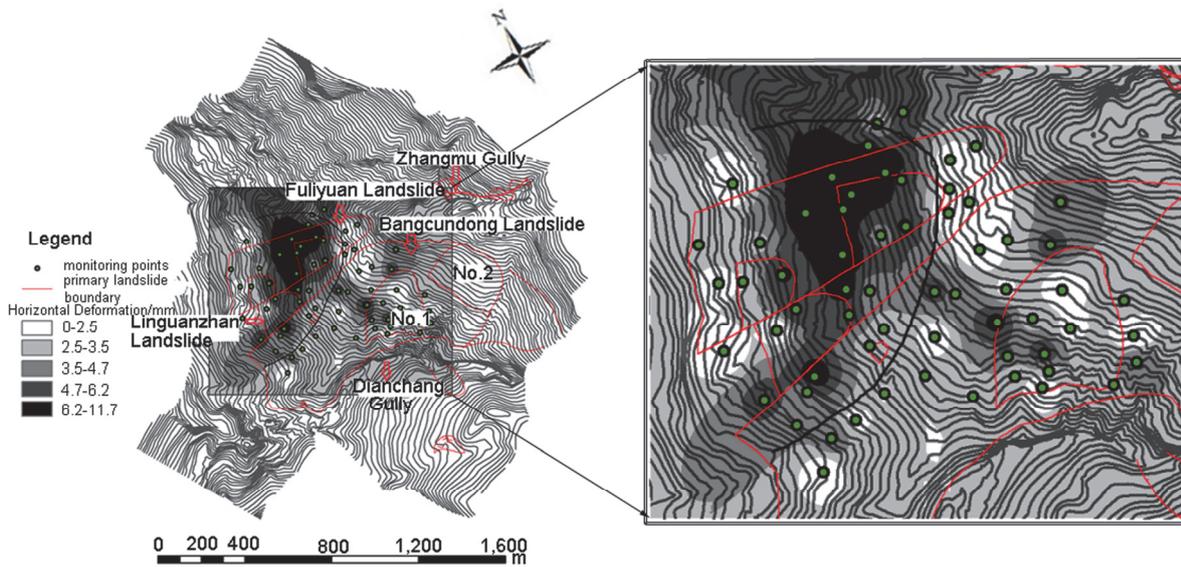
Fig.13 Surface displacement grading figure on Zhangmu Deposit

Based on preliminary ground surface deformation monitoring data, deformation law of the deposit initially studied shows that, surface deformation of Zhangmu Deposit is mainly concentrated on the middle and lower part of the slope along Fuliuyan-Linguanzhan and the east slope of Bangcundong (shown as the grey-dark part in Fig.13), and the deformation is small on the upper and lower slope. Reasons adduced for this situation include that: this area is a transition terrain with big slope gradient, and the slope stability is poor; houses concentrate on this area and human engineering activities is intense; and concave lateral erosion action of Dianchang gully is the main reason of Bangcundong slope's instability. The deformation of the area around Fuliuyan

Landslide is almost as big as that of landslide area. So, from the deformation angle, the range of the Fuliuyan Landslide can be enlarged to the black line as shown in Fig.13. On the area of so-called Bangcundong ancient landslide, there is no uniform deformation and the deformation amount is small, therefore, the justification for its existence is insufficient. From the displacement vector diagram (Fig.14) we can also get the same conclusions which shows that the displacement direction is almost the same along Fuliuyan area and shows relatively intact integrity and obvious landslide characteristic, towards Boqu River (on the left side of the figure); while on Bangcundong landslide area, the displacement vector direction is in chaos and poor in consistency.

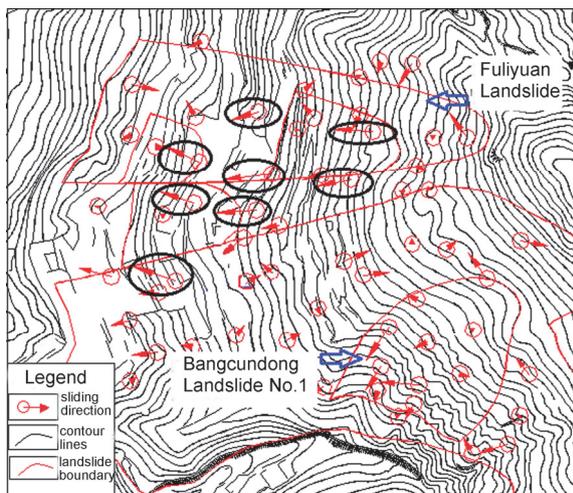
Fig.14 Displacement vector diagram

- 1) As earlier mentioned, the main materials of Zhangmu Deposit are from collapsed accumulation of the upper mountain. There are two concentrative collapsing stages, and they formed the slope with two micro-terraces. So, the protruding topography is not formed by the landslide.
- 2) There was no obvious sign of sliding found around the landslide boundary.
- 3) Slope surface displacement shows no integrity but partial slip characteristic (Fig.14).
- 4) Most importantly, glaciofluvial deposit is

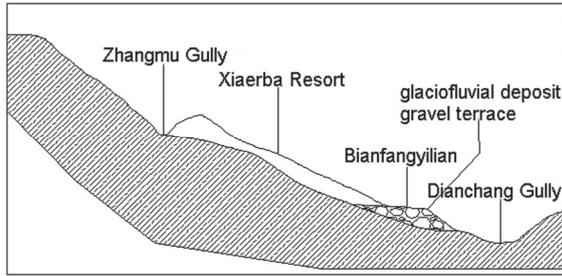
Fig.15 Longitudinal section schematic view of Zhangmu Deposit

found at the lower part of the slope, cemented and is formed clearly earlier than the upper colluvium, and its presence indicates that the slope has never been overall slipped in the history; otherwise the glaciofluvial deposit would have not been preserved. On the other hand, the glaciofluvial deposit cemented well and formed a relatively stable gravel terrace. It not only changed the slip shape of the deposit, but also played a role in sliding resistance to some extent (Fig.15). The presence of gravel terrace also separated the deposit laterally, and blocked its overall slipping (Fig.16).

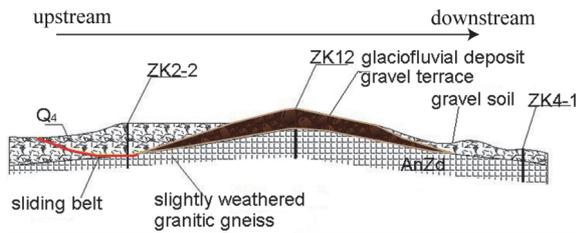
Fig.16 Cross section schematic view of Zhangmu Deposit

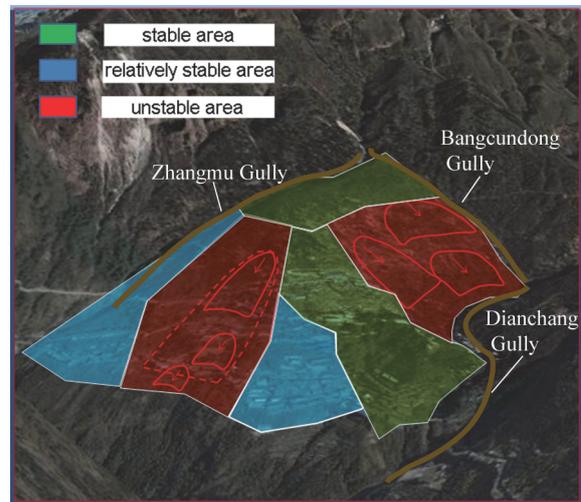
Fig.17 Slope stability zoning map of Zhangmu Deposit

Therefore, overall landslide is hard to develop on the Zhangmu Deposit, and its stability is mainly controlled by the local hazard factors. According to analysis, the main factors of restricting slope local slip include slope gradient, lithology, groundwater activity, human engineering activities, and concave lateral erosion action. Based on these, a preliminary evaluation of slope stability of Zhangmu Deposit was studied and from the result (Fig.17), it can be seen that, the stable slope area is mainly distributed on the top of the slope and Bianfangyilian terrace connected with it where has flat terrain and less disturbance slope. The top of the slope is mainly composed of newly collapsed deposit and Bianfangyilian terrace mainly composed of well cemented glaciofluvial deposit. They are both in a good topographic and geologic condition and both have good slope stability, suitable for urban land development and utilization. The unstable slope area is mainly distributed on Fuliuyan landslide and Bangcundong slope. It has severe surface deformation and intense human

engineering activities, and slides frequently. Therefore, the slopes have poor stability, and need necessary reinforcement. Areas outside these two areas mentioned above have moderate stability.
