## The Geographical features of the Hiroshima landslide disaster triggered by heavy rainfall on August 20, 2014

Shoji DOSHIDA<sup>(1)</sup> and Kiminori ARAIBA<sup>(1)</sup>

(1) National Research Institute of Fire and Disaster, Japan  
E-mail:sdoshida@fri.go.jp

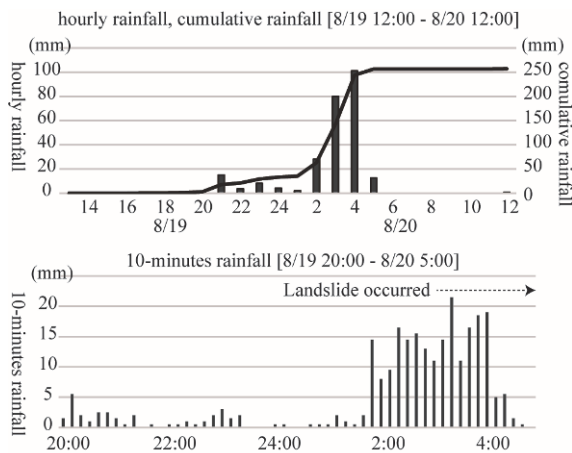
Fig.2 Histograms of hourly rainfall, cumulative rainfall and 10-minutes rainfall.

Asa-kita ward, Hiroshima city, adjacent to the area where landslide disasters occurred frequently, hourly-maximum precipitation is 101.0 mm, 3-hour-maximum precipitation is 217.5 mm and 24-hour-maximum precipitation is 257.0 mm are observed (Fig.2) (Japan Meteorological Agency, 2014a; Japan Metrological Agency, 2014b). These precipitations were the heaviest on the records at the observatory. In this research, We considered the geographical features of two landslides in the disaster by analyzing the LiDAR (Light Detection and Ranging) data acquired before and after the disaster and field survey.

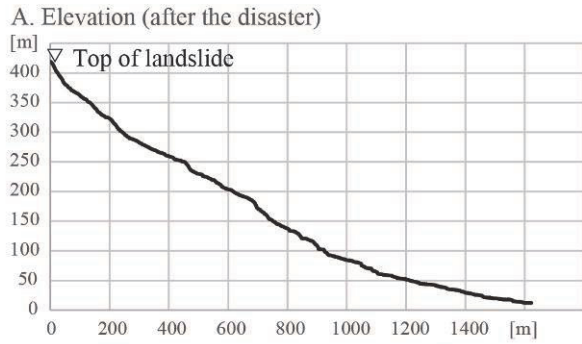
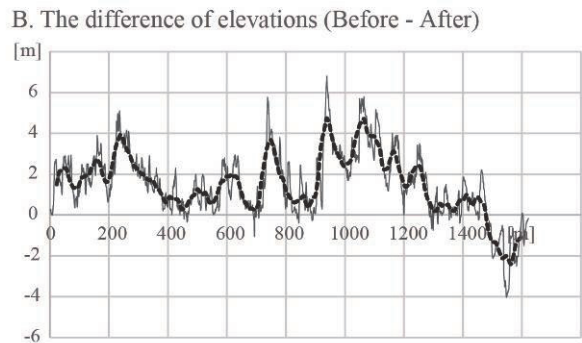
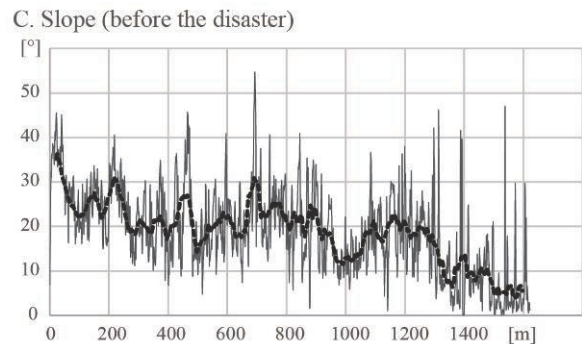
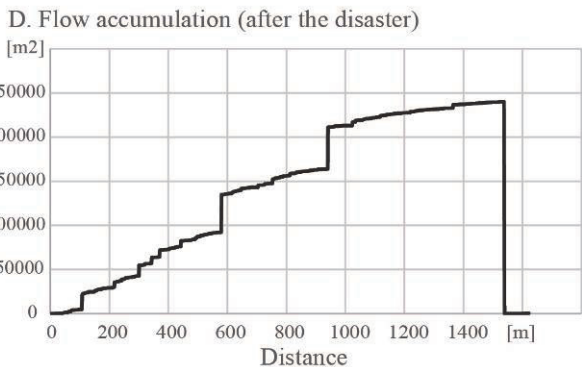
In B graph, the value is changing a lot. The whole tendency shows that there are an area which is easy to do erosion, and an area which is hard to do erosion in Profile A. In order to clarify the geographical features of the easy to do erosion area, we compared the difference of elevations (graph B) and slope before the disaster (graph C). The comparatively large amount of erosion was observed in the area of 20 degrees or less of slopes, especially near 900 – 1100 m (the distance from ridge).

However, overall variation is large and it is difficult to explain all only from the slope before the disaster. Next, we compared the difference of elevations (graph B) and flow accumulation (graph D). In the flow accumulation graph, the part where a value becomes high suddenly show the point where a branch joins a main valley. As a result of comparing, the increase of the erosion was seen in the valley junction (near the point of 580 m and 950 m). However, overall variation is large and it is difficult

to explain all only from the flow accumulation too. As mentioned above, the area where a slope before the disaster is gentle and a valley junction are easy erosion. However, it seems that there are other causes.

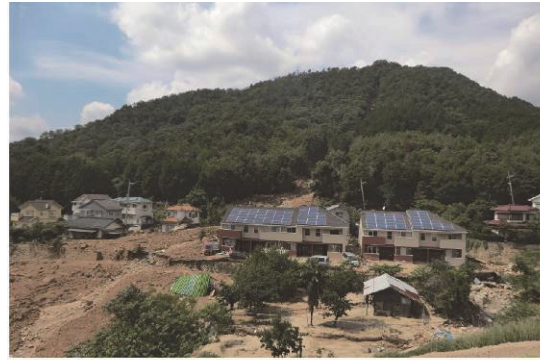
Photo 4. The distant view of landslide

left, we illustrate the landslide distribution, valley lines (flow accumulation more than 1,000 m<sup>2</sup>) and the line of Profile B (Fig.6) with topographic map. The photo 4 shows the distant view of the Kabe-higashi landslide. The landslide occurred near the ridge, flowed straight along the valley line, and hit two or more houses directly. The photo 5 shows the erosion and sediment area, and the photo 6 shows the sediment area of the landslide. With these photographs, the sedimentation structure which two or more times of debris flows reached is seen. The sediment consisted of the sand and the rock of the granite, and the decomposed granite. (Doshida et al., 2014; Doshida and Araiba, 2015)

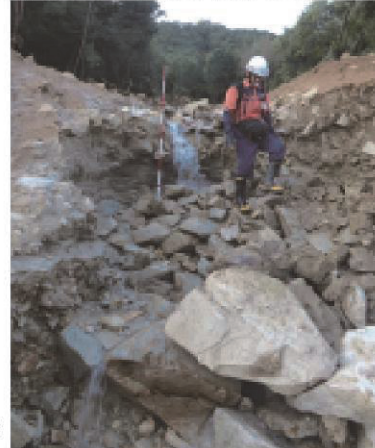
Photo 5. Erosion and sediment area of landslide

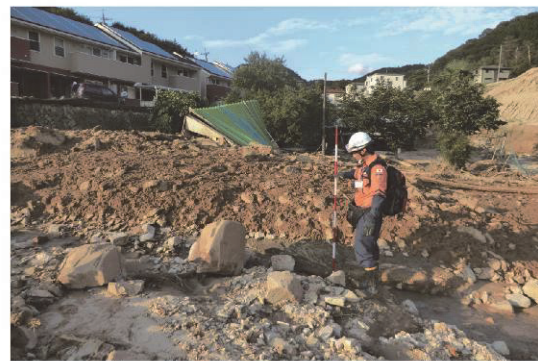
Photo 6. Sediment area of landslide
