Analysis on deformation and failure of rock mass in deeply buried Guanshan railway tunnel under high in situ stress

Guanshan railway tunnel, located in Gansu Province, China, is a deeply buried diorite rock mass tunnel under high in situ stress. On the contrary of the good rock mass classification predicted in investigation stage, the real situation after excavation shows a great change of rock mass parameters and structure, revealing not only the degradation of rock mass quality also the significant anisotropy of rock mass. The degradation and anisotropy of rock mass is described and analyzed based on the statistic analysis of the rock structural plane in field. Meanwhile, borehole camera is adopted to further observe the progressive deformation and failure of rock mass in an interval after excavation. As one of the hard and brittle plutonite, the uniaxial compressive strength (UCS) of diorite is a relatively high index on investigation stage, which is obviously larger than the in situ stress. However, the deformation and failure of diorite rock mass happened prevalently. As the evidence obtained by borehole camera, the micro fracture or closed rock structural plane under high in

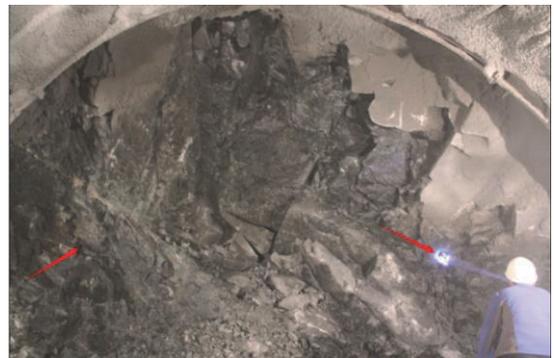
Photo.4 1# (left) and 2# (right) borehole camera observation holes at DIK76+543

For a more intuitive and comparative analysis on the degradation of rock mass after tunnel excavation, we adopted the borehole camera to observe the rock mass situation twice in 1# and 2# observation holes ahead the working face on DIK76+543 (buried depth 795m) respectively, given 6 hours apart (see photo. 4). The two observation holes are almost perpendicular to the working face, with a small inclination.

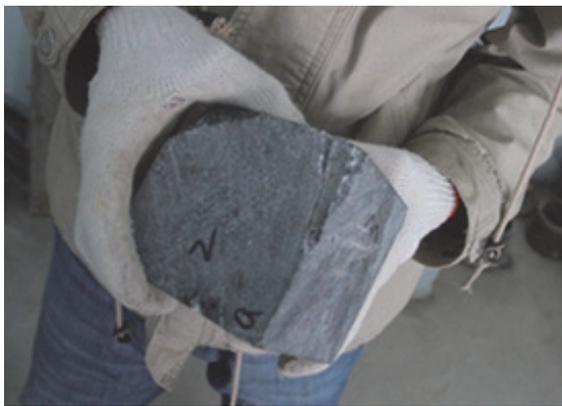
Photo.5 Wedge and crack damages of Sample No. 2 after the first stage 1-1a, 4th round of stress rotation test

We take the detailed test result of Sample No.2 as example, listed in Table 3. During the 4 rounds of repeating compressive pressure rotation, no obvious cracks or wedges happen in first round and then the cracks and wedge damages begin to occur in second round. In third round, wedge damages occur severely and new cracks develop greatly. Finally, Sample No.2 failed with a significant tensile cracks along the direction of uniaxial compressive pressure in the second stage of fourth round.

It implies that, under the influence of stress rotation, the existed and new developing cracks could more fully and easily reactivate and grow in lower compressive pressure than UCS, resulting in the anisotropy and whole degradation of rock sample. Some of the cracks show preferred orientation and induced the significant through cracks to failure. The stress rotation test fully presents the feasibility of progressive deformation and failure process of diorite rock mass nearby the surface during the stress field adjustment after tunnel excavation.
