Enhancement of coastal protection under the context of climate change: A case study of Hai Hau coast, Vietnam

Do MINH DUC⁽¹⁾, Kazuya YASUHARA⁽²⁾ and Nguyen MANH HIEU⁽¹⁾

(1) Department of Geotechnics, Faculty of Geology, VNU University of Science, Vietnam National University, Hanoi

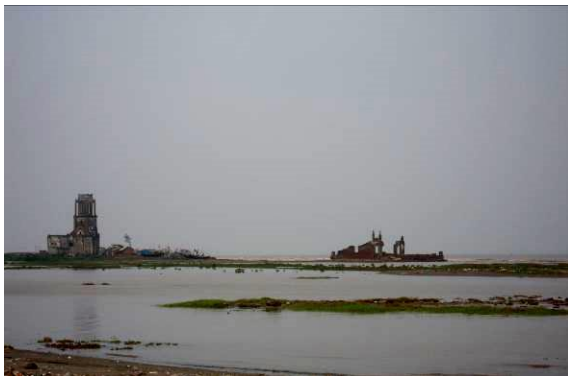
Fig. 2 Land loss due to erosion in Hai Ly

then gradually became the main river mouth in Hai Hau coast. After 1980s, the erosion was prone to decrease because the shoreline was protected by the sea dike system. In the period between 1985 and 1995, the erosion intensity was more 1.5 times higher than the period of 1965-1985. Specifically, at hai Chinh – Hai Hoa segment the erosion speed was 15-20 m/year. Recently, the shoreline in Hai Thinh commune is being the most eroded segment in Hai Hau coast with the average speed of 400 m/year.

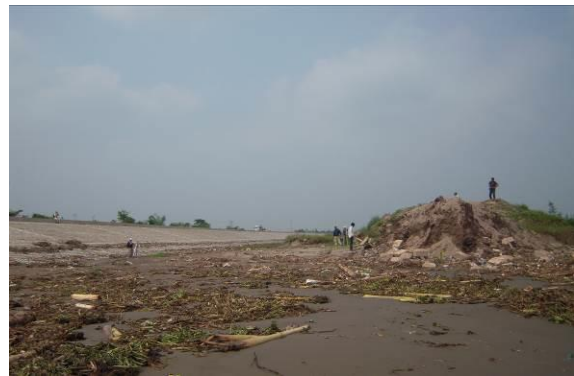
Fig. 3 Broken seadyke in Hai Hau

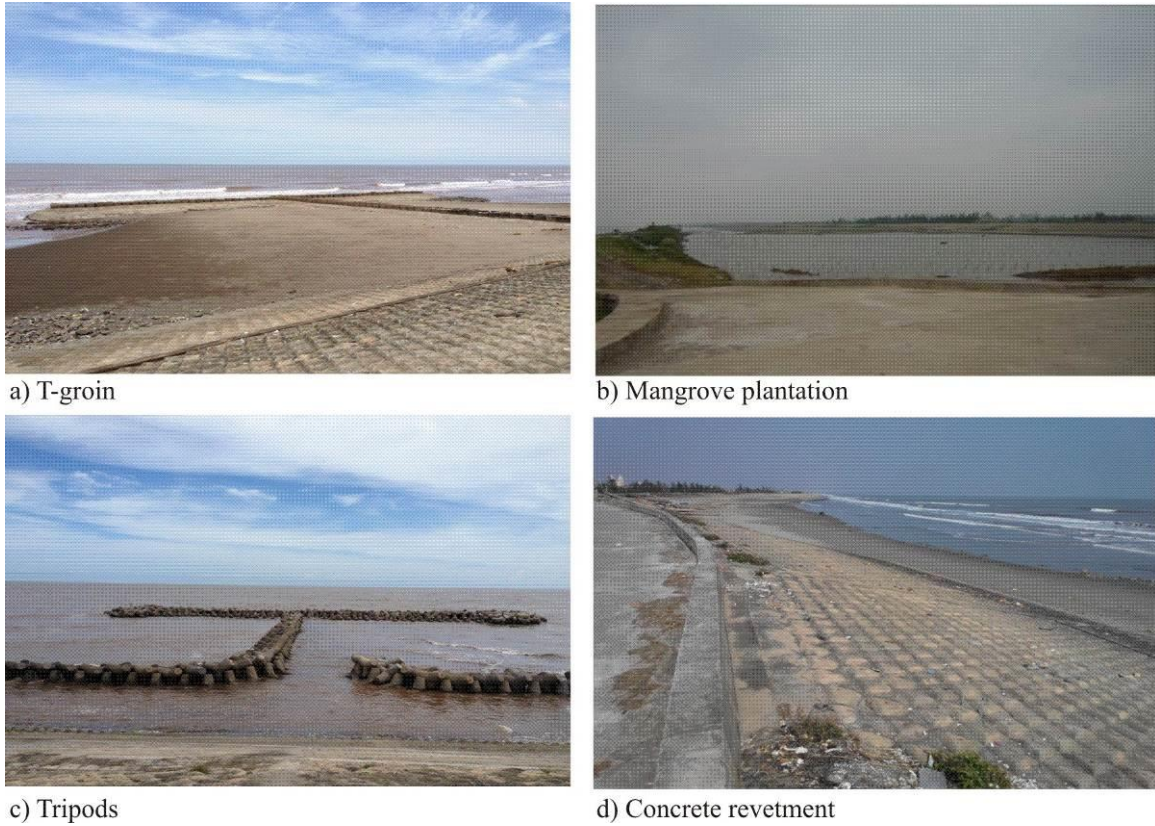
Fig. 4 Conventional measures in Hai Hau coast

In the 1980s, sea dike in Hai Hau coast was simply embanked by available soils which is easily eroded by wave and storm surge in typhoons. To reinforce the dike some conventional solutions were used like T-groins, mangrove forest and tripods (Fig. 4).

The sea dike system in Hai Hau district was intensively reinforced with the height of the dike extending to + 4.5-5.5m, the foot of dike placing at 1.5m depth and concrete revetment covering outer slope.

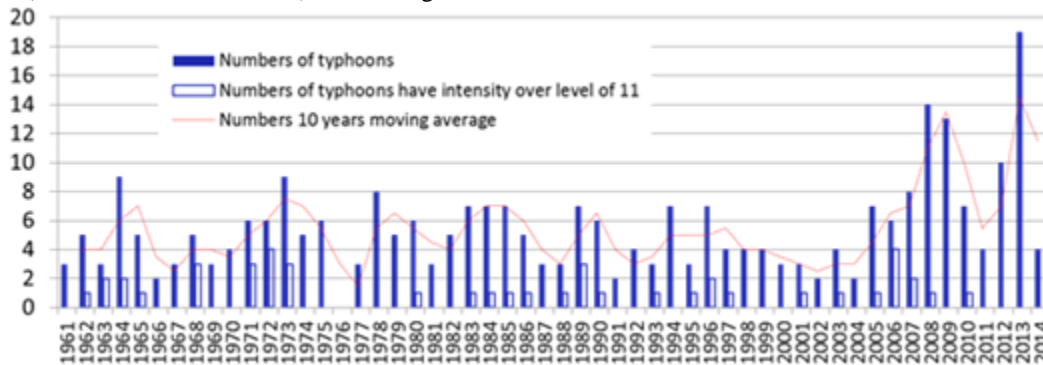
Fig. 5 Number of typhoons attacked Vietnam coast (1961-2014)

It is clear that the number of typhoons landing Vietnam coast rapidly increased from 2005 up to now. Especially, the number of typhoons was 14, 13 and 19 in 2008, 2009 and 2013 respectively. In the period of 1961-2004, the number indicated an unclear relation to climate change but complicated (Fig. 5). Therefore, the number and intensity of typhoons attacking Vietnam coast would be unpredictable in the future.

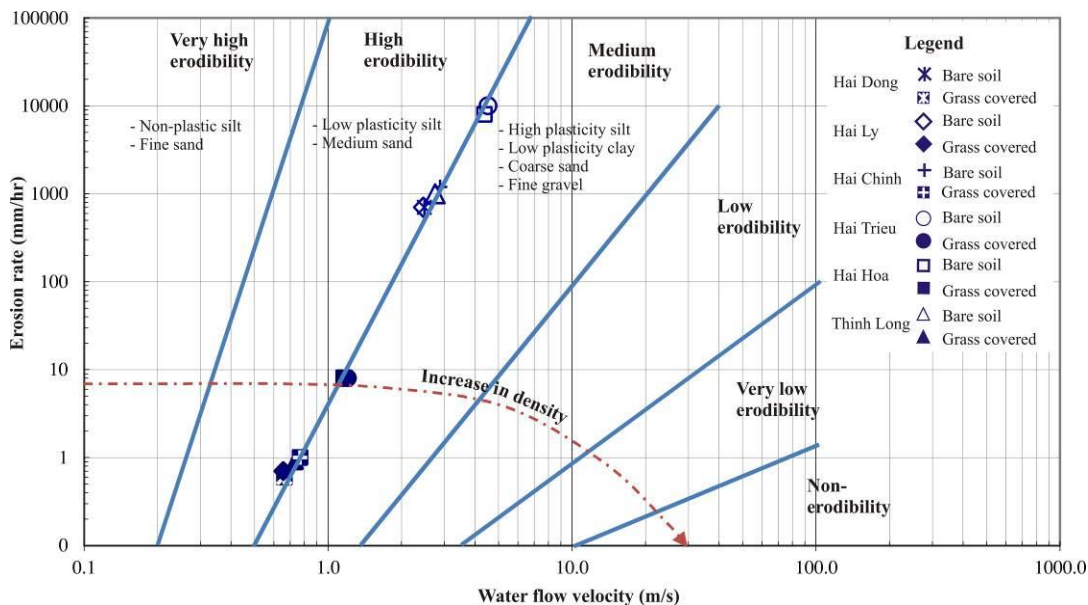
Fig. 7 Estimation of erosion rate in soils at inner slope of coastal dike in Hai Hau coast (Original chart referred from Briaud 2008)

Materials used to build coastal dike in Hai Hau coast are mostly clayey sand with low compaction. Based on empirical relations between water velocity and erosion rate for various types of soils (Fig. 7) of Briaud (2008), erosion rates at the inner slope of the Hai Hau dikes during a typhoon are shown in table 1.

Erosion is very severe at Hai Hoa, Hai Trieu, Hai Chinh, and Hai Ly, especially in Hai Trieu where inner slope was bare soils and no vertical concrete wall to prevent wave running up. It shows a good match with the fact of the Damrey typhoon, when coastal dikes in Hai Hoa, Hai Trieu, and Thinh Long were broken. After the typhoon, coastal dike in Thinh Long was rebuilt and the current one has much higher resistance to overtopping-induced erosion.

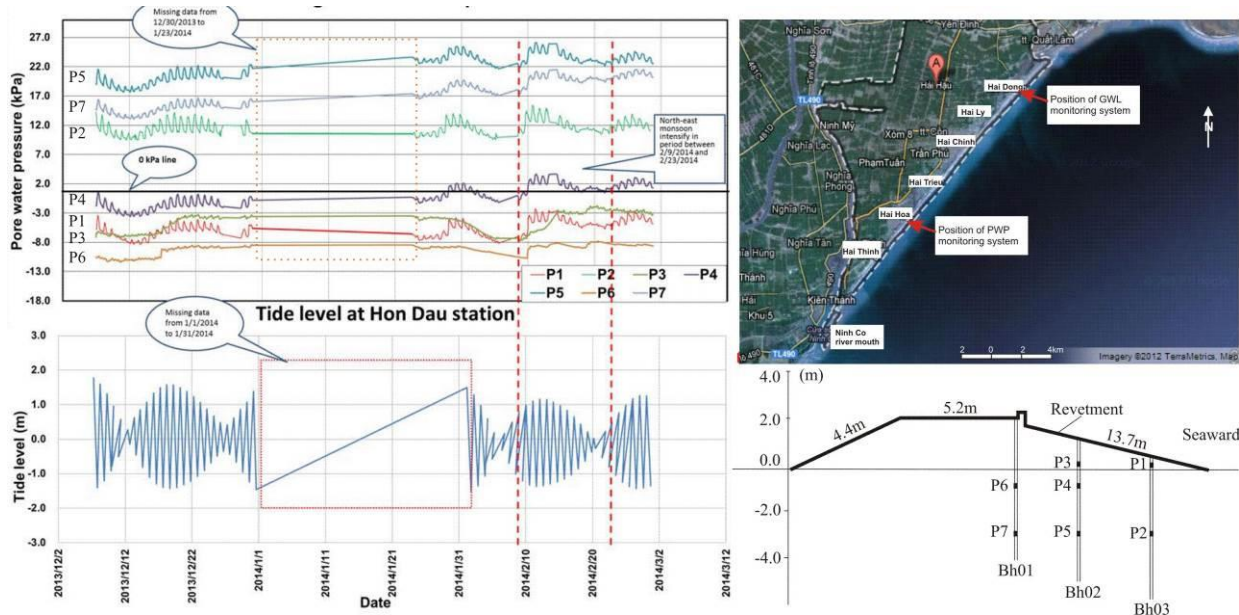
Fig. 9 Relationship between tide level and change in PWP in Hai Hoa

Calculations to determine PWP under the ground through data of GWL are somewhat incorrect because of concerned factors like tide, wave and stratum. Therefore, in order to have a precise insight into variety in PWP in the dike body and ground, a PWP monitoring system was installed in the area (Fig. 9).

Equipment used for the system is provided by Slope Indicator. Sensors are Vibrating Wire (VW) type possessing a high accuracy in range of pressure from 0.7 Bar to 35 Bar. Totally, 7 piezometers were installed in and under the sea dike.

The piezometers are located at different depth and isolated from each other to establish a net of multi-level PWP inside and under the dike.

PWP at the same depth but different positions inside and under the dike are different. PWP in the same borehole but different levels are also different. The deeper piezometers are located the higher PWP value they show. North-east monsoon strongly impacts on changes in PWP, inducing higher PWP even in lower tide level conditions.
