## The deformation and failure mechanism of the toppling slope of the dam reservoir area near Xinlong hydropower station

### Abstract

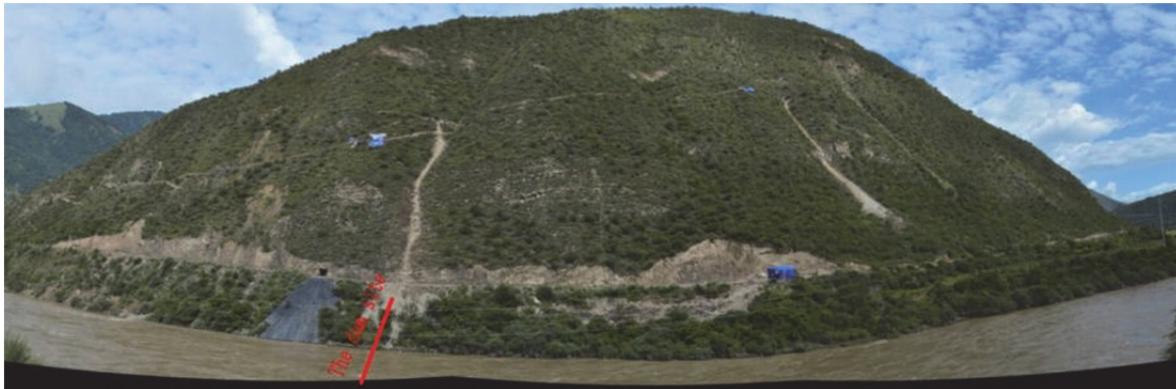
Fig.1 Full view of the slope on the right bank

The slope in dam site area locates about 1km upstream of Xinlong County, Dilong Village of the main stream channel segment of Yalong River. The length of the channel segment in dam site area is about 0.5km, and Xinlong gutter imports from the upstream left bank in dam site area. Yalong River flows into the dam site at an azimuth angle of S32°W, turns into S55°W near the dam monolith, and finally flows out the dam site in the direction near "W". Valley in dam site area is the oblique~transverse valley, which is in asymmetric "U" shape, and the valley is deeply cut. The valley is steep on the left bank, with a natural slope angle of 50°~60°, and the height of slope on the verge of rivers 300m~350m; the valley is also steep on the right bank under 3130m, with a natural slope angle of 40°~45°, and the valley above 3130m is gradual, with a natural slope angle of 15°~20°, and the height of slope on the verge of river is 130m~280m (see Fig. 1). By early crustal uplift and unloading of rock, some deformable landslides are embedded near the right bank of the dam.

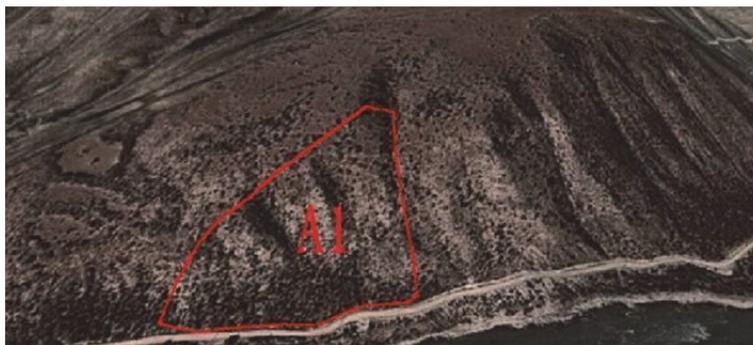
Zone A1 locates at the downstream segment of the slope, and the length along the river is about 332m. Its main features are as follows: 1) strong deformation occurred on entire slope surface, with the thickness of 18-30m, rock mass crushed severely, and it is nearly horizontal or the angle

less than  $40^\circ$  after the stratum topples, with partial granular media form and poor self-stabilization; 2) thickness of weak deformation is maldistributed; 3) topography and geomorphology is relatively gradual (with a slope angle of  $35^\circ \sim 40^\circ$ ), and residual colluvium deposits distribute in the foot of the slope (see Fig. 6).

Fig.6 Downstream side zone A1 of slope

Analysis shows that, this area is actually a residual body of the early strongly toppling rock mass after surface peeling. Strong deformation has spread throughout the slope and residual colluvium deposits distribute in the foot of the slope. The overall stability of slope in zone A1 is generally poor, with poor partial stability, which is unfavorable for the slope engineering.

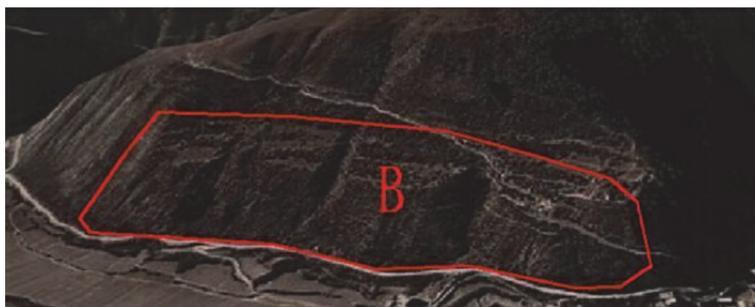
B zone locates in the upper reaches of the slope, which is 616m in length along the river. A notable distinction to A1 zone and A2 zone is that, terrace accumulation is reserved in the middle part of the slope in this zone. The main characteristics

are: 1) Strong deformations distribute on almost the whole surface of the slope, but thin in thickness, which is about 10-20m. After toppling, the strata are nearly horizontal or in a dip of less than  $40^\circ$ , and the rock is broken in cataclastic structure with general self-stability. 2) Weak deformations are in general distribution, the thickness of which is close to that of A2 zone, which is in the range of 35-80m. After toppling, the strata are in a dip between  $40^\circ$ - $70^\circ$ , and the rock is in mosaic structure. Part of the strata are in relaxed state due to the impact of weak unloading. 3) In addition to the terrace accumulation in the middle part of the slope, there are residual colluvium deposits at the foot of the slope. The rest parts are also relatively steep (slope angle greater than  $40^\circ$ ) (see in Fig.8).

Fig.8 B zone in the upper reaches of the slope

Distribution of earlier terrace accumulation in the middle part of the slope shows that this zone is similar to A2 zone. But after a wide range of slump in early times, alluvial accumulations (IV steps of terrace) is able to accumulate due to the convex bank impact of Yalong River.

Consequently the overall stability of the slope becomes better due to pressing foot or pressing slope. Overall stability of the slope is good. As a whole, overall stability of the strong toppling rock mass on the surface of B zone is good, except that the local stability of the slope foot is in a general
