# Brief report of the 2024 Noto Peninsula Earthquake in JAPAN

IAEG Japan National Group (Japan Society of Engineering Geology)

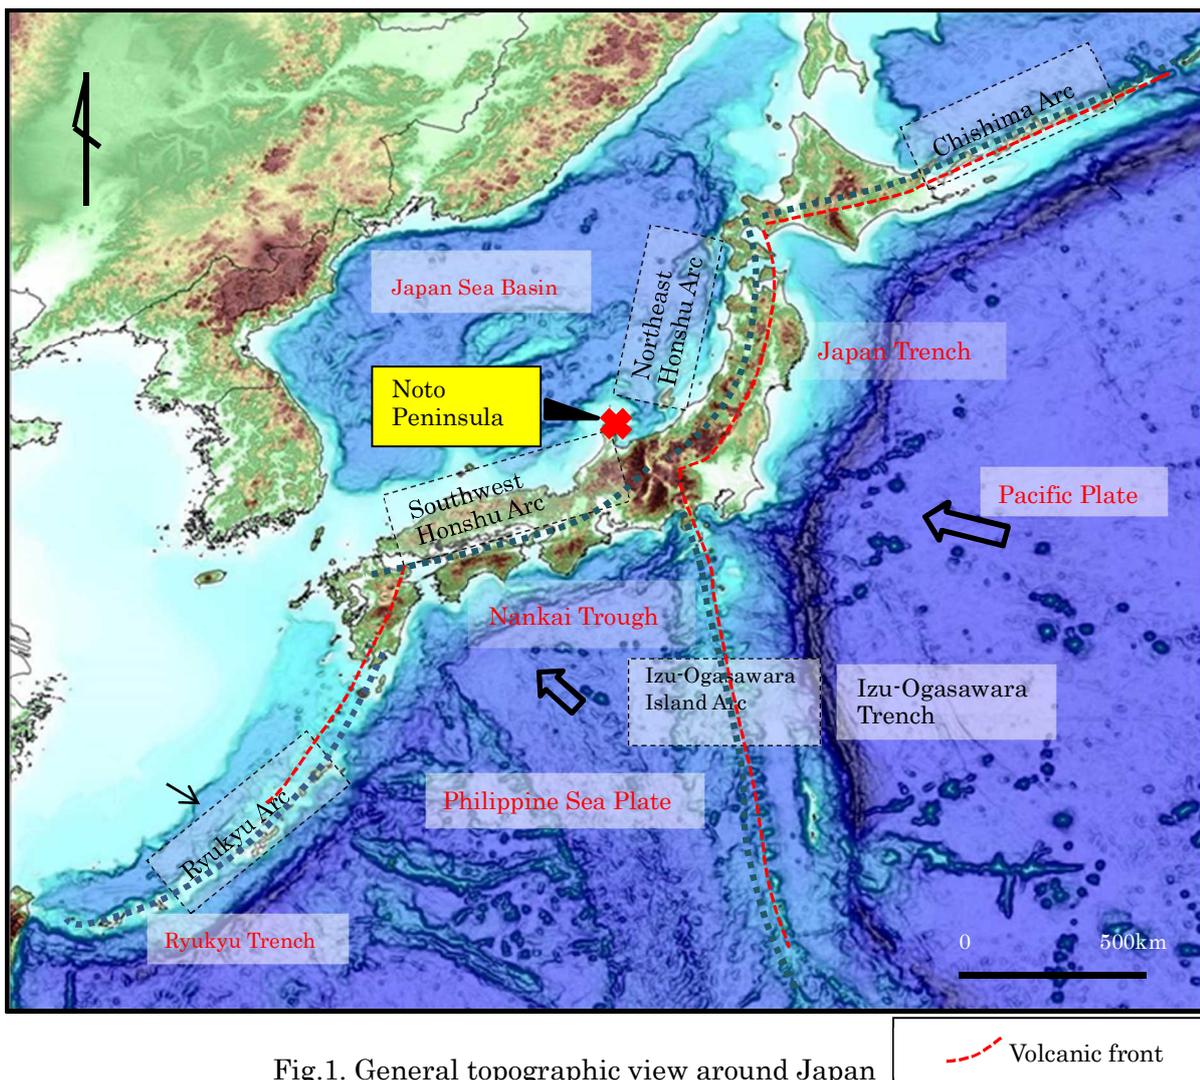
Figure 1 shows the general view of Japan. The Japanese Archipelago is comprised of five island arcs as shown in the figure. The Philippine Sea Plate has been moving to NW direction 4 cm/yr. on average and subducting in the Nankai Trough. On the other hand, the Pacific Plate has been moving to WNW direction 9 cm/yr. on average and subducting in the Japan Trench and the Izu-Ogasawara Trench. Moreover, the Izu-Ogasawara Island Arc have collided with Honshu Arcs and intruded to north direction. These continuing movements on the subduction zones at the boundary of the plates are the main causes of large earthquakes and tsunamis. And many active faults are distributed in the island arcs.

Fig.1. General topographic view around Japan

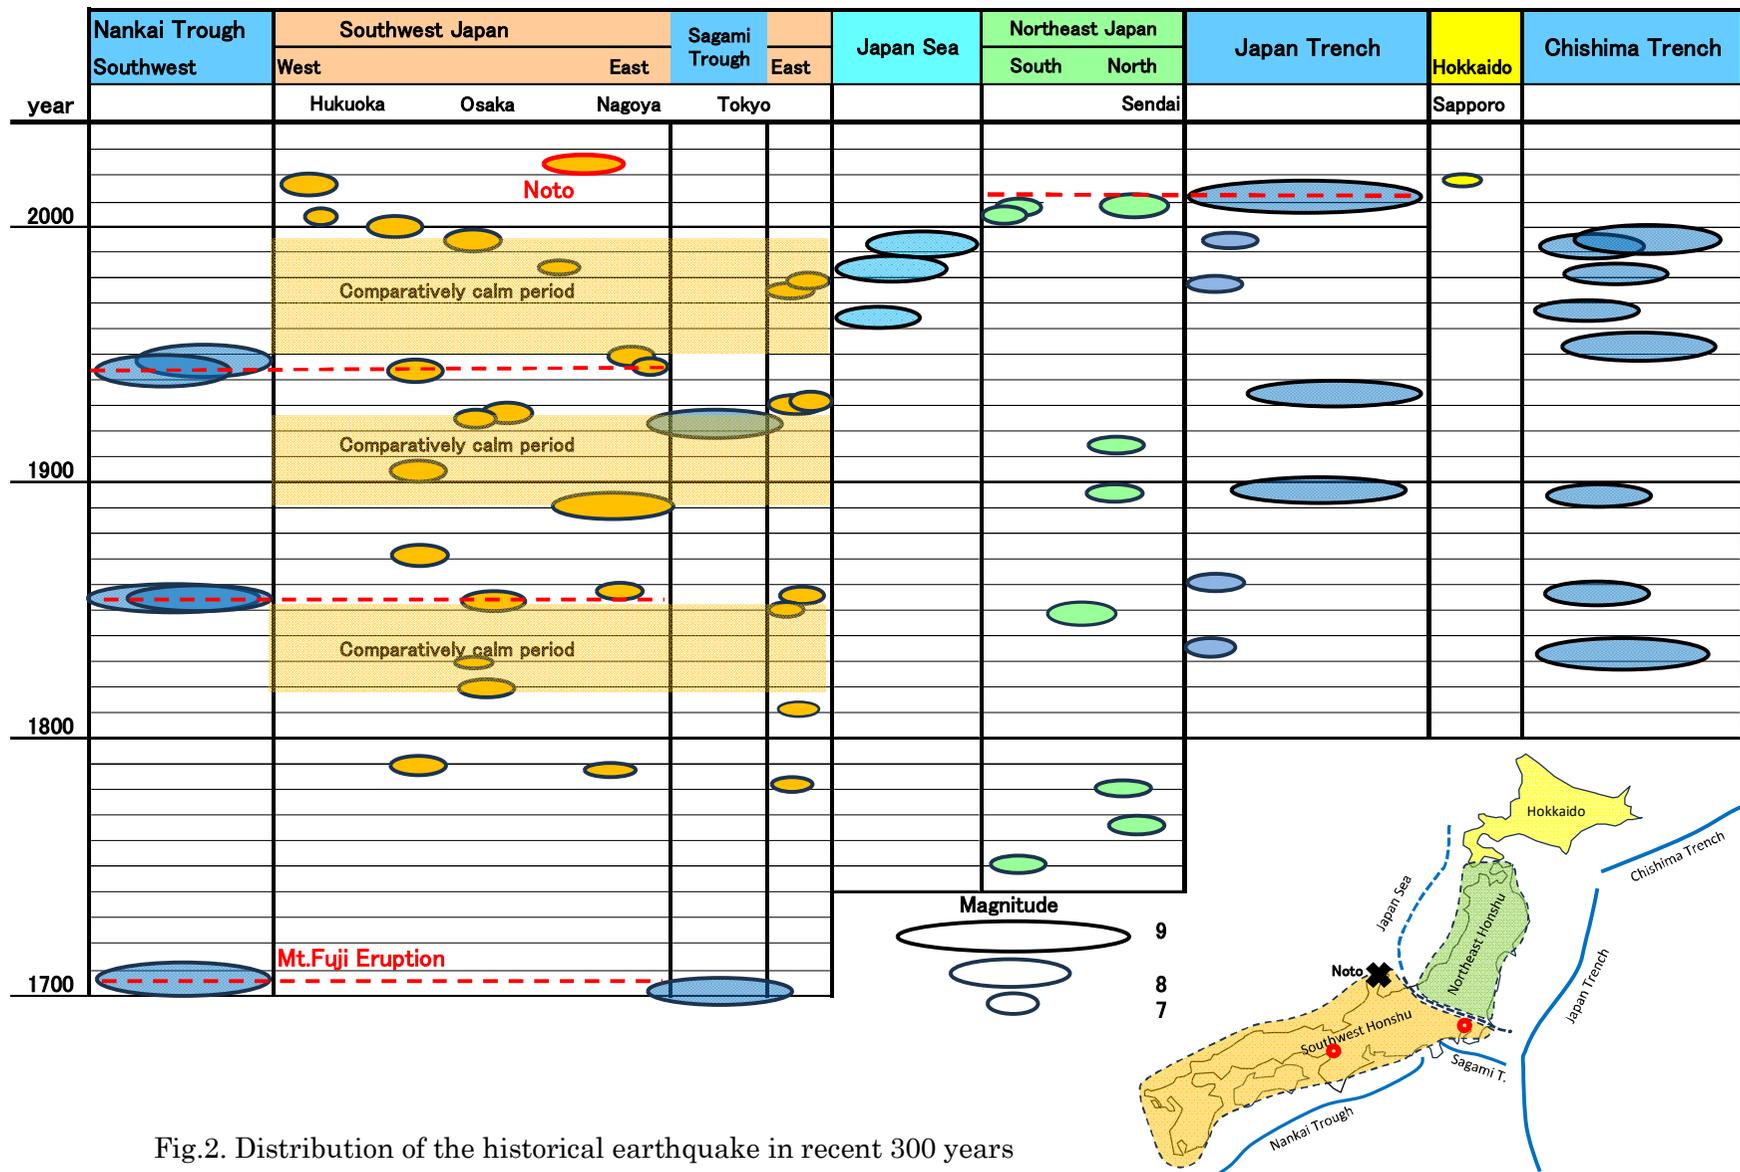
Fig.2. Distribution of the historical earthquake in recent 300 years

Figure 2 represents distribution of the historical earthquake in recent 300 years in Japan. Huge plate boundary earthquakes have sometimes occurred between Philippine Sea plate, Pacific Ocean plate, North American plate, and Eurasian plate respectively around Japan island Arc. Nankai trough is existed between Philippine Sea plate and Eurasian plate in the Pacific Ocean of west Japan island south. It is known that huge historical Nankai Earthquake in this trough have occurred in 100 years to 150 years interval and inland earthquake activity mainly in western Japan island have increased toward the occurrence of this plate boundary earthquake. After the Hanshin earthquake which occurred in 1995, activity of earthquakes looks like to increase gradually in all Japan island. It is not obvious that this time Noto Peninsula earthquake concerns with such increasing of activity and possibility of nearing Nankai Earthquake occurrence.

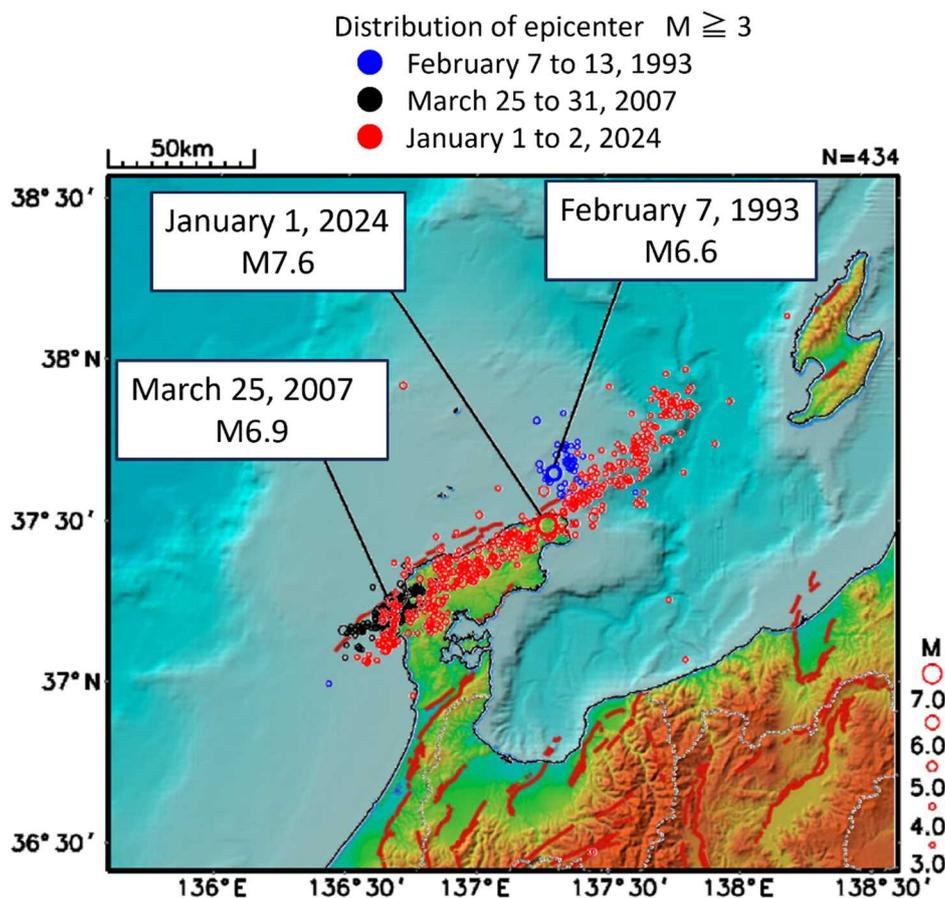
Fig. 3. Past seismic activity around Noto Peninsula. The size of circles indicates the magnitude of earthquakes. This figure is edited to "The 2024 Noto Peninsula Earthquakes" Past Activity, Comparison with the Topographical Map posted on the website of The Headquarters for Earthquake Research Promotion: [https://www.jishin.go.jp/main/chousa/24jan\\_noto\\_2/index-e.htm](https://www.jishin.go.jp/main/chousa/24jan_noto_2/index-e.htm)

In the Noto Peninsula area, there have been earthquakes of magnitude > 6.0 in the past, including a magnitude 6.6 earthquake off the northeast coast on February 7, 1993, and a magnitude 6.9

earthquake off the southwest coast on March 25, 2007 as shown in Figure 3. In recent years, seismic activity had just increased from December 2020, increased from around May 2023, and then once seismic activity had returned to its post-December 2020 state. From December 1, 2020 to December 31, 2023, there were 506 earthquakes with intensity  $\geq 1$ , of which 67 earthquakes with intensity  $> 3$  occurred. The seismic activity was mainly centered in the northeastern and northern areas of the Noto Peninsula. The seismically active area since January 1, 2024 has traversed the northern part of the Noto Peninsula in a northeast-southwest direction.

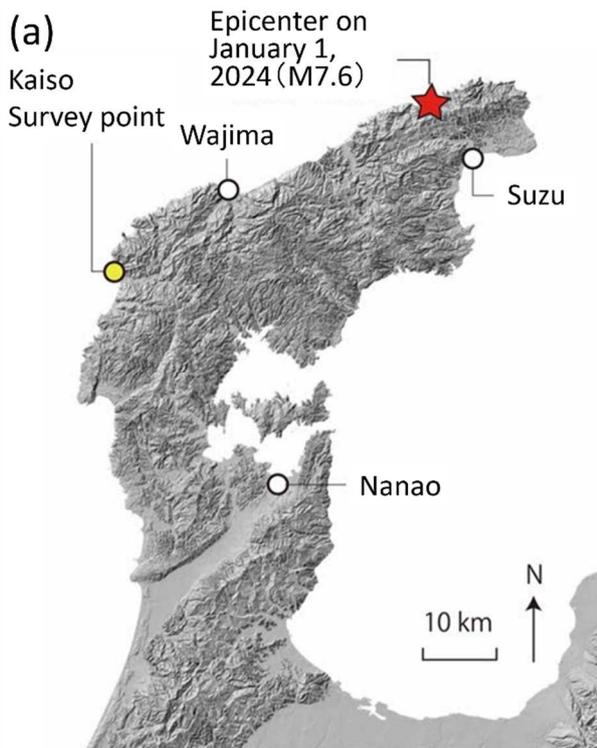
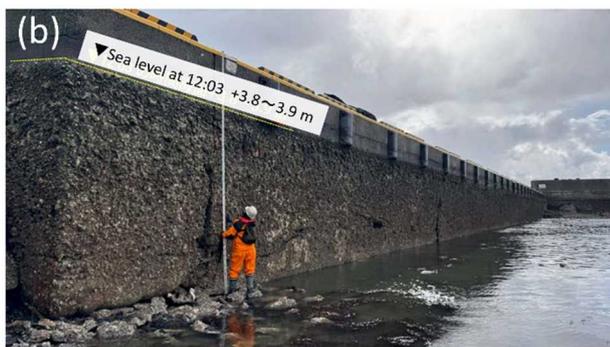
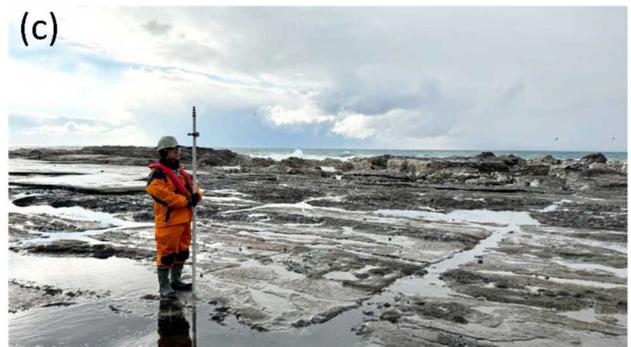
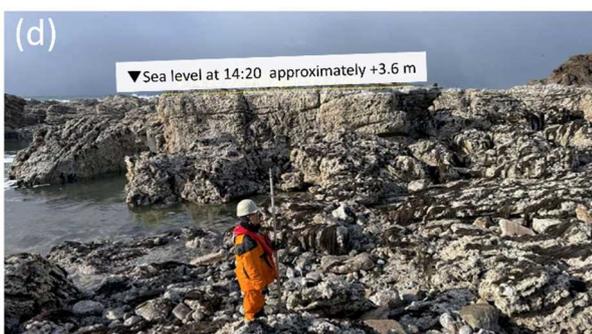
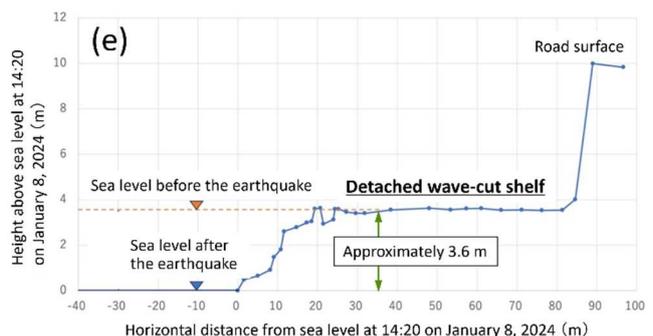
Fig. 4. Coastal Uplift Survey for the 2024 Noto Peninsula Earthquake (edited to the figures posted on the website of Geological Survey of Japan: <https://www.gsj.jp/hazards/earthquake/noto2024/noto2024-04.html>)

According to an analysis of geodetic observation data by the Geospatial Information Authority of Japan (GSI) (2024), an uplift of up to 4 m was reported in the Kaiso area, Monzen-machi, Wajima City, Ishikawa Prefecture. At Kaiso Fishing Port (Fig. 4. (a) yellow point), oysters, serpulidae, and other organisms adhering to the seawall surface were observed to have been displaced by the uplift (Fig. 4. (b)). The upper altitude of the sessile organisms, which indicates the approximate pre-earthquake location of the sea surface, was measured at several points after the earthquake ranged from 3.8 to 3.9 m. Figure 4 (c) shows a wave-cut shelf has dried up due to upheaval caused by the earthquake, as seen in the area north of the Kaiso fishing port. Wave-cut shelves, which are formed by weathering of the bedrock and erosion by waves, are originally spread out at approximately the height of the mean sea level. The front of the wave-cut shelf is a cliff (Fig. 4. (d)), and the difference in height from the sea level after the earthquake is approximately 3.6 m. Cross-sectional topographic survey using a lightwave rangefinder revealed the terraced topography shown in Figure 4 (e), indicating the formation of marine terraces.

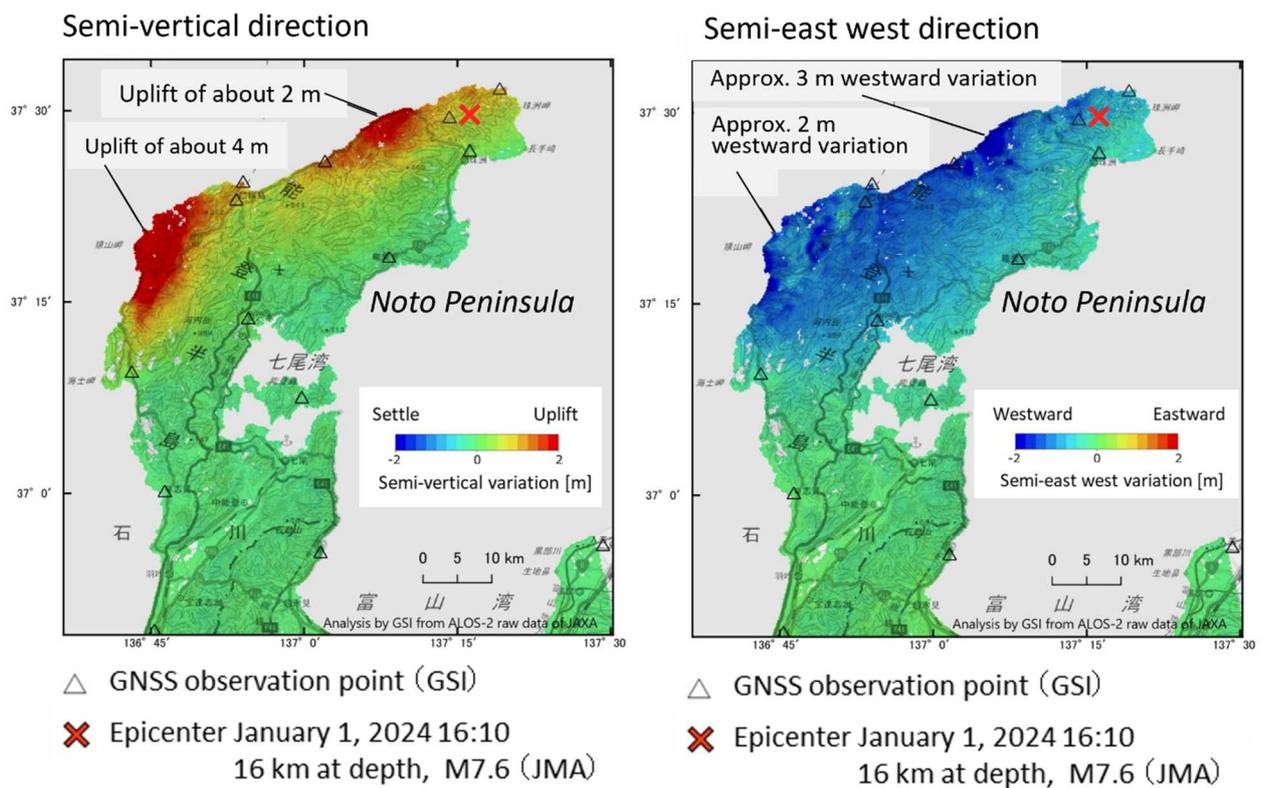
Fig. 5. Amount of crustal deformation based on 2.5D analysis of DAICHI-2 observation data (edited to the figures posted on the website from Geospatial Information Authority of Japan updated January 19, 2024: [https://www.gsi.go.jp/uchusokuchi/20240101noto\\_insar.html](https://www.gsi.go.jp/uchusokuchi/20240101noto_insar.html))

Figure 5 shows crustal deformation over the entire Noto Peninsula based on 2.5D analysis, using observation data from ALOS-2 (DAICHI-2). These results show a maximum uplift of approximately

4 m and a maximum westward movement of approximately 2 m in the western part of Wajima City. A maximum uplift of approximately 2 m and a maximum westward variation of approximately 3 m can be seen in the northern part of Suzu City.

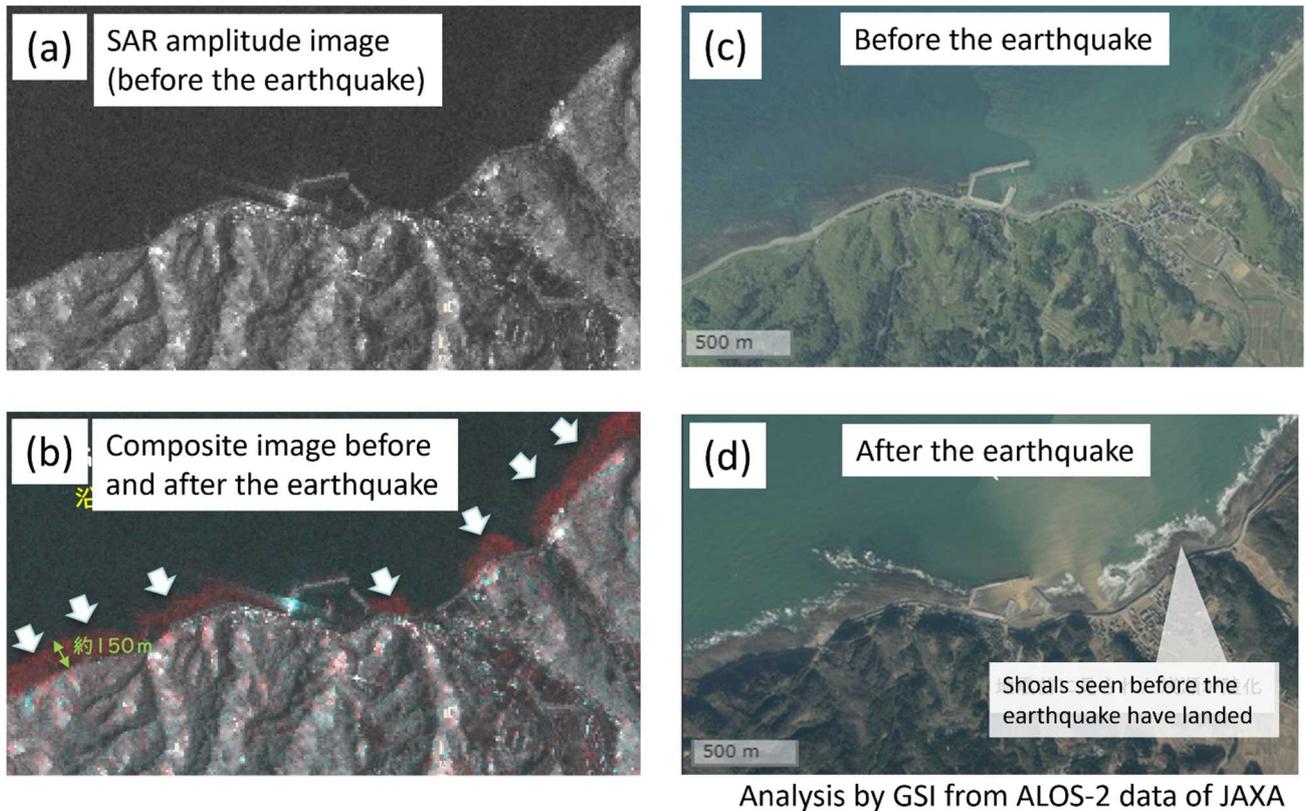
Fig.6. ALOS-2 SAR intensity composite images acquired (a) before and (b) after the earthquake, aerial photographs (c) before and (d) after the earthquake around Nafune-machi in Wajima City. Red zones indicate the zones where the uplift associated with the earthquake was detected. These figures are edited to Coastline change caused by the 2024 Noto Peninsula Earthquake detected by ALOS-2 SAR satellite image (Jan. 4, 2024) posted on the website of Geospatial Information Authority of Japan: <https://www.gsi.go.jp/uchusokuchi/uchusokuchi-e31001.html>

In the coastal area in Wajima City, an uplift of approximately 4 m was detected and the coastline has changed by approximately 150 - 200 m along the coastal line (Fig.6).

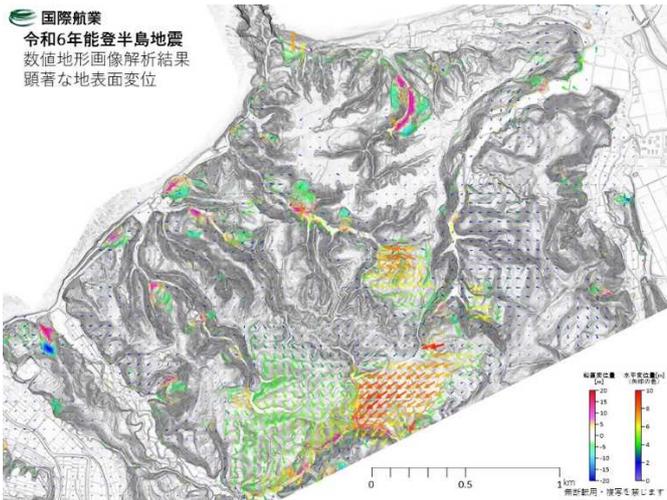
Fig. 7. Slope Variation by Numerical Topographic Image Analysis

Numerical topographic image analysis (Patent No. 4545219) using detailed topographic data before and after the earthquake was conducted in the area from northeast to southwest of the Noto Peninsula. In the northeastern part of the survey area, a 1500 x 1000 m area of land surface displacement was observed on a mountain slope near Machino-machi, Wajima City (Fig. 7). The ground surface displacement was divided into several blocks, and the maximum displacement of the slope, calculated by correcting the amount of displacement due to crustal deformation, was approximately 8 m.

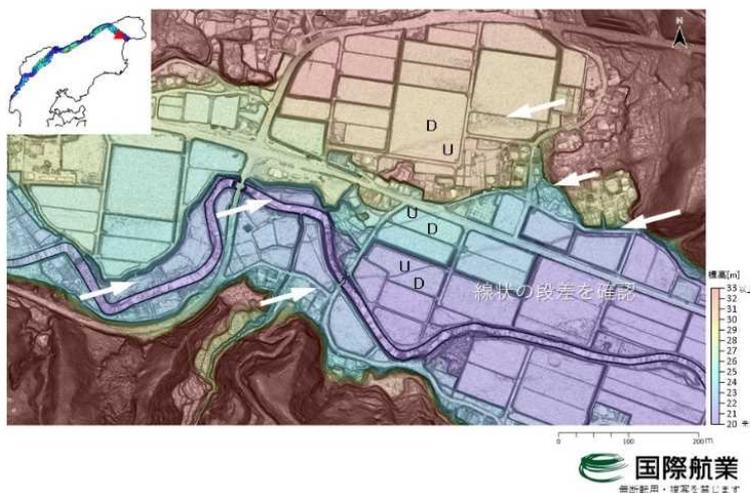
Fig. 8. Linear steps seen in Wakayama-machi of Suzu City

In the Wakayama-machi of Suzu City, linear deformations were found in the GSI survey. It has confirmed a rise in the ground approximately 4 km long and 100 to 200 meters wide from east to west. A maximum of 2.2 m high steps across fields and rivers were also observed. Aerial laser measurements show steps as indicated by the white arrows in Figure 8. It is believed that the ground was uplifted by strong compression in the north-south direction.

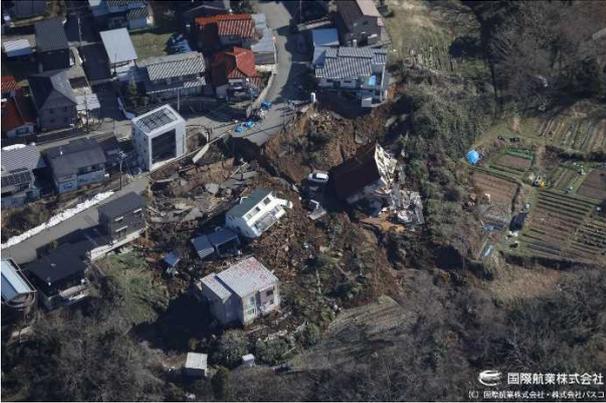
Fig. 9. Damage to buildings in Tagamishin-machi, Kanazawa City, Ishikawa Prefecture

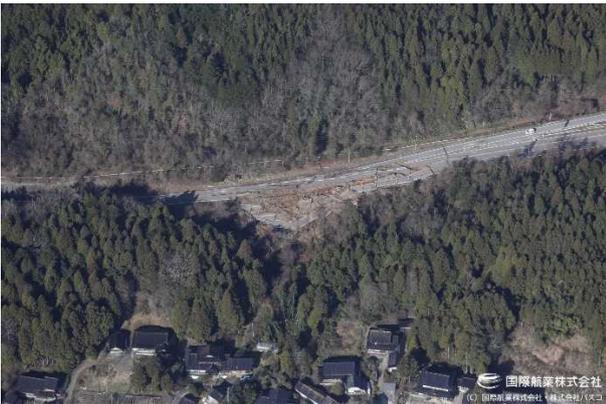
Fig. 10. Damage to the Noto Satoyama Kaido Road, that directly connects Kanazawa City to the Noto Peninsula, Ishikawa Prefecture

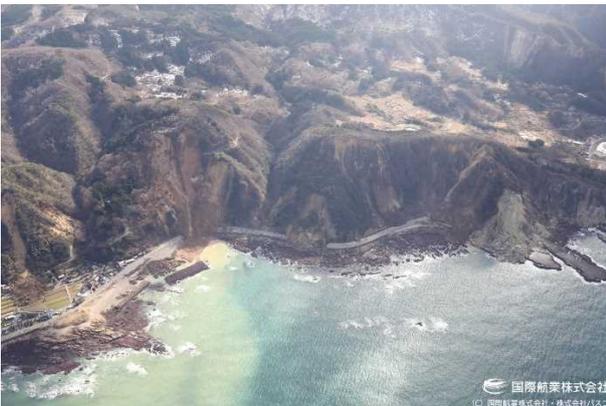
Fig. 11. Collapse of slope along Route 249, Matsunagi-machi, Suzu City, Ishikawa Prefecture
