JSEG 火山地域の応用地質学的諸問題に関する研究小委員会巡検行程案 ver.231011

実施日：2023 年 11 月 7 日（火）

➤ Technical Tour Schedule

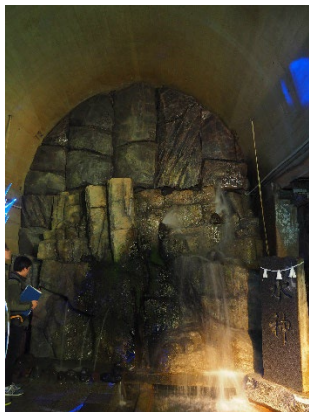
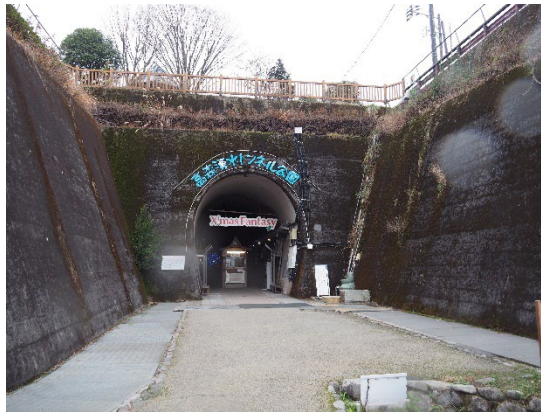
Stop 1: Takamori Tunnel

Located in the southeastern part of the Aso Caldera Wall, the Takamori Tunnel was planned as a railway tunnel for the Takachiho Line connecting Kumamoto City and Nobeoka City, and excavation of this tunnel was suspended in 1975 due to a large amount of spring water (about 64t/min). Today, the spring water from this tunnel is a water resource for Takamori Town and continues to drain about 32 t/min.

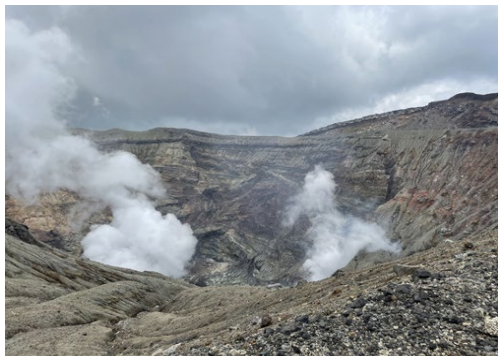
Stop 2: Nakadake Crater at Aso Volcano

Nakadake is one of the post-caldera volcanoes of the Aso caldera, and the only active volcano with a record of eruption in the historical period. The summit crater can be reached directly by bus, and proximal facies of volcanic ejecta such as agglutinate can be seen along the trail. The crater emits volcanic gases including  $\text{SO}_2$ , and people with respiratory problems should be careful. Entry to this area may be restricted depending on the status of volcanic activity.

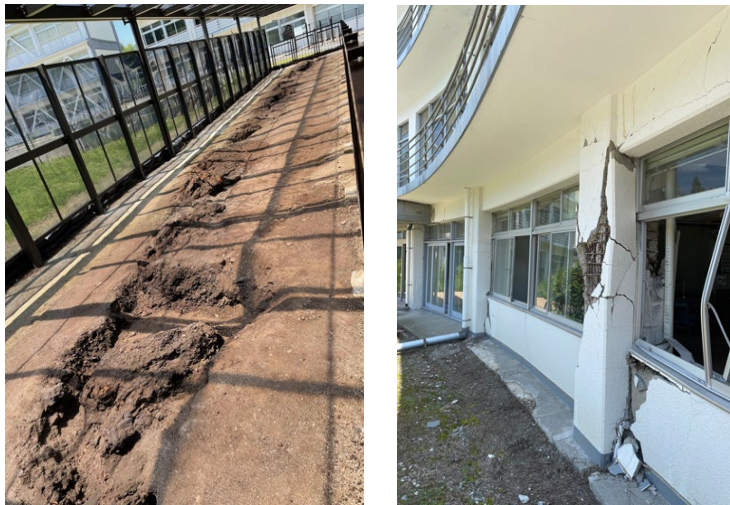
### Stop 3: Former Tokai University Aso Campus (Surface Earthquake Fault, Building No. 1)

This location is close to the eastern end of the Futagawa Fault, which caused the 2016 Kumamoto earthquake. A surface earthquake fault runs underneath the Building No. 1 built in 1973. The building was damaged by an intensity 6 upper earthquake (JMA) shaking and fault displacement. This building could avoid collapse because it had been reinforced against earthquakes beforehand, but was further reinforced after the earthquake in order to preserve it. The surface earthquake faults on the outside of the building have also been preserved and can be observed.

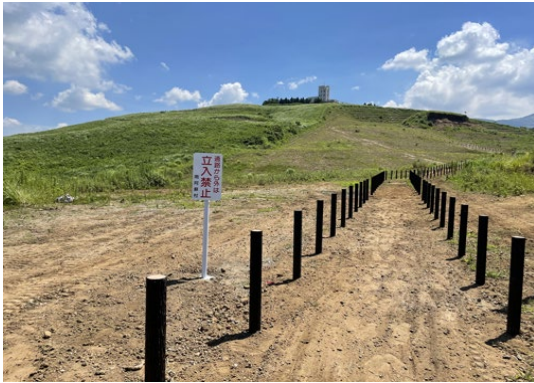
### Stop 4: Takanodai and Aso Volcanological Laboratory, Kyoto University (Large-scale landslide)

Five people in Takanodai area were killed in a landslide caused by the main shock of the Kumamoto earthquake on the morning of April 16, 2016. This hill consists of the Takano-obane lava dome (about 50,000 years ago), and the alternation of tephra and soil that covered it were slide down by the earthquake motion. Tephra layers from Aso volcano such as the Kusenrigahama tephra, Aira Tn (AT) and Kikai-Akahoya (K-Ah), which are widespread tephra originating from southern Kyushu, can also be observed in the **scarp**. The disaster prevention park in Takanodai is equipped with a variety of disaster prevention facilities and equipment, including a water storage tank, a storage warehouse for blankets, and benches with built-in kamado.

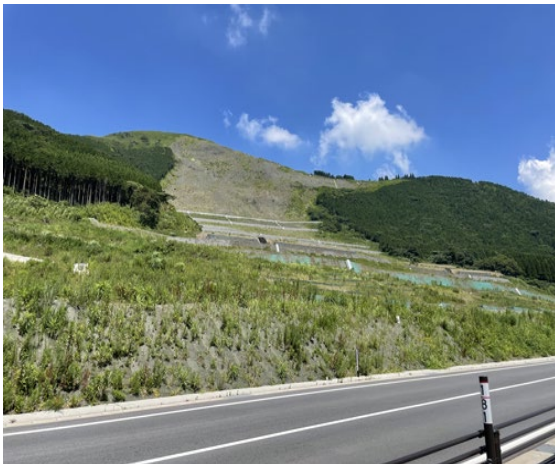
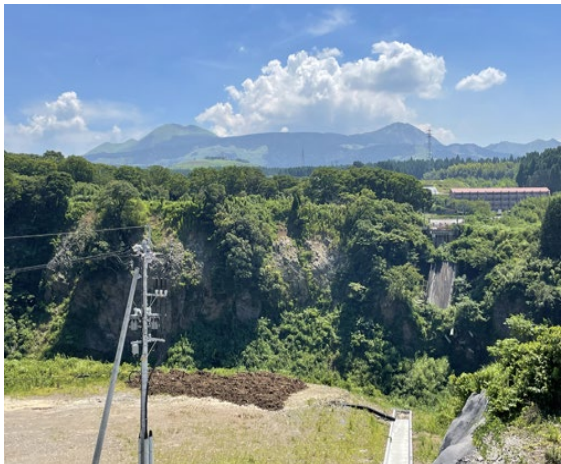
**Stop 5: Former Aso Bridge (remaining bridge girders) and the Sugaru-Kuzure (large-scale hillside collapse)**

The slope collapse occurred on a steep slope consisting of the Pre-Aso volcanic rocks, and caused serious earthquake damage, including the destruction of critical infrastructure such as National Road 57 and JR Hoho Line. Currently, part of the collapsed bridge remains trapped in the gorge.
