## Historical and pre-historical gigantic landslides in Tateyama Caldera and their mechanism of occurrence

Tamotsu NOZAKI

This paper examines the mechanism and the genesis of a cluster of deep-seated and very large landslides in the Tateyama Caldera. There is a big depression, called the “Tateyama Caldera” in the Northern Japan Alps. This caldera, however, was not formed by volcanic activities but created by mass wasting processes which are still active as the site is littered with steep unstable slopes of historic and pre-historic, deep-seated and very large landslides. The basement rocks in the region consist mostly of granodiorite which is extensively sheared and locally hydrothermally altered as the caldera is located along one of the major active fault systems in central Japan. The higher elevations and rims of the caldera are underlain by middle to late Quaternary volcanic deposits. Active erosion of the unstable slopes and the possibility of deep-seated landslides pose serious future problems. To further complicate the situation, the bottom of the caldera is underlain by thick deposits of older landslides and related debris. Furthermore, recent studies revealed that the in

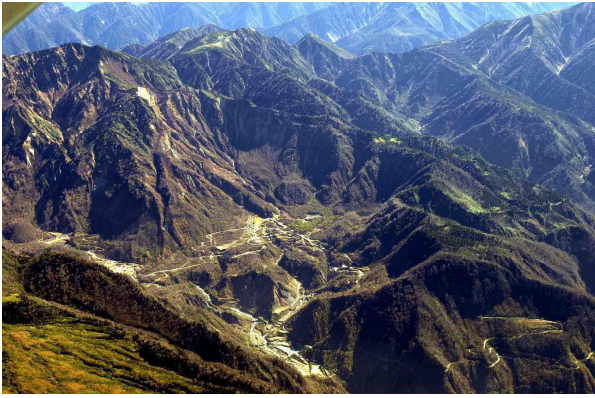
Fig.3 Aerial photograph of Dashiara depression overlooking from the north (Photograph by Takashi Inokuchi)

“Dashiara depression” (Fig.3), and another one is located at the western side of Mt.Kunimidake showing a shape of big bowl (Fig.4 & Fig.5). The 1858 Ootombi-kuzure occurred at the southeastern part of the former one burying the old Dashiara with its thick debris of Tombi-doro, and made the floor of gentle relief. Buried under the Tombi-doro, the rock mass of “Dashiara landslide” has been found by drilling test. The latter depression used to have been believed as a remnant of volcanic crater because of the circular depression. It is now clarified, however, that the wide high-terrace so-called “Matsuo-daira” along both side of the Matsuo-dani, which is adjacent to the lower end of the circular depression, is composed of very thick debris of “Kunimi-doro” derived from this depression. Besides, it is clarified that another gentle slope “Outa-men” adjacent to the eastside of the circular depression was formed by the pre-historical rockslide “Kumini landslide” (Nozaki & Kikukawa, 2012).

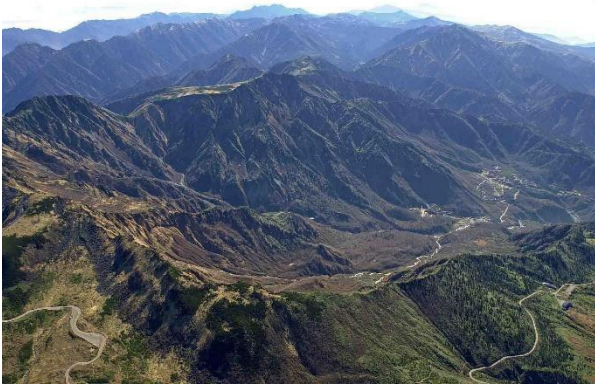
Fig.4 Whole view of Tateyama Caldera. Circular depression of foreground is the source area of Kunimi-doro. Dashiara depression can be seen on the right. (Photograph by Takashi Inokuchi)

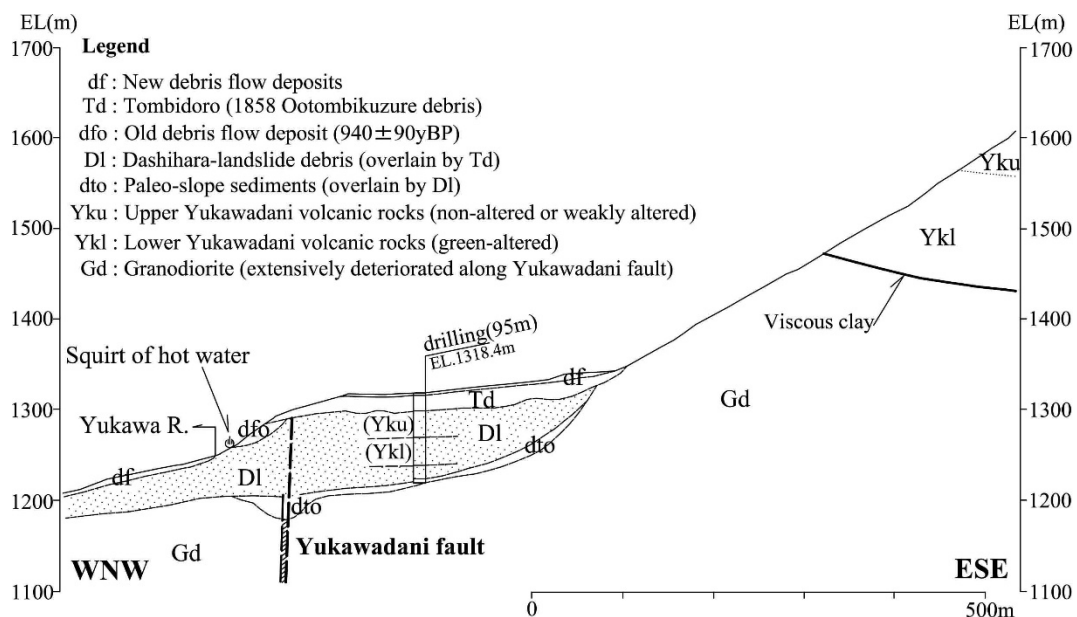
Fig.14 Geological section of Dashiara landslide depending on drilling test near the old Tateyama spa (Nozaki & Kikukawa, 2012)

of the Yukawadani volcanic rocks have been suffered by the hydrothermal alteration due to their own residual liquid in a circumstance of the ancient pond (Harayama et al., 2000). These green rocks are not so fragile, but the author found a continuous layer of viscous clay (chlorite and mixed layer of illite-smectite) between their base and the granodiorite in the Kanayama-dani as shown in Fig.12. Fig.14 shows the geological section from the Kanayama-dani to the Yukawa through the drilling site.

The actualities of Dashiara landslide are not well known, because the landslide mass and debris are completely covered with the Tombi-doro except for only a little at the confluence of Makawa and Dashiara-dani. Fig.8 and Fig.14 respectively show the geological column of drilling test and section in the proximity of the old Tateyama hot-spa. The formation of rock facies of the core from 18.4m - 90.8m shows those of the Yukawadani volcanic rocks, that is, the upper layer consists of weakly altered volcanic rocks, whereas the middle and lower layers consist of altered green rocks. The lower layer is cracky or partially fragmented and stained with reddish brown due to the oxidation in spite of the reduction zone filled with hydrothermal water, of which the temperature reaches to 150°C at present, and underlain by non-oxidized soil. Of course the triggering cause cannot be clarified now, and even the primary cause has not been necessarily known yet. It is inferred, however, that this rock-slide mass slowly moved down the east wall of Dashiara depression taking advantage of the clay layer intercalated at the boundary between altered volcanic rocks and granodiorite as a potential sliding surface, because the slid-mass is not so fragmented except a part of the lower layer in spite of the relative height between the present position of intact volcanic rocks and landslide mass under the Tombi-doro.
