## **Analysis of the post-earthquake stability and research on deformation and failure mechanism of the talus slope located in front of the dam of Zipingpu hydraulic project**

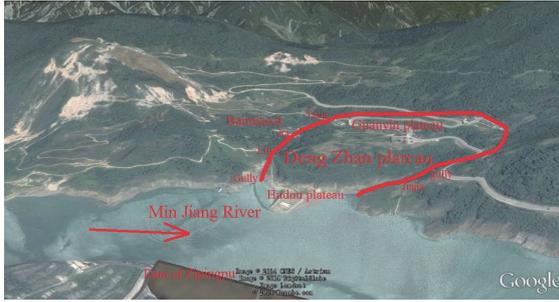
Fig.1 Location of the study area(from Google Earth)

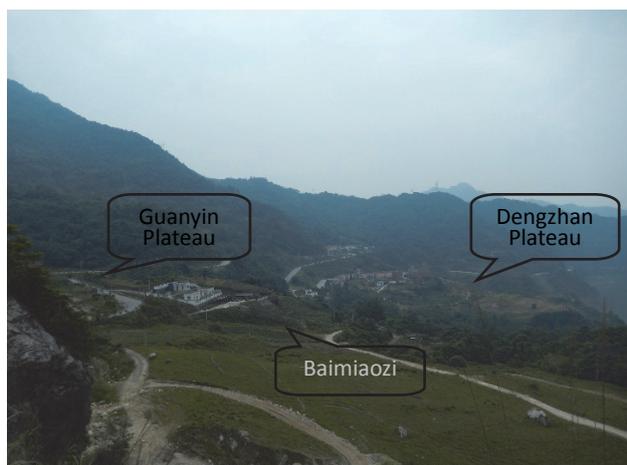
Fig.3 Landform characteristics of the II zone of the talus slope

Outcrops and pit holes by exploration revealed that the talus slope is mainly piled up by gravel and clay. Block gravel mainly composed of limestone and dolomitic limestone, with a small amount of fine sandstone and diabase can be divided into 7 layers according to its obvious vertical zonation, from the new to the old respectively: Q<sup>7</sup>(gravel containing clay), Q<sup>6</sup>(clay containing gravel), Q<sup>5</sup>(gravel containing clay), Q<sup>4</sup>(gravel containing clay), Q<sup>3</sup>(gravel), Q<sup>2</sup>(gravel containing clay), Q<sup>1</sup>(clay containing gravel). The bedrock below has a morphology of steep-to-slow shape on downslope direction (similar to the surface shape of the slope) with a tendency out of the slope, and in the longitudinal view the interface between rock bed and overlying talus at both ends is steep while the middle is relief, inclination angle could up to 13.5° ~ 16°, with a minimum of 5.5°~ 6°, the surface of rupture on the back edge of the Dengzhan plateau is 42 °.

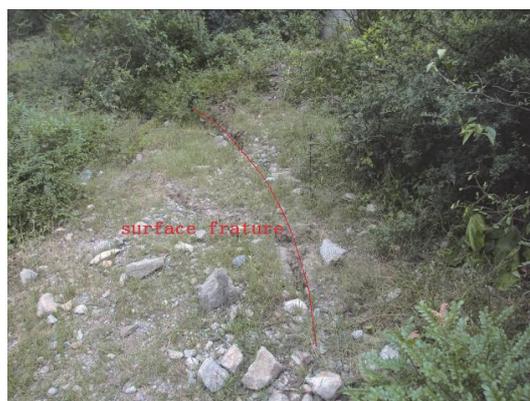
Though suffered from the “5.12” Wenchuan earthquake in 2008, the whole talus slope did not slide, yet only four small-scale collapses and two surface deformations appeared under the road on elevation of 890m on the front edge of the Dengzhan Plateau. The small-scale collapses are less than 30m high; while the surface deformations located downstream outside the road, the visible length of the fracture is about 30m, the maximum width is about 50cm with a dislocation about 20cm and a depth of about 1m.

Fig.4 Fissure on the surface in the vicinity of 890m elevation

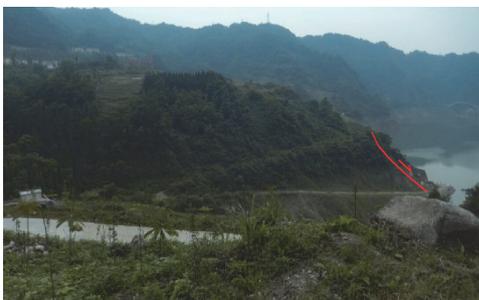
under different water levels, which illustrates that underground water plays a less important role in various factors that influence the stability of the slope. Strong earthquake affects the front edge of the Dengzhan Plateau severely, results in collapse and deformation by reducing its stability; but the whole terrain and the interface between rock bed and overlying soil are generally gentle, though dislocation might appear along the interface between the rock bed and overlying soil, the short duration of vibration and the resistance from the gentle interface made the whole slope stable. The results from the analysis point out that the whole talus slope kept stable though suffered from the "5.12" earthquake, while only the front edge where the steep part joints the gentle's(part of CD) of Dengzhan Plateau collapsed. This phenomenon has a close relation to the micro-terrain, especially the gradient of the slope. The angle of the talus slope and interface between rock bed and overlying soil are generally about  $20^\circ$  and  $13^\circ$  respectively, while the deformation part is  $30\sim 40^\circ$ . This is because the protrusion and gradient transition part of the slope has an amplification of seismic waves on vertical and free face(Xu Guangxing et al, 2008), which made the slope suffered more intense vibration damage.

Fig.7 Collapse deformation on the front of the Dengzhan plateau after the earthquake

The front edge of Dengzhan Plateau is relatively steep, which results in the concentration of stress in the vicinity of the free surface, so a tension area was formed in the shoulder of the slope, where deformation and failure are easily to generate because of the maximum stress difference or the maximum shear stress here. In addition, seismic wave will produce instant tension stress(Zhang Zhuoyuan et al, 1994), so the shoulder of the slope will probably generate relative large displacement or collapse, while those gentle slope will keep stable or only generate small displacement.
