Washout of clay-rich gouge in a pre-grouted fault zone and increase in groundwater inflow during tunnel excavation in Neogene siliceous mudstone (Horonobe, Japan)

Eiichi ISHII⁽¹⁾, Yuta HASHIMOTO⁽²⁾ and Daisuke INAGAKI⁽³⁾

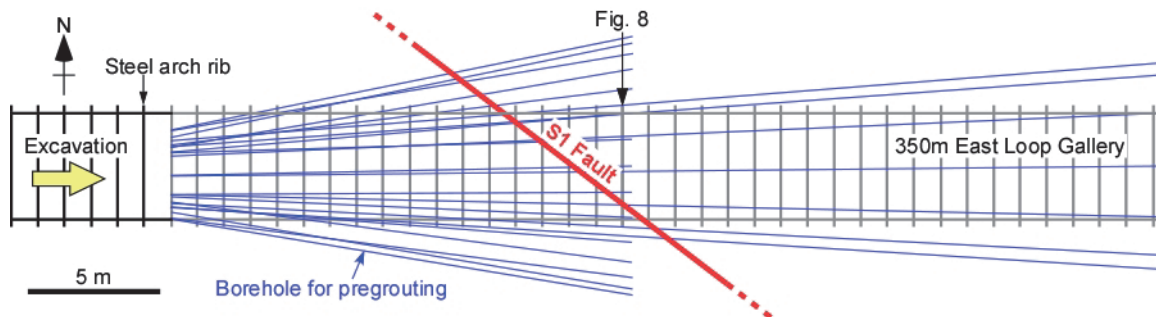
Fig. 5 Layout of boreholes drilled for pre-grouting at the 350 m East Loop Gallery (horizontal map).

Tunnel excavation was carried out while pre-grouting the fault zones; however, when one of the fault zones (the S1 Fault) comprising clay-rich gouge (mainly smectite; Figs 3 and 4; Table 1) was pre-grouted at the 350 m East Loop Gallery (Fig. 5), unusual muddy material exhibiting the same results

ejected from boreholes during drilling (Fig. 6). Excavation of the S1 Fault revealed clay-rich gouge (~10 cm thick) and a surrounding damage zone (a few meters thick). However, the gouge itself was not cemented by grout material (Fig. 7) whereas the gouge-bounding fractures and damage zone fractures were cemented. Intensive spalling occurred at the S1 Fault. During excavation of the fault, the clay materials were increasingly washed out into the tunnel through the rockbolts penetrating the fault and along the boundary between the shotcrete and the gouge on the excavation sidewall (corresponding to the spalling zone and possibly not fully shotcreted) at a flow rate of $<1 \text{ m}^3/\text{hr}$ (Fig. 8a and 8b). After an excavation face exposing the S1 Fault was temporarily shotcreted, a major groundwater inflow suddenly occurred, breaking the shotcrete corresponding to the gouge (Fig. 8c). As a result, the inflow rate temporarily increased to five tens of cubic meters per hour. Observations of the broken shotcrete and at the excavation sidewall revealed that the gouge
