Invitation to the Geo-Tetsu Tour by Train Trips, Visiting of the Railway Route for Geohazard: A Case Study of the JR Dosan Line in Shikoku, Southwest Japan

Keywords: Geo-Tetsu, Geo-Point, Dosan Line, disaster, disused line, railway facility

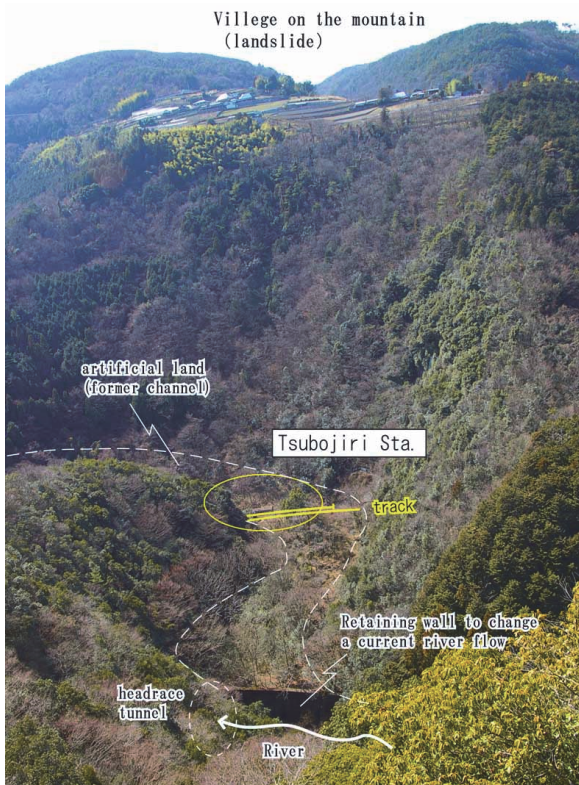
Photo.2 Overlooking view of the Tsubojiri station and the landslide on the mountain (Kato, 2013)

When the train goes over the Sanuki Mountains, it must run up continuous grade 25 ‰. In order to make the train stop and depart safely in the middle of the incline for going over the mountain pass, the switchback was constructed at Tsubojiri Station opened in 1929 as signal station. The station and switchback facilities were constructed on the artificial land which filled up a river channel (Fig.2, Photo.2), because that was located in the rugged valley, and little flat ground was around there. The flow of the river was changed at three places, and they were transferred by headrace tunnels. At a glance, the location of the station looks dangerous, but the erosion does not advance in old river channel, and the filling abutted the valley wall is stable enough to collapse. Therefore the area is relatively safe from disaster.

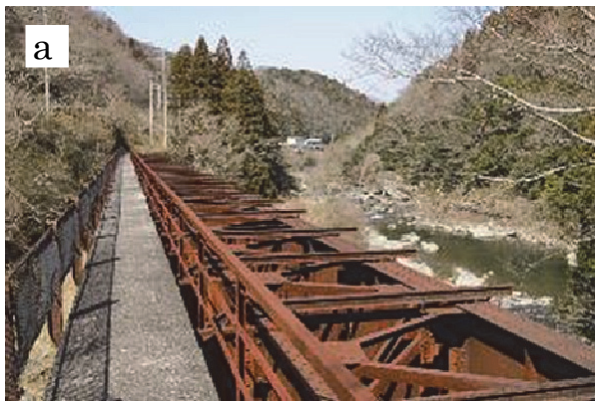
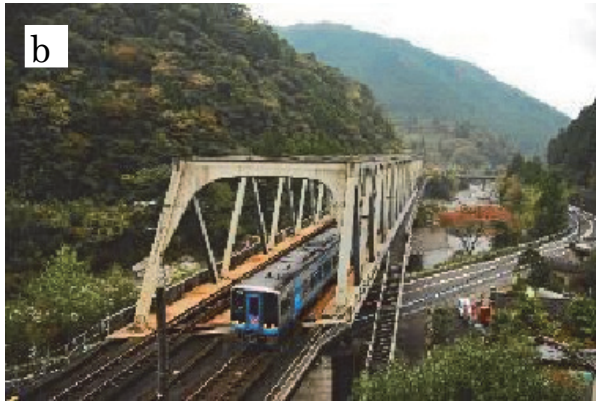
Photo.3 a : Remains of railway bridge located between Osugi Station and Tosa-Kitagawa Station
b : Tosa-Kitagawa Station built on a railway bridge

between Osugi Station and Tosa-kitagawa Station (6.1km) along the Ananai River at the Kochi Prefecture (Fig.3; Photo.3-a; Yokoyama, S., et al., 2012). The train must run over the toe of landslide that consists of Mikabu greenstones in northern part of the section. On the other hand, it must run through the rock-fall area that consists of quartz schist in southern part of the section. There are many disasters occurred frequently, the railway route on river side was changed to two long tunnels and a railway bridge.

In southern part, Tosa-Kitagawa Station was transferred to a railway bridge from the ex-location along the Ananai River. The station having a platform on a railway bridge is rare in Japan (Photo.3-b). The construction of Tosa-Kitagawa Station on the railway bridge is advantageous for disaster prevention, because it does not suffer from influence of the slope failure directly. We can recognize that a lot of huge quartz schist rocks of the past collapse still remain in the Ananai River.

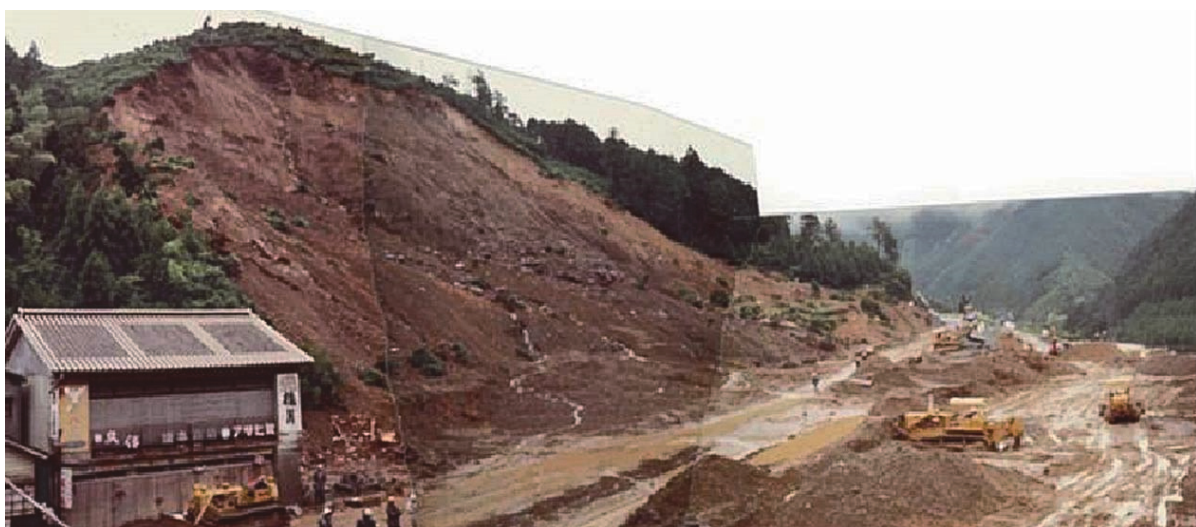
Photo.4 : Shigeto Station six days after the disaster on July 11, 1972. The station facilities and the stopped train were washed away by slope collapse (Photograph by OYO Corporation)

In contrast to them, the large-scale slope failure took a heavy toll of human lives at Shigeto Station in Kochi Prefecture on July 5, 1972 (Photo.4). The heavy rain continued for two days, it triggered the collapse. At first, the slope collapsed within the small area several times, at the north side of Shigeto Station facing to Route 33. And then, a large slope failure occurred around 10:50. The train which just stopped at the station was involved in the debris flow and fell to the Ananai River. About 60 people that were the crews, the passengers, the inhabitants, and the fire fighters etc. died of the disaster. In the source area there is distributed the Chichibu terrane which was formed in high angled reverse-dip. It is suggested that

the collapse was happened by unstable and long-term weathering. It is one of the examples that showed the strictness of nature in Shikoku mountain district as a slope disaster. Now surroundings of the Shigeto Station are restored, there we can understand the disaster to compare with the present and the past by a photograph.
