11. GIS Analyses of the landslides in Japan

わが国の斜面災害の GIS 解析の諸例

○ Hiromitsu Yamagishi (Ehime University), Netra Prakash Bahndari (Ehime University), Lulseged Ayalew (University of Hamburg), Junko Iwahashi (Geographical Survey Institute, Japan), Shoji Doshida (University of Tokyo), Edgar Piemonte (Lund University), Fumikai Yamazaki (Kashika Vision)

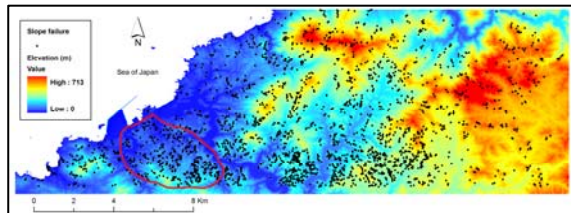
Fig. 2. Distribution of slope failures (Pimiento and Yokota, 2006) and elevation from 10 m DEM (Geographical Survey Institute of Japan, 2009). The centers of the source area of the failures are represented as points. Notice that the encircled area is sub-area which is much concentrated in failures.

The slope failure distribution (Fig. 2) was obtained from the stereoscopic interpretation of 1:8,000 scale black-and-white aerial photographs that were taken just after the rainstorm. Fig. 2 shows only the source areas of the failures; the deposits of slope failures were

omitted. The average size of rupture surface was 1,400 m²; and 40% of all failures had a surface of rupture between 500-1,000 m² (Pimiento and Yokota, 2006).

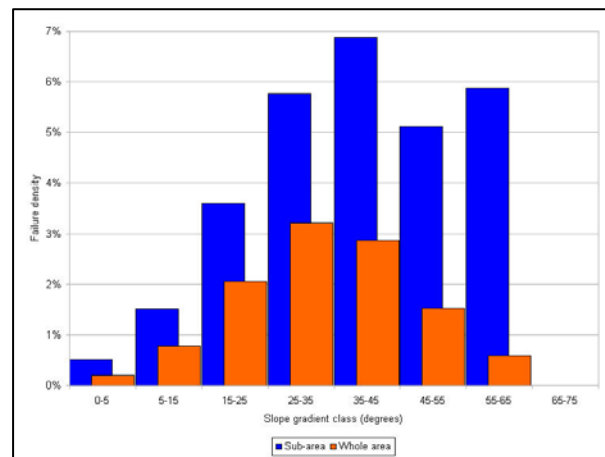
Fig. 3 . Frequency distribution of percentage of failure density in relation to slope gradient classes. Whole area analyses indicate that the peak is around 25-30 degrees, but sub-area is that density increases with the slope degree.

The slope failure distribution map (Pimiento and Yokota, 2006) was compared to slope gradient and elevation. The elevation data is the 10m DEM downloaded from the Website of Geographical Survey Institute of Japan (2009). In relation to slope gradient, in the total area (Fig. 2), the failure density increases up to around 35-45° with slope degrees (Fig. 3). While, the failure density of the sub-area (Fig.2) which is highly concentrated, show that the peak of 3.2% for the 25-35 degree slope class.

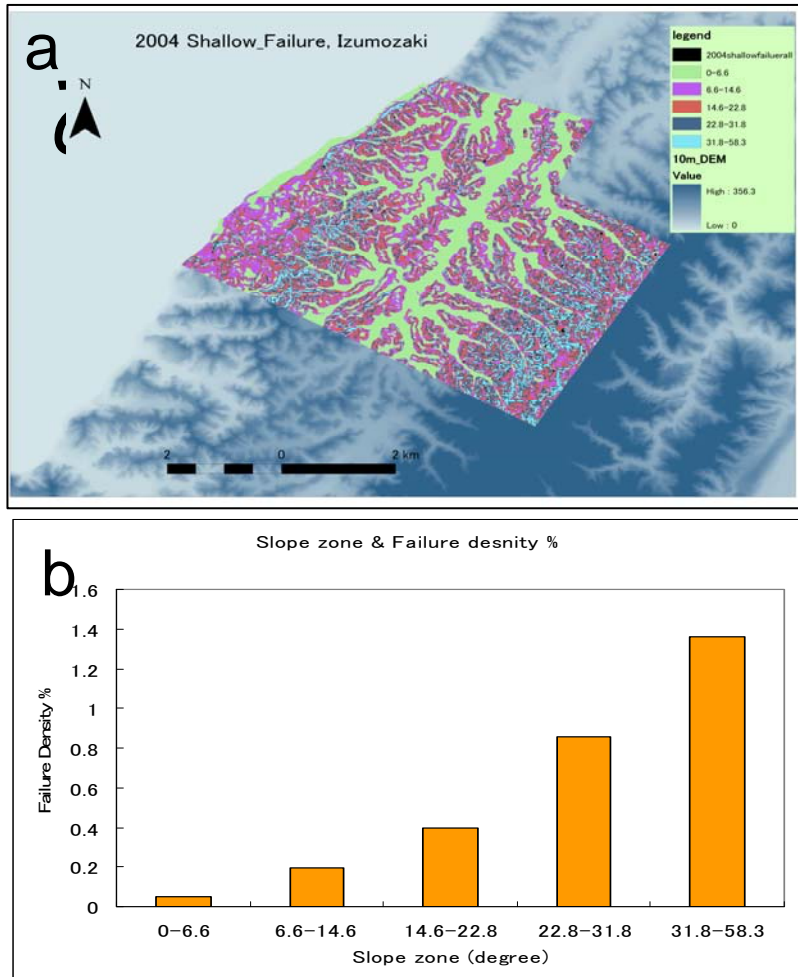
Fig. 4 a: Map showing the interpreted area of the 2004 heavy rainfall-induced failures in Izumozaki, Niigata . **b:** Graph showing the relationship between the failure density and slope gradient zones

1961), 1980 (1976-1978 rainfalls) and 2004 (just after the July 13 rainfalls) .In this paper, using GIS, we have analyzed the failures on July 13, 2004 in order to make clear the relationship between the failures and slope degrees in the polygonal area as shown in Fig. 4a. We have made slope distribution map derived from 10 m grid DEM(GISMAP) and divided into 5 zones in gradient zones with intervals of 8° degree.

As the results, we have revealed that shallow failure density is exponentially increasing up to 31.8-58.3 zone (Fig. 4b). The fact suggests that failure density mostly depends on the slope degrees.

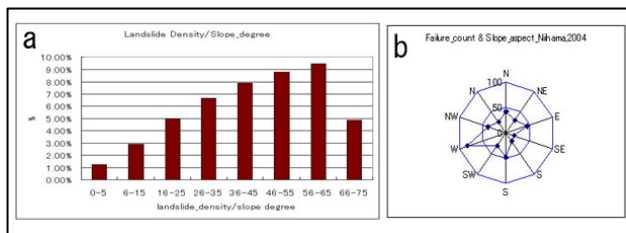
Fig. 6 a: Relationship of the failure density to the slope degree class. b: Radar chart of the failure directions of the 2004 Niihama disasters.

In the highly affected area (Takahama; Fig.5), east of Niihama City, the total number of slope failures was 900 with a total area of 1.2 km². Slope gradient values were reclassified into 10-degree classes and the failure density gradually increased to 9.5% for the 55-65 degree

slope class; then it decreased drastically for up to more than 65° degree (Fig. 6a). In relation to elevation, failure density increased gradually and was higher than the average density between 120 and 250 m; then it decreased for higher elevations.

The number of the failures gradually increased to about 300 for the 130-140 m class, and then the frequency decreased gradually for higher elevation classes. Finally, the number (count) of the failures are preferably concentrated to the western original slopes (Fig.6b).

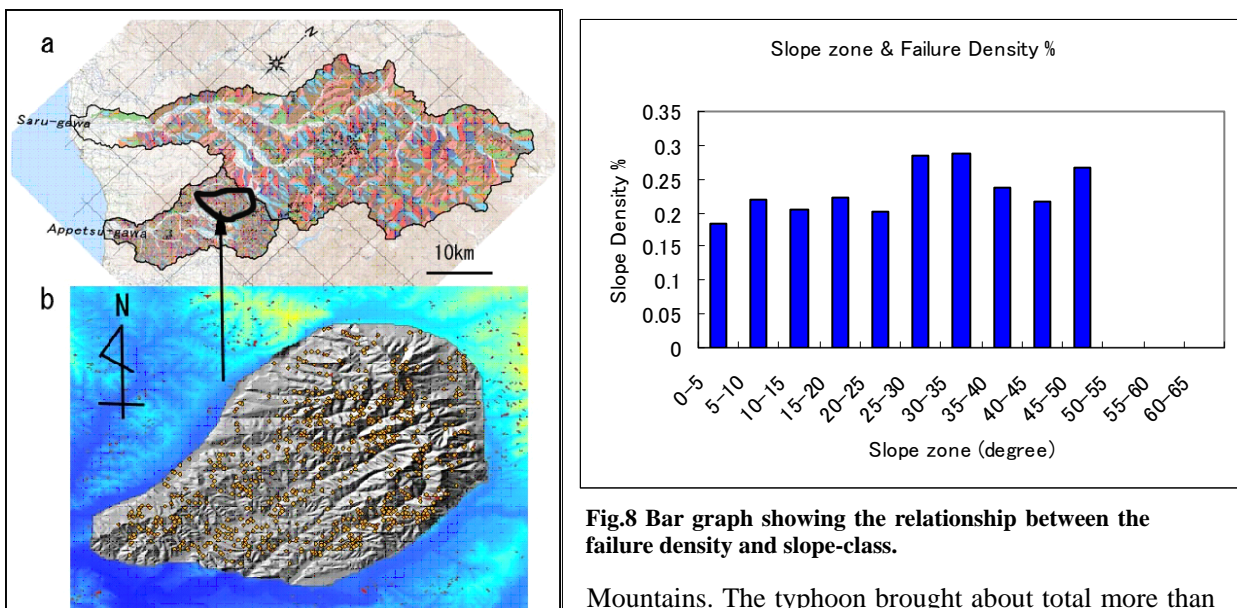
Fig.8 Bar graph showing the relationship between the failure density and slope-class.

Fig. 7 a: Failure distribution map of Sarugawa and Appetsugawa Tributaries. b: Failure concentrated area which is dealt using GIS.

Mountains. The typhoon brought about total more than 400mm precipitation within two days. At maximum, 50mm/hour was recorded. As the results, total 20,000 failures were inventoried along the Sarugawa and Appetsugawa tributaries (Fig.7a). In this section, we are focusing the concentrated failure area along the

Appetsugawa (Fig.7b).

As the results, we have obtained the graph in Fig.8. The graph shows different patterns from the failures of the other areas; even gentle slopes show relatively high failure density, and the highest peaks are ranging from 25 to 35 degrees. While, the failure number related to slope gradient has a peak at 25-30 degree.

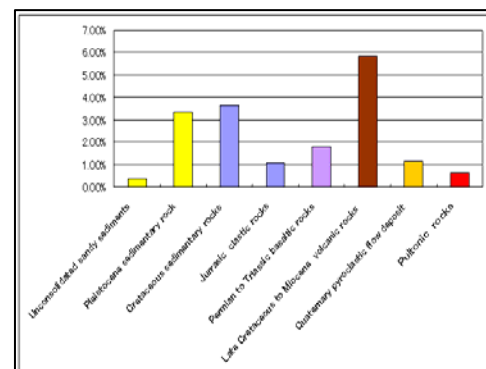
Fig.12 Bar graph showing the landslide density at each geologic unit (total 13 geologic units).

Hokkaido Island has more than 12,000 deep-seated landslide sites according to Yamagishi (1994). GIS analyses of the landslides related to Geology (total 200 legends of GeoDB were
