Study on the deformation characteristics and dynamic mechanism of seismic fractures in Wenchuan earthquake shattered slopes

Jin Ke YUAN, Run Qiu HUANG and Xiang jun PEI

State Key Laboratory of Geohazard Prevention and Geoenvironment Protection, Chengdu University of Technology, Chengdu 610059, Sichuan E-mail:yuanjingke@163.com

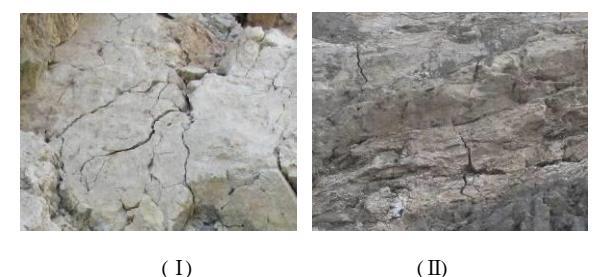
Surface type seismic fracture was refer to the rockmass surface shattered longer length from its characteristics, but its width and visible depth is generally small. Small scale of such fractures were developed in all kinds of slope structure, and there is no obvious directional distribution, it distributed in the rockmass surface, and had poor deep interconnectivity (Fig 1).

Fig. 1 Surface seismic fracture

[1] broken line type: The spreading direction in plane of seismic fractures was turning, bent point of the polyline or arc-shaped, and then continue to extend(Fig. 1 I).

[2] Linear type: The overall spreading direction in plane of seismic fractures was extended straight, little change in direction, no significant turning or bending in the process of extending(Fig. 1 II).

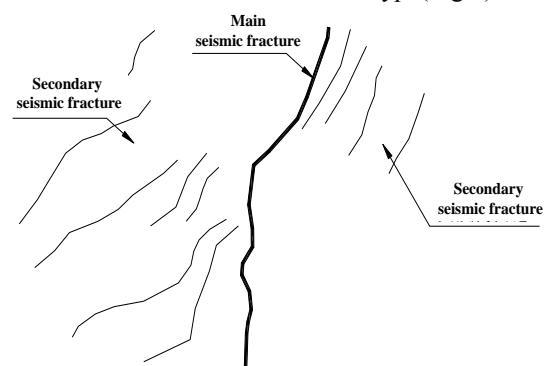
[3] En-echelon type: it formed by a series of seismic fractures whose direction substantially the same, enechelon distribution presented on the plane, seismic fractures were broken line or linear type(Fig 2).

Fig. 2 Distribution schematic diagram of en-echelon type seismic fracture

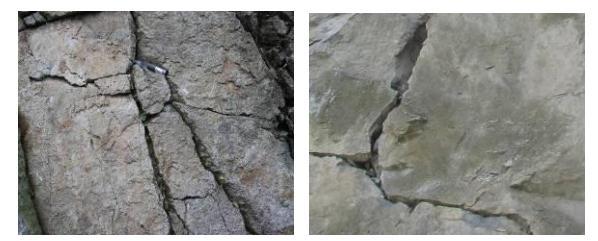
groups of seismic fractures whose extension direction were different, cross each other, the distribution shape on the plane was "X" or "Y"shaped(Fig 3).

(I) "X" shaped seismic fracture (II) "Y" shaped seismic fracture Fig. 3 Crossover type seismic fracture

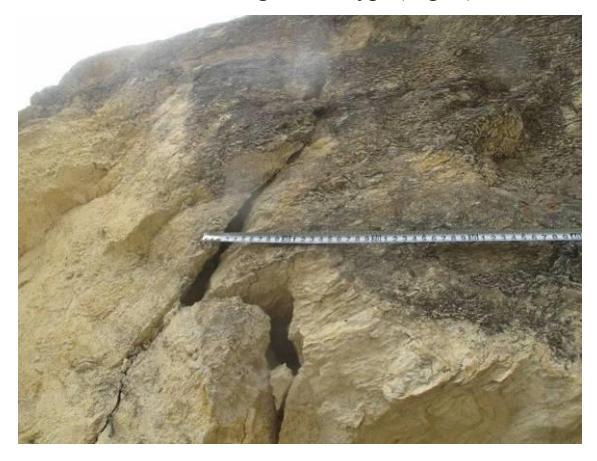
Comparatively speaking to seismic fracture surface, the transfixing seismic fracture not only long extending length, but also large opening degree, visible depth was up to 10m. The fracture had good interconnectivity, linear extension in plane, joint interface jagged, throughout inside the rockmass by the form of pinch-out. For survey, the majority of seismic fractures belong to this type(Fig. 4).

Fig. 4 Seismic fracture throughout inside rockmass

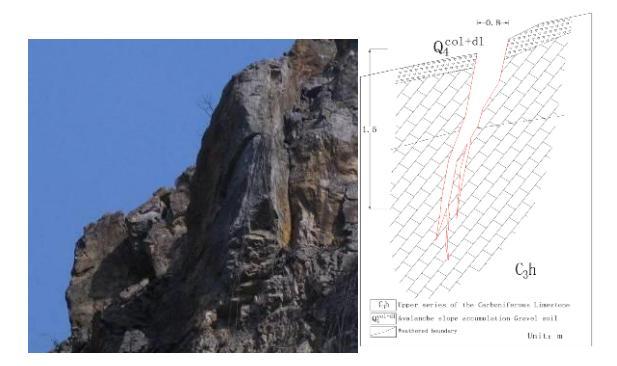
The development scale of ransfixing seismic fractures were large and had good interconnectivity, it caused significant damage to rockmass structure and affect the deformation and instability of rockmass. Through the investigation of fractures on slope, such fractures developed in better position as slope top, steep slow border, free face to formed the trailing edge or side edge boundary of cutting rock mass, it become the main controlling factors of shattered rockmass stability. Seismic fractures cutting rockmass to formed the dangerous rock body on slope(Fig. 5).

Fig. 5 Dangerous rock formed by seismic fracture cutting

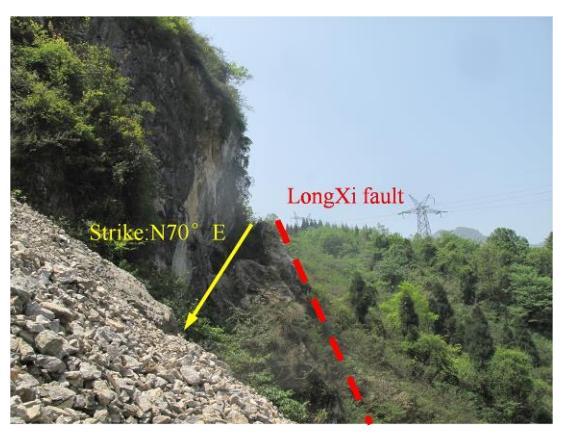
According to the extension direction of seismic fractures, the strike type seismic fracture was refer to its length along the strike direction was larger than along the dip direction, fracture developed mainly along its strike. The extension direction of strike type seismic fracture was identical or similar to the direction of tectonic force (such as the strike of fault). These seismic fractures extended along its strike, they had strong directional (Fig 6). Since this type of seismic fractures developed was mainly due to the effect of tectonic force, so their developmental scale were generally larger.

Fig. 6 Seismic fracture developed near the fault

Strike type seismic fractures exposed on slope by lesser extent of subjected to the influence of terrain and surface features, their extension length along the strike direction was large. Seismic fractures were mainly distributed in the vicinity of fault. It was due to the strong earthquake force existed at the fault, higher degree of rockmass shattered, fractures could easily developed along the strike direction of fault. And seismic fractures which existed at other locations, owning to their extend process was limited by the influence of terrain and surface features, so the characteristics along the strike extension was not obvious. The strike of this type seismic fracture was $N30^{\circ} \sim 60^{\circ}E$ by field investigation, seismic fractures which developed along their strike direction were located in the vicinity of fault.

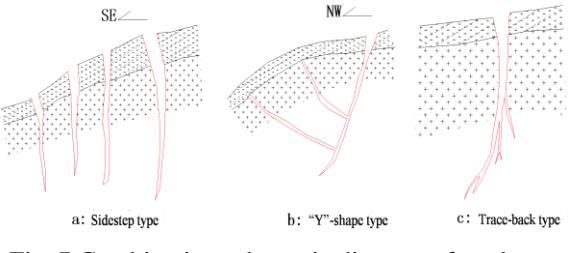
seismic fractures, the Ladder type, "Y" -shape type and Trace-back type had presented in the morphology of profile combination (Fig. 7). Ladder type seismic fractures was characterized by a series of fractures which inclined, extended to the same direction, parallel or nearly parallel to each other. Due to the visible depth limited in such seismic fractures, so this type fractures may also intersected in the deeper position of rockmass. The characteristics of "Y" -shape type seismic fractures was that a series of different tendencies seismic fractures crossed in the extend process to the deep, "Y" -shape presented in the profile. Trace-back type seismic fracture was refer to the fractures occurred one or more branches, the secondary seismic fractures which continuous or intermittent appeared in its extend process into the deep.

Fig. 7 Combination schematic diagram of tendency type seismic fractures

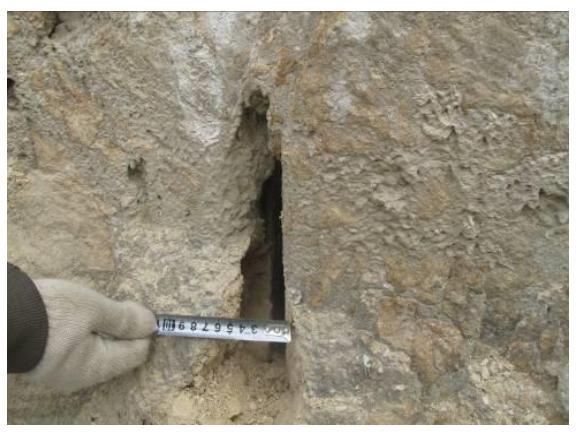
For the extending trendence in the distribution plane of seismic fractures, the joint interface on this type of fractures uneven in extension process, at both ends of the fracture closed or nearly closed, but the intermediate portion is open, small opening width (Fig. 8).

Fig .8 Closure type seismic fracture

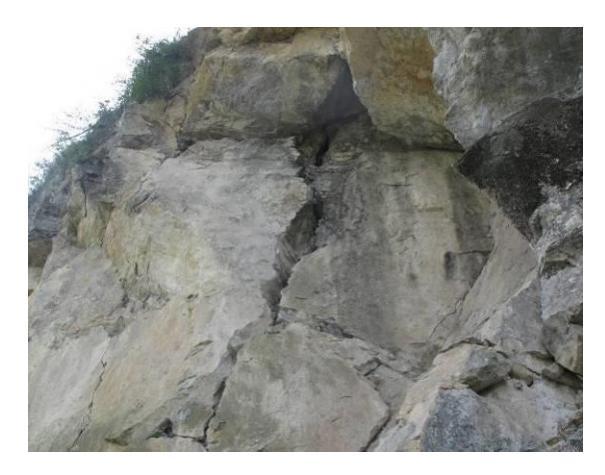
Extended type seismic fracture refers to its extension in the section, one end was gradually open, and extended to the slope surface with opening gradually large, one end gradually pinch out into the deep, and had the wedge-shaped gap of wide upper-narrow lower. This kinds of fractures was large opening degree, filling less or no, the joint interface was rough and jagged(Fig.9).

Fig. 9 Extended type seismic fracture

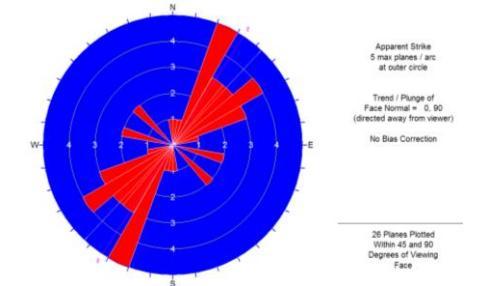
Seismic fractures was N30 $^{\rm o} \sim 60$ $^{\rm o}$ E trending(Fig.10), it is basically the same with the

triggering seismic faults in Wenchuan earthquake, the extension direction of fractures has obviously effected by the triggering seismic fault. Some larger degree of shattered opening fractures spread by linear shaped, good extension, generally not subjected to the influence of the terrain and surface features in its extending direction. Some seismic fractures were corresponding with the fault which influenced their development. American scholars (Leonard 1929; Holzer et al. 1987)put forwarded the view of tectonic origin in seismic fractures by analysis the earthquake force, they thinked the tectonic is the dominant factor in formation and development of seismic fractures.

Fig. 10 Statistical graph of typical seismic fractures

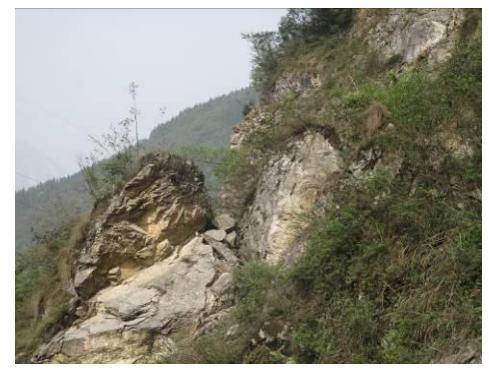
The extension length of seismic fracture refers to its continuous length exposed on the slope surface. The fractures extended length generally longer, more than 6m. Some shattered serious fractures was up to 10m in length, portion extended to the top of slope. Collapse pit, tensional slot were exposed in the process of extending(Fig.11). Large number of secondary seismic fractures were distributed around the main seismic fractures. The secondary seismic fractures discontinuous distributed and poor continuity.

Fig. 11 Tensile groove developed

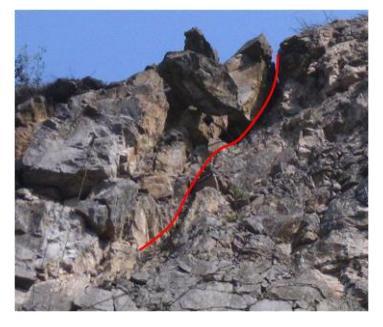
The opening degree of seismic fracture mainly refers to the width of crack in rock and soil mass by shocked tension in the earthquake force. Through the survey, the opening degree of seismic fracture was the form of wide upper-narrow lower shaped, pinch out into the deep(Fig.12). Cai and Zhang (2001) indicated that the seen seismic fracture was wedge shaped fractures on the wide upper-narrow lower form. For some better overall structure of rockmass, the opening degree was small, generally only a few centimeters to a dozen centimeters; Some rockmass with poor structure and structural plane significantly developed, their fractures opened a greater degree. And the seismic fractures located around the triggering seismic faults had the wedge-shaped gap of wide upper-narrow lower, the opening degree in top was closed to 1m, it is illustrated the rockmass around the faults was serious shattered.

Fig. 12 Schematic section of seismic fracture

The shattered width of Surveied fractures were 20cm or more, inclination angle greater than 60 °, extended to deep by jagged-shaped, but it extending to the deep, the shattered width became smaller gradually.

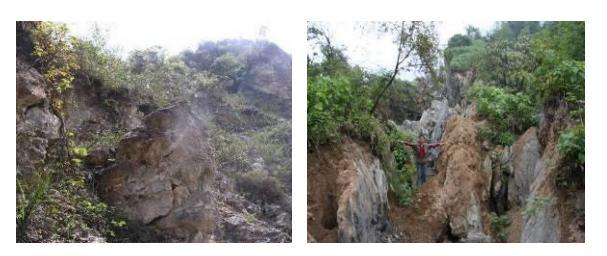
These seismic fractures were large opening degree generally, filling less or no, overhead rockmass. The joint interface was relatively new and bedrock exposed, straight or jagged, extending longer. Wide upper-narrow lower shaped in the form of fractures, shattered stone fragments were filled in it. Both sides of rock and soil collapsed was caused by some seismic fractures which had large degree opening(Fig.13).

Fig. 13 Collapse induced by the slope rockmass were shattered

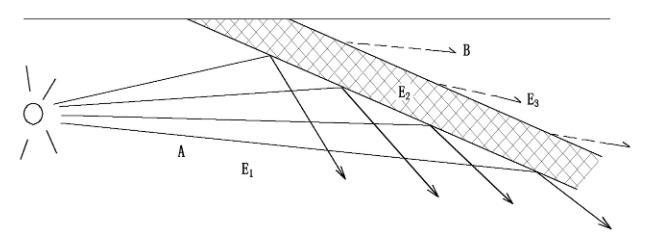
Seismic fracture was mainly caused by the earthquake force. Refraction and reflection of seismic waves occurred in the structural plane when the seismic waves affected it (Fig.14), so the rockmass in structural plane shattered crack due to the tension crack which caused by the accumulated stress(Zhang et al. 1993). The slope damage caused by seismic force was closely related to the effect of seismic waves, seismic wave is divided into P-wave (longitudinal wave) and S-wave (shear wave), both joint action at the structural plane of rockmass. P-wave and S-wave with frequency up-down and horizontal vibration, this generated n-pull, anti-pull repeated stress to rockmass in the structural plane, and rockmass in the structural plane cracked open along the structure plane under the dynamic action of powerful earthquake force(Zhang et al. 2005; Feng et al. 2009; Newmark 1965). The shear strength of structure plane quickly lower owning to it suffered repeated shear stress, rockmass was cutted along the structure plane by the action of strong shear stress, rockmass opened and deformed. Myer (1990) studied the propagation characteristics of seismic waves through the rockmass joint surface and the force between the rockmass interface controlled by the Coulomb criterion. Liang (2003) holded that the structure plane formed shattered face by the earthquake force, the rockmass above the surface would out of the parent rock and continue to movement, and the rockmass below the surface would generate a new free surface due to the influence of upper shattered face.

Fig. 14 Schematic diagram of stress wave propagation effected by the structural plane

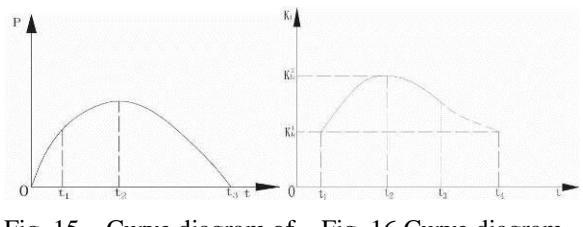
Seismic fracture formed by the process of rupture, perforation, extend in rockmass, internal fracture was further developed into large fracture in the slope at last. The ruptured of rockmass was mainly due to seismic waves, Fig 15 shows a simplified seismic waves schedule figure, Fig 16 is a figure of simplified equivalent stress intensity factor curves. Use the fracture mechanics theory to analysis the process of rupture, propagation and crack arrest in rockmass (Li 2010).

Fig. 15 Curve diagram of Fig. 16 Curve diagram of seismic wave course stress intensity factor

Combined with fracture mechanics, the rupture criterion of rockmass is the maximum stress intensity factor criterion, law of K, the rockmass will produce tensile failure if the stress intensity is greater than the fracture toughness. At time t=0, seismic waves is not yet in effect, the structure plane only in the static stress field, $K_I \leq K_{Ic}^{1}$ (K_{Ic}^{1} fracture toughness), it is in the closed state. With the seismic waves apply to the structure plane, the earthquake intensity gradually apply to the structure surface. Increase over time, the intensity gradually increase, the equivalent stress intensity factor will also increase accordingly, the stress intensity factor reaches K_{Ic}^{-1} with the increase of earthquake intensity until $t=t_1$ the rockmass will rupture along the structural plane if it met the fracture conditions.

The fracture generated in the internal of rockmass after it rupture. With the continuing effect of seismic waves $(t_1 \le t \le t_2)$, the fracture continue to expand, this is driven by the equivalent stress intensity factor KI, the maximum rate of expansion obtained by the fracture when the seismic waves reach the peak intensity at t=t₂, K_I reach maximum K_{Ic}^2 . The stress intensity factor KI is gradually reduce with the weakening of seismic intensity after $t > t_2$, the effect course of seismic waves will end until t=t₃. The effect of seismic waves will stop after $t > t_3$, extended fracture is in the static stress field. If the stress intensity factor is still greater than the fracture toughness of rock mass, the fracture will continue to extend in the static stress field, it stop the extension until $t=t_4$.
