Validation of topographical and geological conditions involved in shallow landslide using statistic methods

Yuichiro NISHIKANE⁽¹⁾, Takeshi KAWAGOE⁽¹⁾, Takuya URAKOSHI⁽¹⁾ and Tomokazu ISHIHARA⁽¹⁾

(1) Railway Technical Research Institute E-mail:Nishikane.yuichiro.48@rtri.or.jp

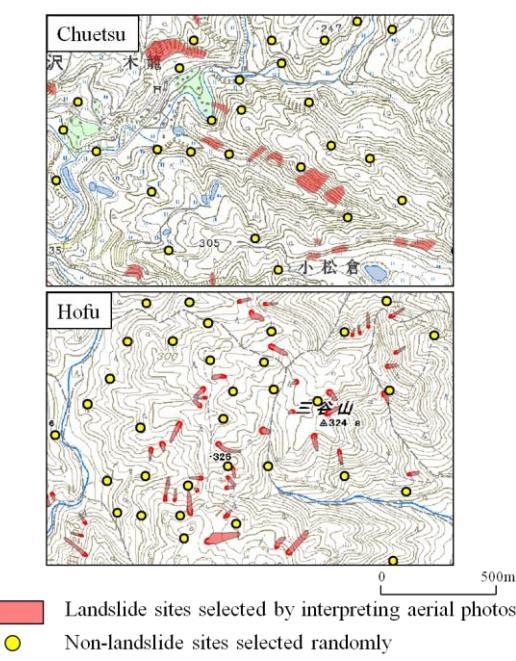
Fig. 1 The selected landslide sites and non-landslide sites

*The shown areas are extracted from the study areas.

order to compare the topographical and geological settings between the landslide sites and the non-landslide sites. The non-landslide sites were selected by generating random numbers on the coordinates on maps of the study areas excluding areas of landslides, pond and artifact. 400 non-landslide sites were randomly selected in each study area. The locations of the landslide sites and the non-landslide sites in a part of the study area are shown in Fig. 1.

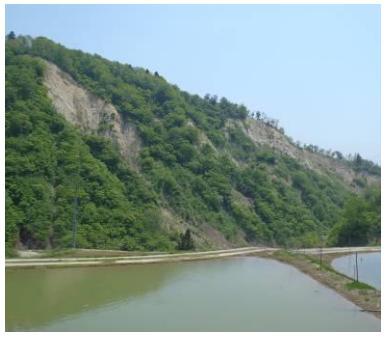
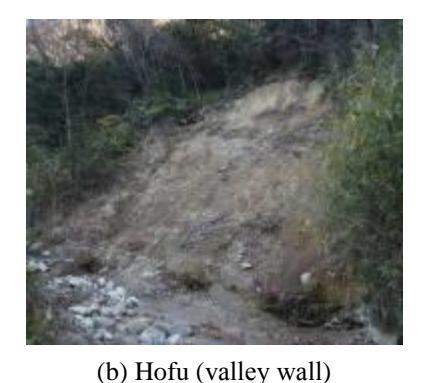
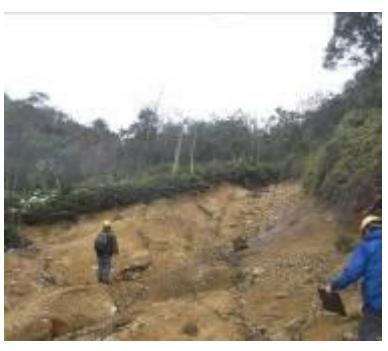
Photo. 1 Shallow landslides in Chuetsu and in Hofu

(a) Chuetsu

(c) Hofu (near the crest)

The result of the check of the conditions is shown in Table 2. The check was conducted at 44 landslide sites and 36 non-landslide sites in Chuetsu, and 5 landslide sites and 2 non-landslide sites in Hofu (Photo. 1). Because of the situations of vegetation and location, the authors could not check whether respective sites satisfied all the topographical and geological conditions. The "satisfaction ratio" in the Table 2 is the ratio of sites where each condition was

"Slope angle" was confirmed to contribute to the discrimination between the landslide site and the non-landslide site only in Chuetsu. In Hofu, a lot of shallow landslides occurred at the lower slopes (valley walls) whose angles are around 40 degrees (Photo. 1(b)) and at gentle slopes near crests (Photo. 1(c)). Weathered granitic bedrock was distributed in lower slopes, and decomposed granitic soil was

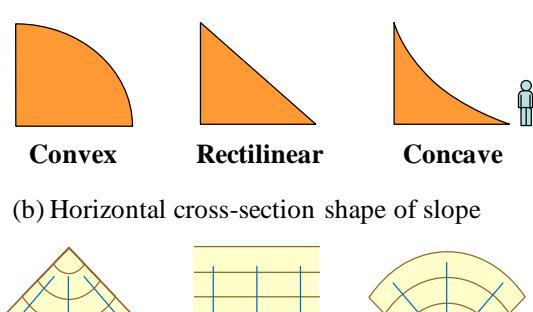
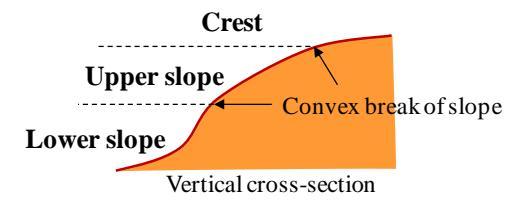
Fig. 2 The classification of topographical information

*Arrow shows a direction of water flow.

(c) Location on vertical cross-section of slope

[1] Vertical cross-section shape of slope (Fig. 2(a))

[2] Horizontal cross-section shape of slope (Fig. 2(b))[3] Slope angle

[4] Location on vertical cross-section of slope (Fig. 2(c))
